Kewaunee Nuclear Power Plant  
N490, State Highway 42  
Kewaunee, WI 54216-9511  
920-388-2560

Docket 50-305  
Operating License DPR-43  
Kewaunee Nuclear Power Plant  
Reportable Occurrence 2000-010-01

Testing and Evaluation Determine the Service Water System has a Lower Design Basis Temperature Than Previously Believed

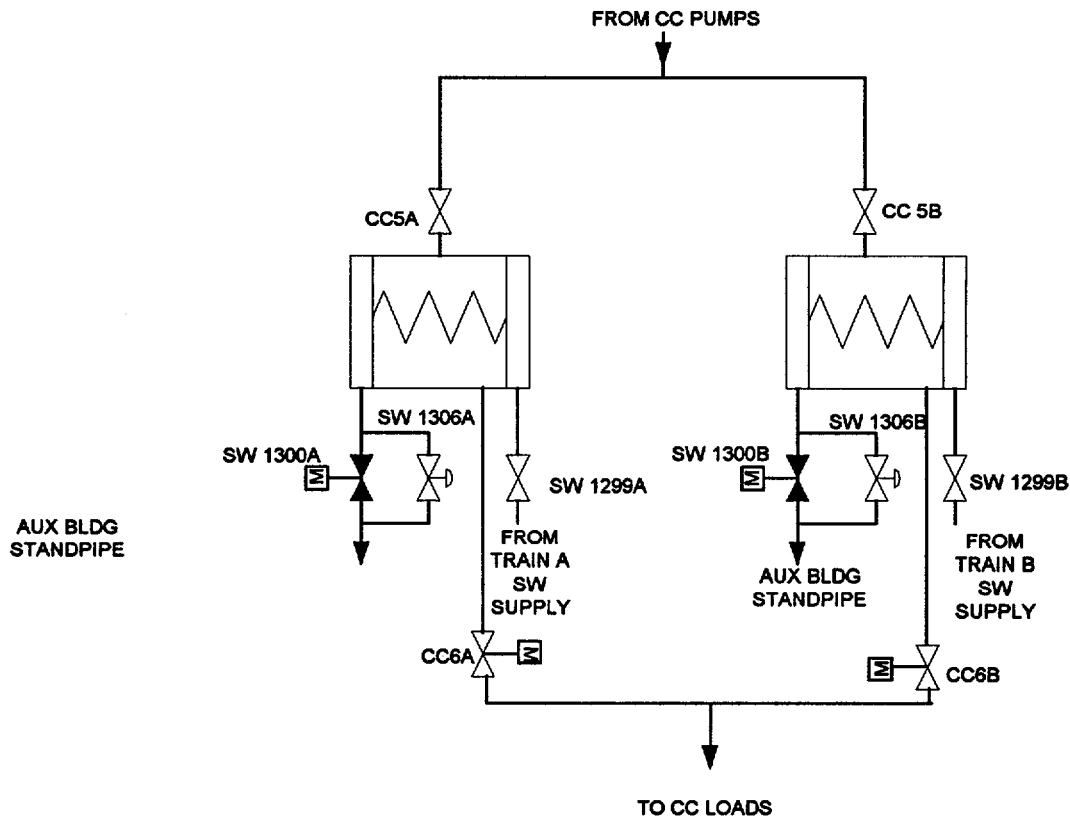
Figure 1

- 4) Failure of containment fan coil unit [FCU] discharge throttle valves [V] to fully open, and
- 5) The effects of component cooling water heat exchanger [HX] control valves failing open (refer to Fig. 1).

The testing performed this outage also revealed that the margin on containment fan coil units and component cooling water heat exchangers were less than expected. The containment fan coil units are used to reduce containment pressure following a design basis accident. Containment fan coil units [BK] were re-analyzed at a reduced flow and found to have adequate heat removal.

- 5) To add margin to the containment fan coil units, a design change was performed to change the safety injection signal to the component cooling water heat exchanger (HX) SW outlet valves. Each component cooling HX has two SW outlet valves; a throttle valve used for normal operation and a motor operated gate valve that opens on a safety injection signal (Fig. 1). Testing has demonstrated that for immediate emergency operation, the throttle valve provides sufficient cooling to safeguard components. The gate valve would be required for plant cool down during containment sump recirculation. Previously, the gate valve received an open signal and the throttle valve's position was temperature controlled. The design change results in the throttle valve opening at the start of the

accident with the gate valve closed. The gate valve can be opened as required when containment sump recirculation is started. This adds margin to the containment fan coil units while maintaining sufficient flow through the heat exchangers for immediate emergency loads. The increase in service water pressure is required to ensure maximum heat removal without flashing in the service water lines during maximum containment temperature. Containment temperature will have been reduced significantly by the time containment sump recirculation is required allowing the gate valve to be opened without flashing in the service water lines.

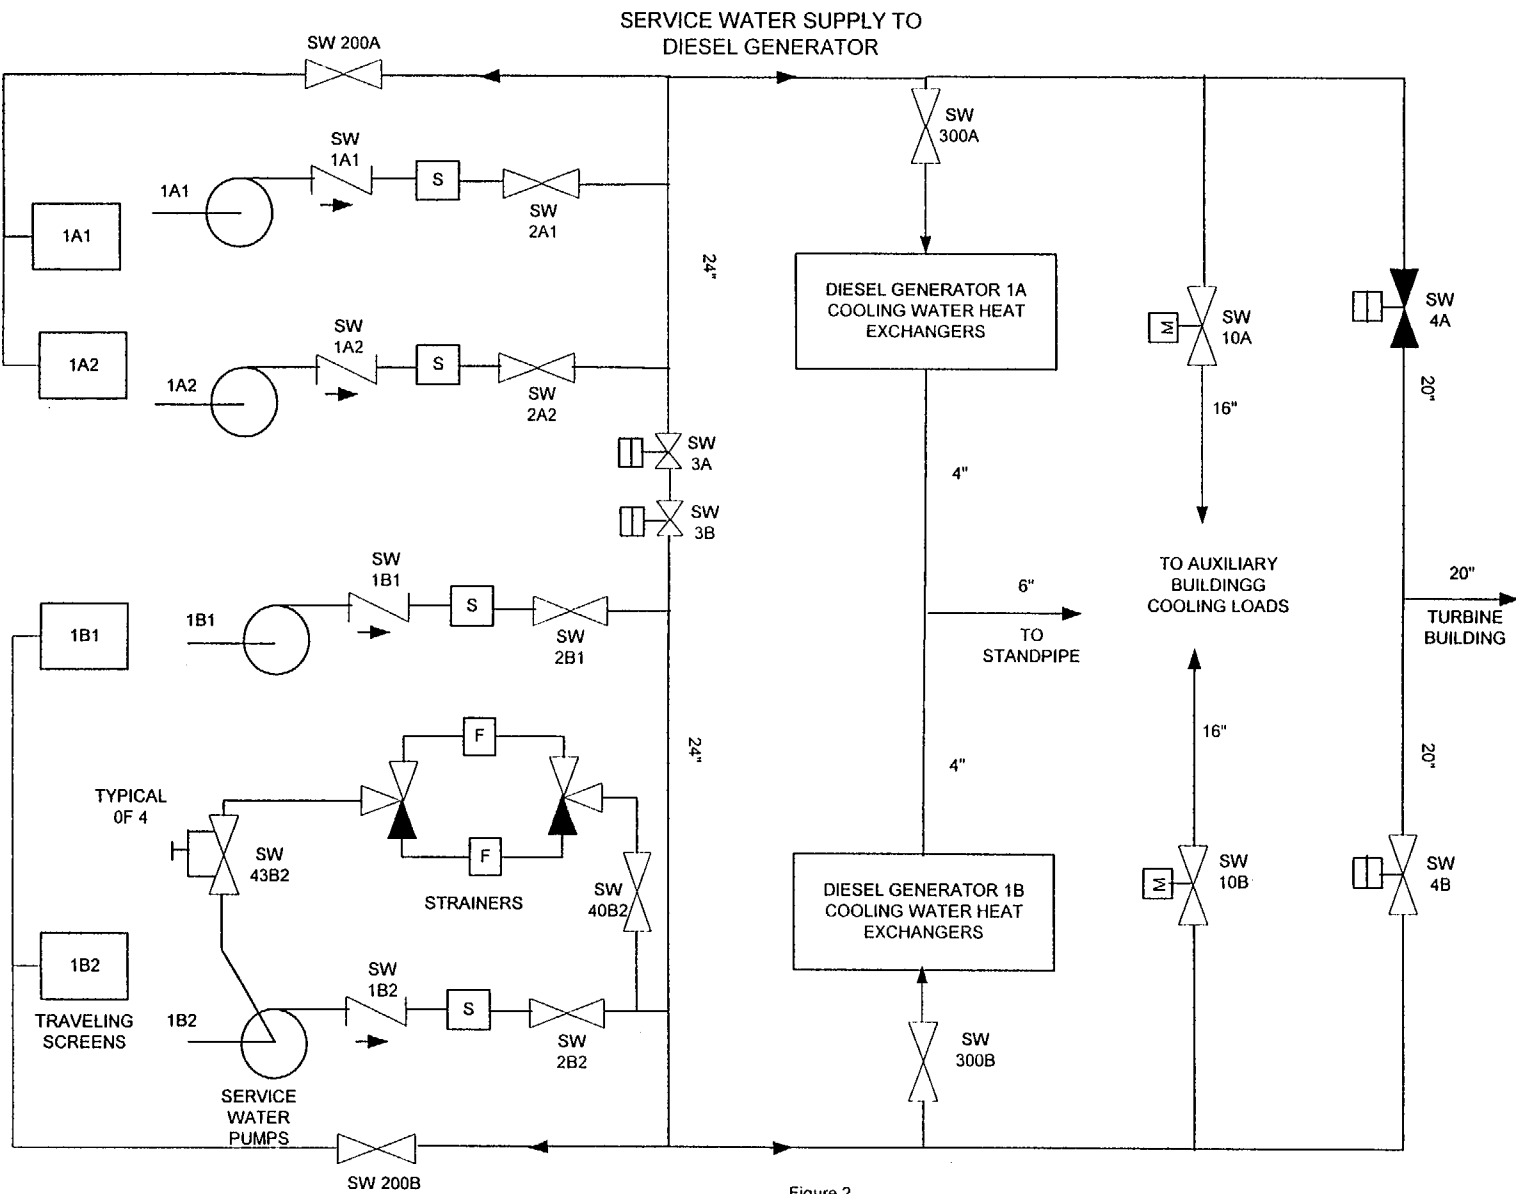
Each emergency diesel [DG] jacket water cooler is supplied by its associated train of service water. These separate trains of service water discharge into a common header after exiting the jacket water coolers (refer to Fig. 2). During the 1990 and 1991 tests, the cooler in the train not under test had no flow established. This line-up maximized flow through the train under test but did not reflect reduced flow associated with a backpressure. This reduced flow would have caused elevated diesel generator jacket water temperature under design basis accident conditions with a service water inlet temperature of 80° F. Calculations determined that during accident conditions, assuming measured fouling factors, both diesels remained operable as long as service water inlet temperature remained less than or equal to 75.7° F. Because the elevated jacket water temperature was not within the parameters supplied by the diesel generator manufacturer, the diesel generators were conservatively assumed to be out of service whenever lake temperature exceeded 75.7° F. This occurred on August 8, 1991 from 19:21 hours to 20:11 hours.

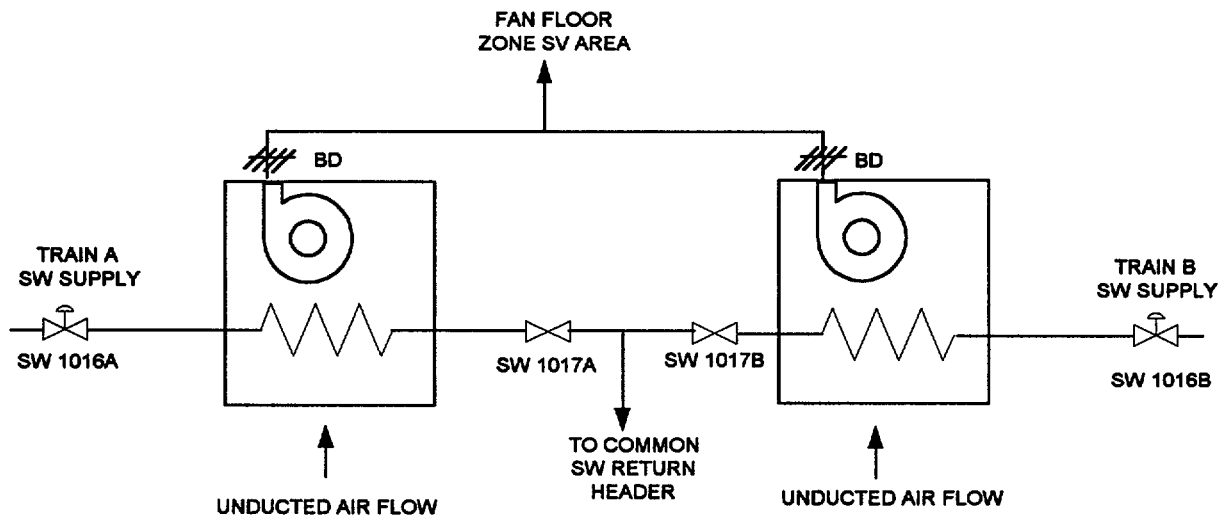
Figure 3

For the fan floor fan coil units, a failure of cooling water to one train while both trains are running was found to be worst case. This occurs because airflow is reduced due to a backpressure in the air duct and service water is supplied to only one unit (refer to Fig. 3). Analysis revealed that the fan floor fan coil units would not have removed the required heat load on several occasions because of high lake water temperature and assuming a failure of the service water supply valve to one train. Based on historical service water temperature data, both fan floor fan coil units have been out of service 11 times since 1990. The maximum time both fan coil units were out of service was 36 hours on August 22 to August 23, 1995.

- 6) The service water discharge piping for the mezzanine fan coil units was split. This will eliminate the backpressure effect thereby increasing service water flow to both units.
- 7) A temporary design change was implemented to fail open the inlet valves to the fan floor fan coil units. A permanent design change is being implemented to remove these valves.
- 8) A design change will be implemented at the next refueling outage, which will split the discharge header of the diesel generator cooler outlet. This will remove the backpressure effect and allow removing the final administrative action (corrective action 1).

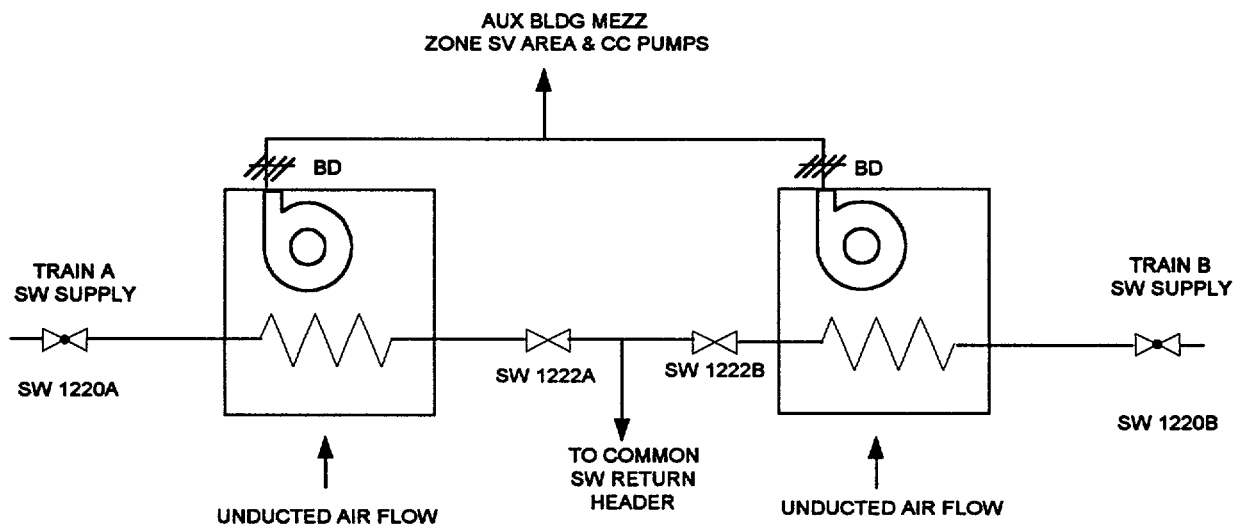
Figure 4

The mezzanine area fan coil units do not have a control valve in the service water supply line like the fan floor area fan coil units (refer to Fig. 4). Therefore, a failure of one fan with both trains of service water available is the worst case for these units. Analysis revealed that the mezzanine area fan coil units would not have removed the required heat load on three occasions because of high lake water temperature and assuming a fan failure. Both mezzanine fan coil units have been out of service three times since 1990. The worst case was for eight hours and 47 minutes, which occurred on August 17, 1995 from 14:32 hours to 23:19 hours.

- 2) The air filters were removed on the Auxiliary Building mezzanine fan coil units to increase airflow.
- 3) A temporary change (TCR) was implemented to fail open the train A strainer backwash valves. The backwash valves flush debris from the strainers when differential pressure across the strainers reaches a predetermined value. Placing the strainers in continuous backwash prevents a high differential pressure from developing in case of instrument failure. A high differential pressure would reduce the margin on the containment fan coil units. When the design change to add margin was completed (see corrective action 5), this temporary change was removed.
