Re: License No. SUA-1534  
Docket No. 40-8943  
Annual Pond Inspection Report

**CROW BUTTE MINE  
DAWES COUNTY, NEBRASKA**

**2000 POND INSPECTION REPORT**

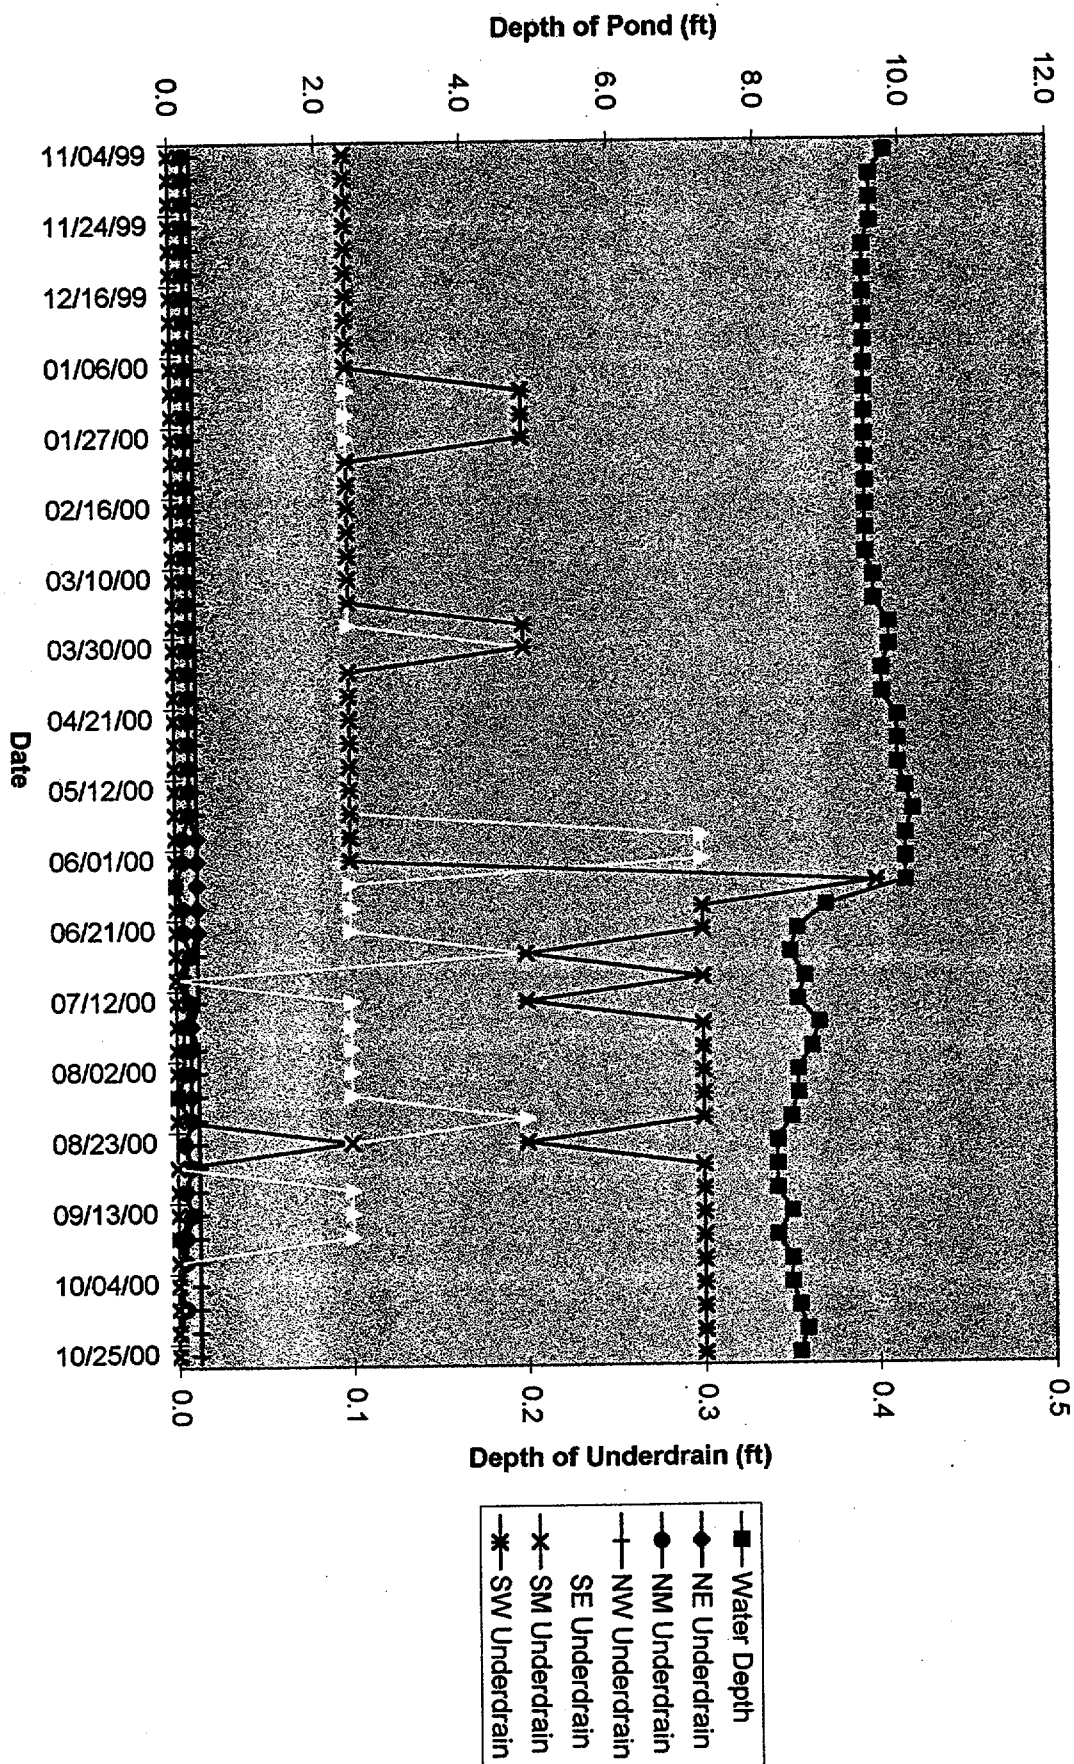
# Commercial Pond 1 - 2000

Three upper liner leaks were detected during the year. The southwest underdrain of Commercial Pond 1 had elevated indicator parameters on June 9, 2000. The south middle underdrain of Commercial Pond 3 had elevated readings on August 24, 2000. On May 19, 2000 elevated readings in the northwest underdrain of Commercial Pond 4 were detected. Repairs have been made to the ponds as necessary and the ponds have been returned to a normal operating status as of the end of November 2000.
