SUBJECT: ARKANSAS NUCLEAR ONE, UNIT 2 RE: DISCUSSIONS REGARDING  
PLANNED CODE REPAIRS TO 12 PRESSURIZER HEATER SLEEVES

## Code Weld Repair of Pressurizer Heater Penetration

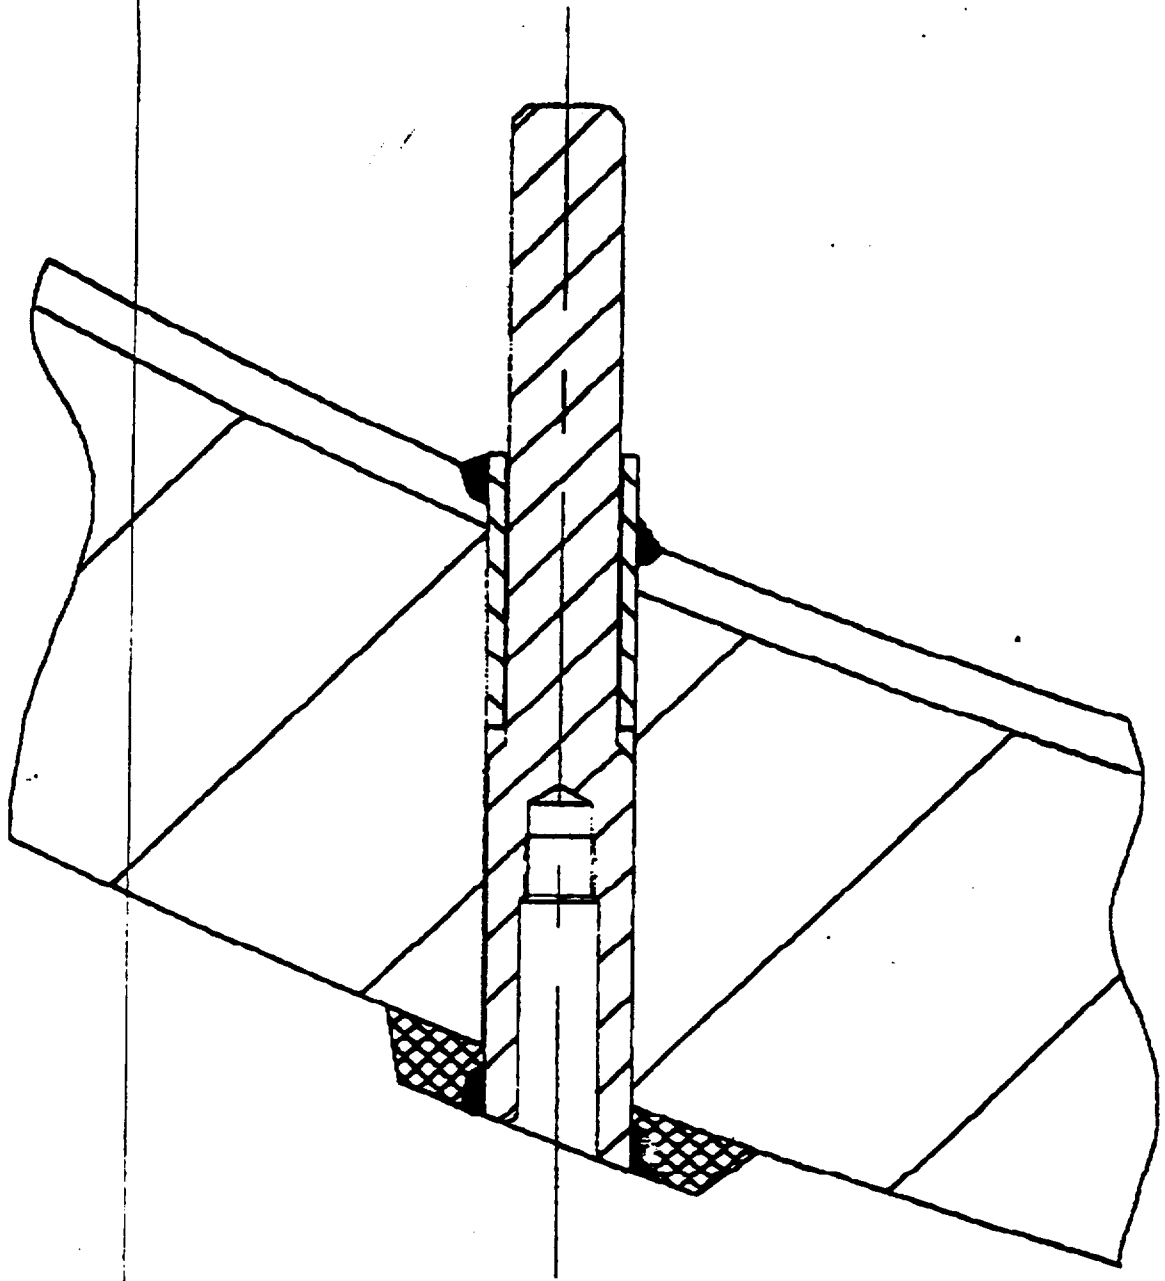
FIGURE 1

As shown in Figure 1 the repair consists of partially removing the existing heater sleeve and replacing it with a dummy heater welded to the outside of the head. The end configuration meets the requirements of NB-3300 and specifically is intended to be a Category D attachment to a Class 1 pressure vessel. Figure 2 shows the dummy sleeve (manufactured in accordance with NB-2000) inserted and ground flush with the OD of the head. The dummy heater does not bottom out against the existing heater sleeve.

The hole meets the reinforcement requirements of NB 3330. Install Plug flush with vessel.

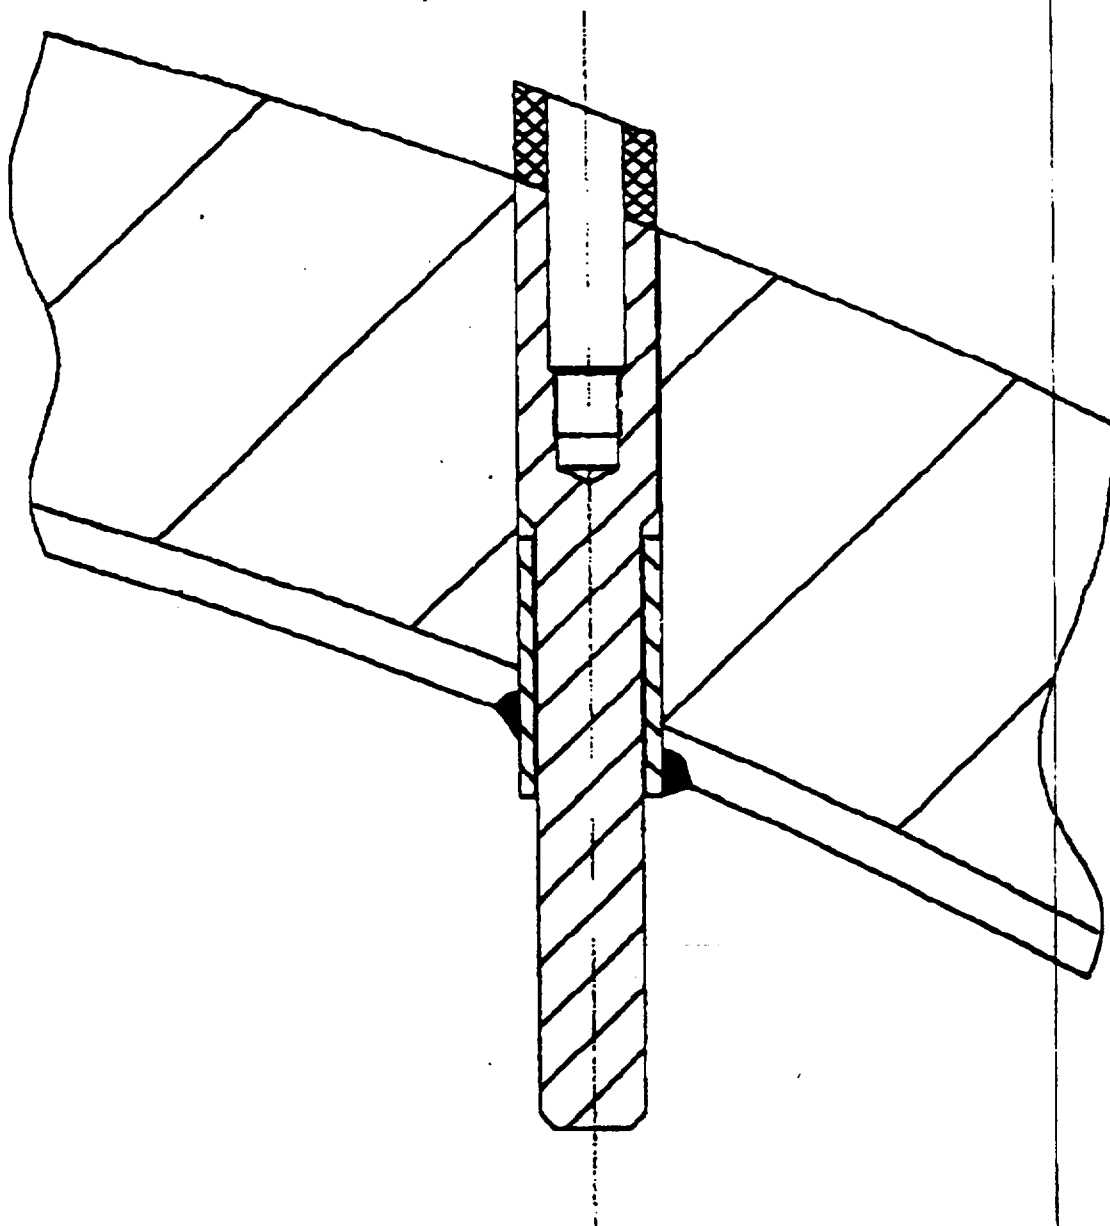
FIGURE 3

Figure 3 illustrates performing a weld build-up on the end of the nozzle. Note this is an artificial step but this could have been performed in accordance with NB-4130 "Repair of Material" the volumetric requirement of NB-2539.4 (Radiography) is not performed but an Ultrasonic examination in accordance with IWA-4530. NB-2500 has no specific provision for substituting UT for RT but this is common practice for Section XI repairs. Also remember this is an artificial step for illustration purposes.

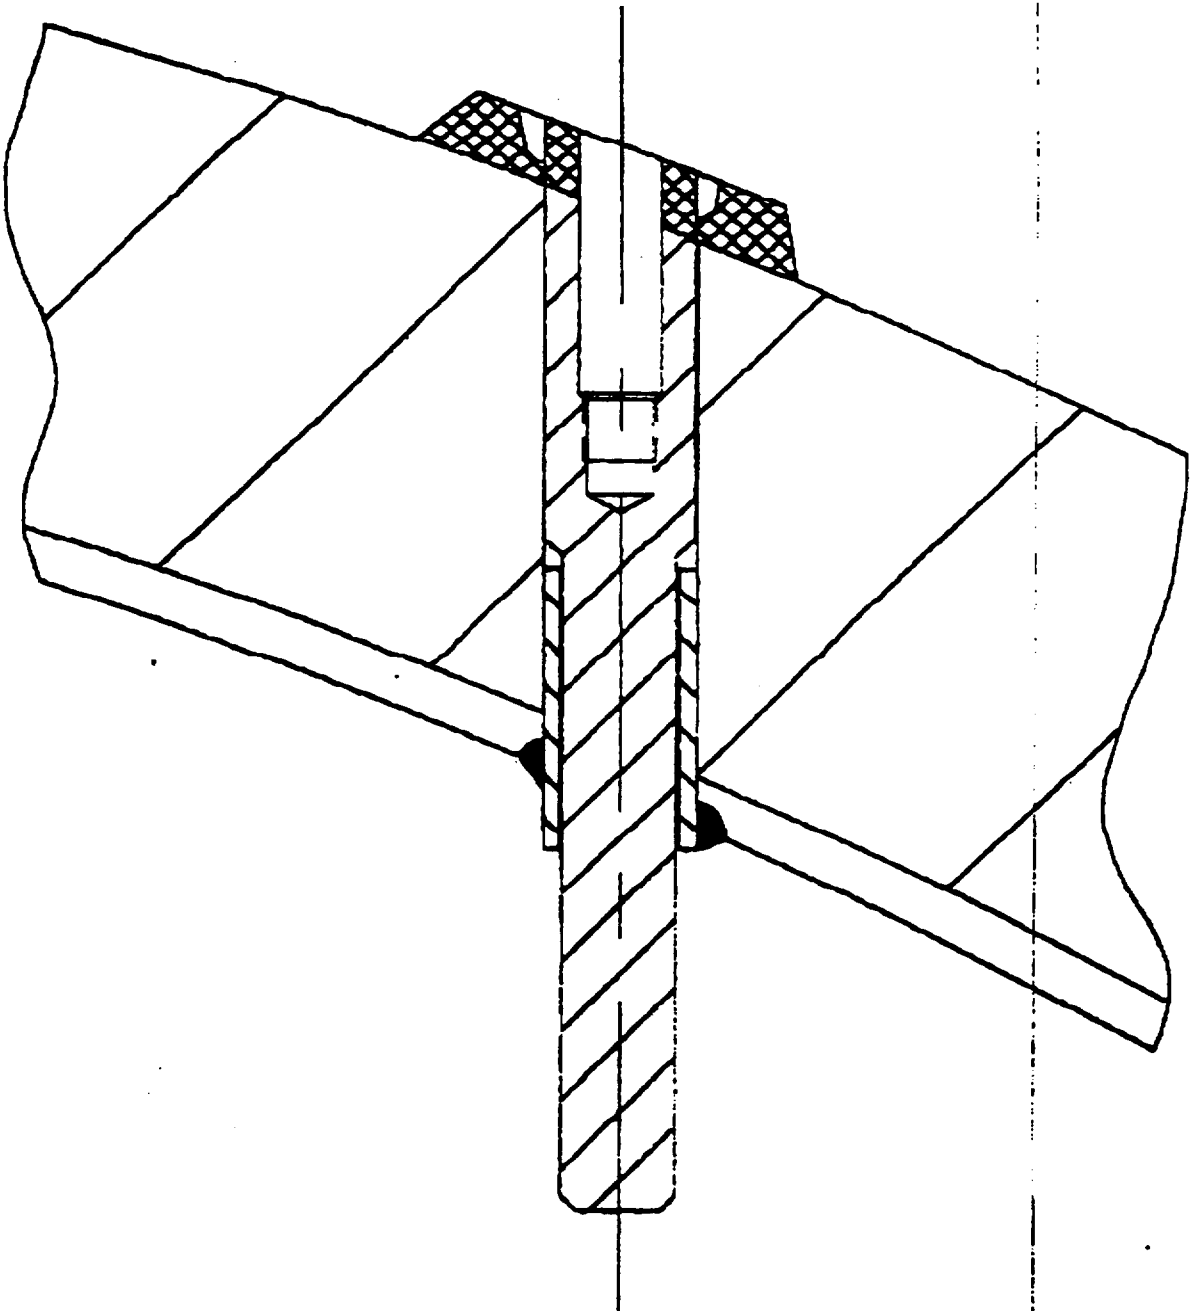
FIGURE 4

Figure 4 illustrates construction of the weld pad in accordance with IWA-4530 leaving a J-prep adjacent to the nozzle which has dimensions sufficient to meet the partial penetration weld requirements of NB-3352.4 and Figure NB-4244(d)-1 (a). The penetration and repair geometry also meet the reinforcement requirements of NB-3300.

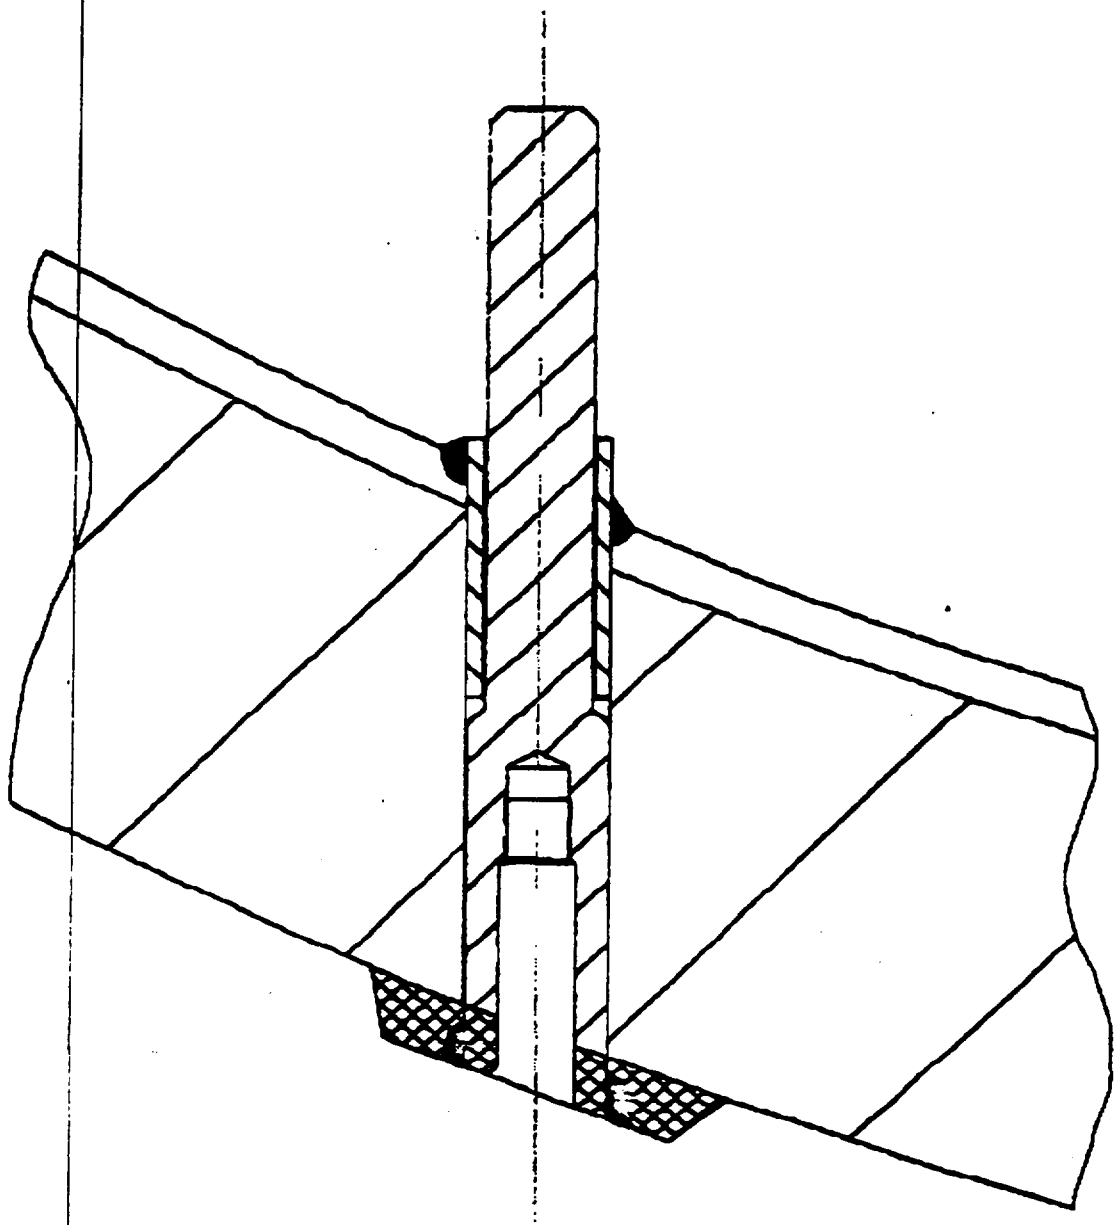
FIGURE 5

Figure 5 illustrates filling the J-prep in accordance with the Code WPS and again the weld meets all of the sizing and NDE requirements Section III and Section XI as applicable.

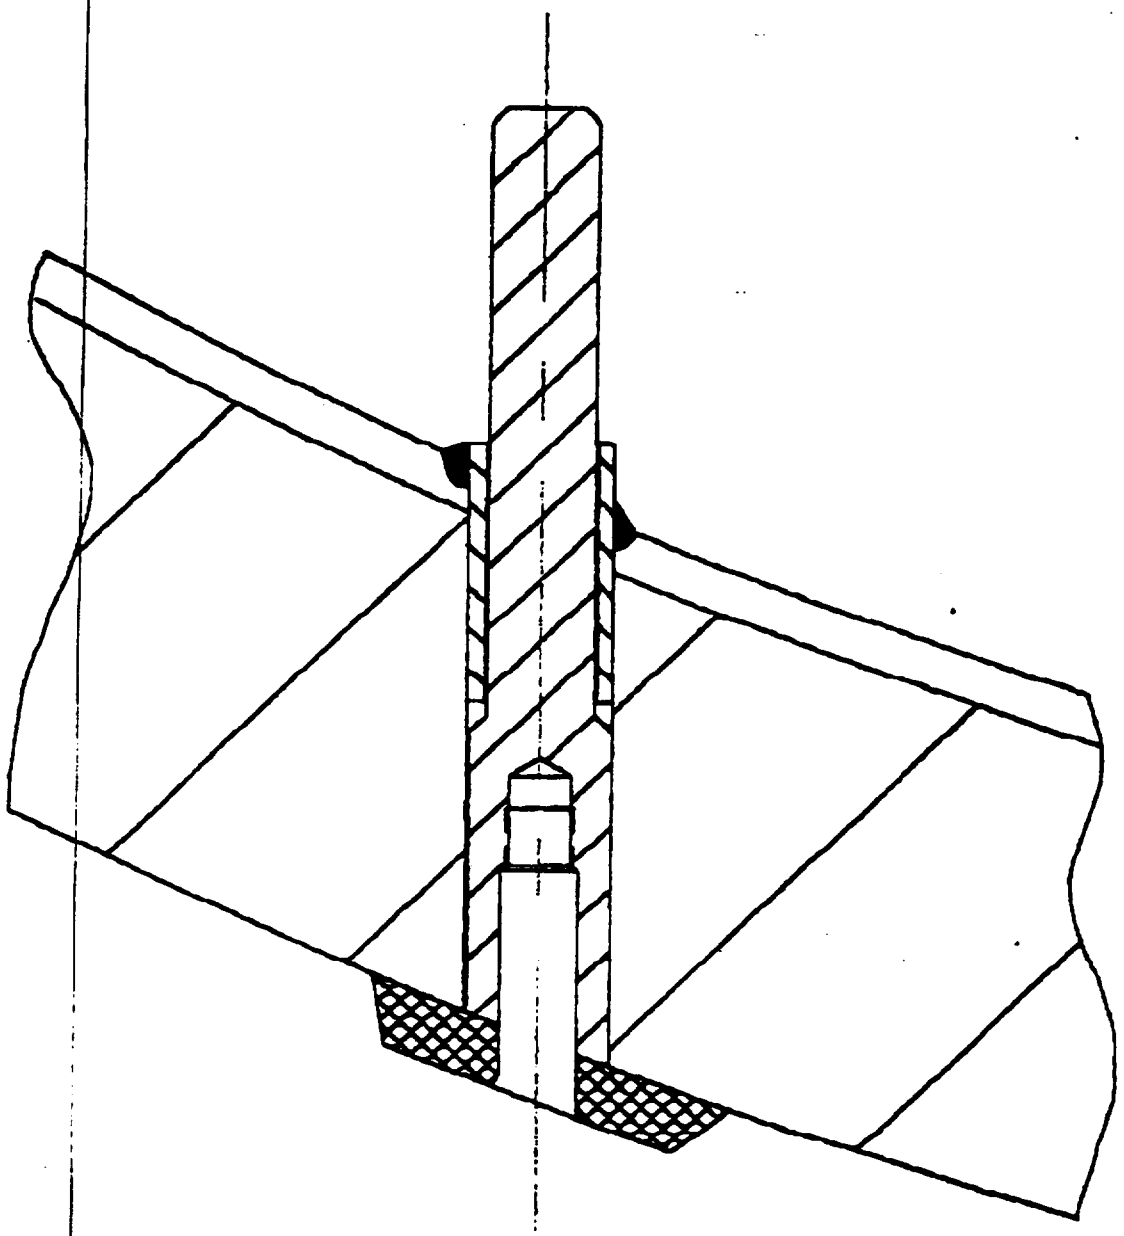
FIGURE 6

The final Figure 6 illustrated the actual as finished weld which is welded continuously except for the stops required for intermediate NDE. Again the pad satisfies at least the NDE requirements of a partial penetration weld in accordance with NB-5260 (dye penetrant) and the additional requirements of IWA-4500 UT of final configuration.
