NPL 2001-0003

DOCKET NUMBER 50-266
LICENSEE EVENT REPORT 266/2000-011-00
LOSS OF 120 VAC VITAL INSTRUMENT BUS DURING INVERTER MAINTENANCE
POINT BEACH NUCLEAR PLANT UNIT 1

Loss of 120 VAC Vital Instrument Bus During Inverter Maintenance

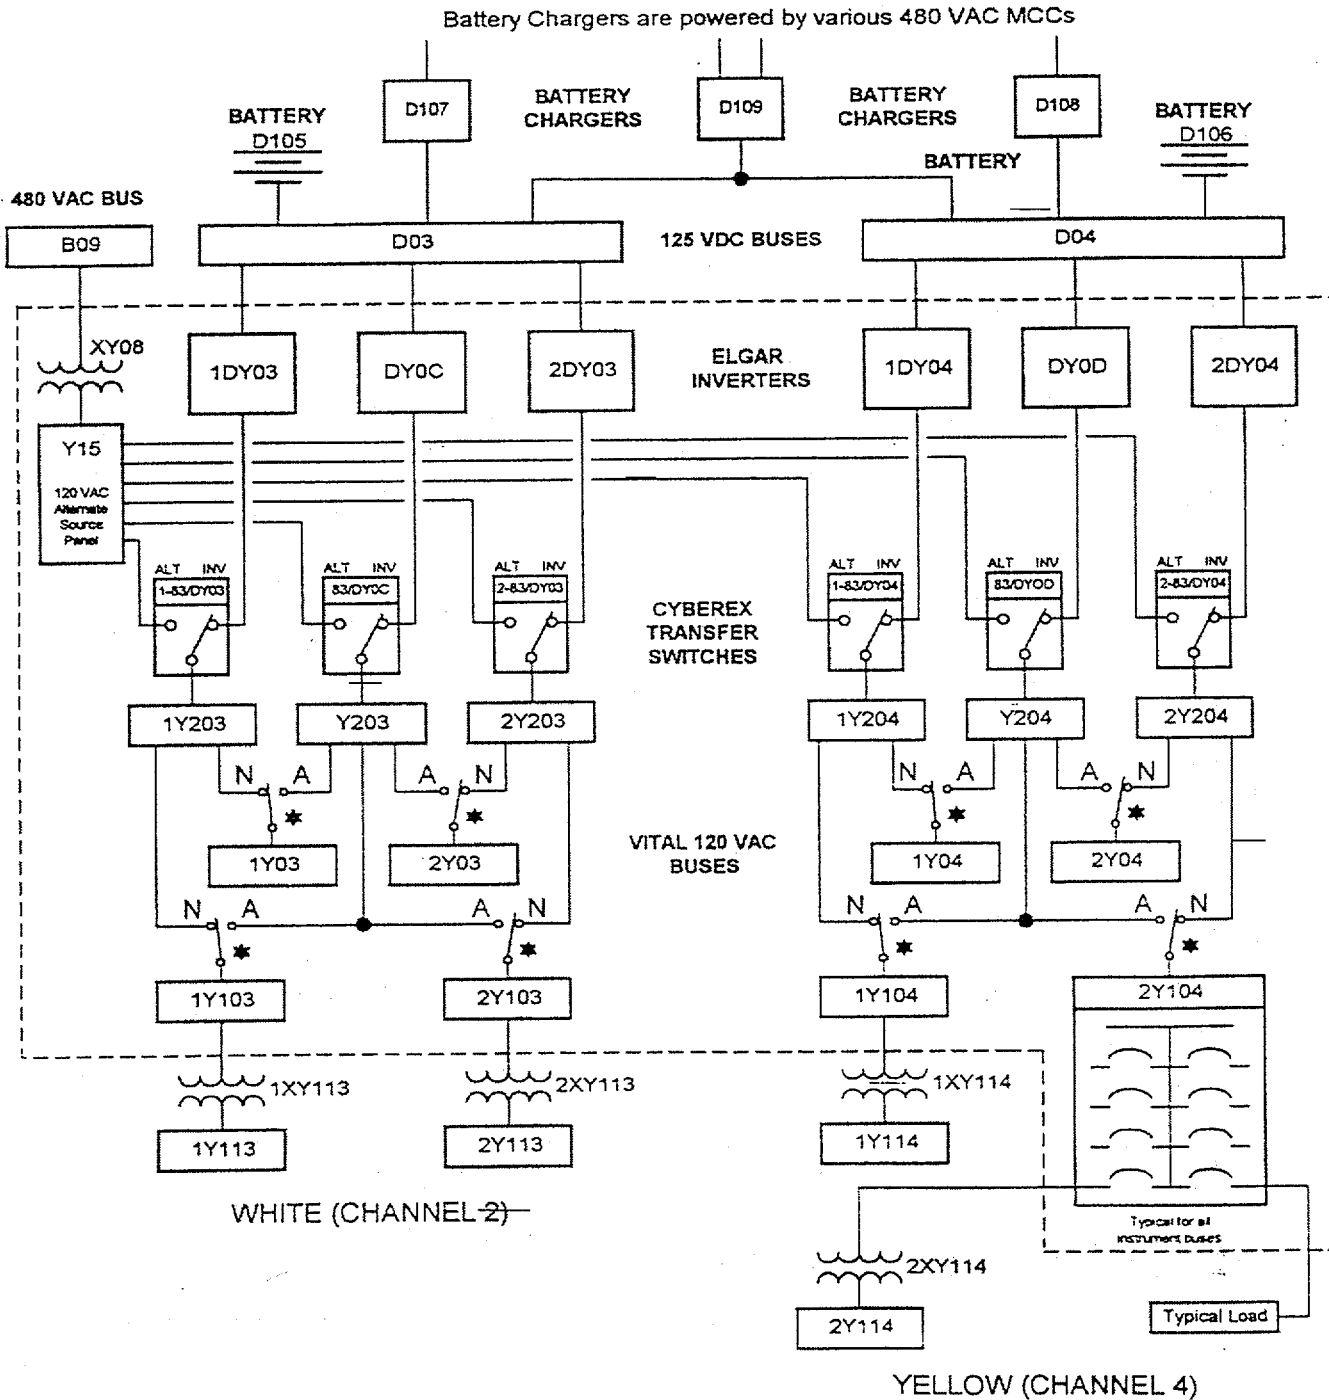
Figure 1-4: White and Yellow Instrument Bus Configuration

Each channel is powered by three inverters (see attached figure). One inverter is dedicated to the Unit 1 bus group and a second inverter is dedicated to the Unit 2 bus group. The third inverter is an alternate, and can swing between the Unit 1 and Unit 2 buses. Shifting between normal and alternate inverters is accomplished using manual make-before-break transfer switches. Use of the alternate inverter allows either dedicated inverter to be removed from service for maintenance. The function of the inverters is to convert 125 volt DC from the station batteries to 120 volt AC. The inverters are; therefore, powered from the 125 volt DC system.

The three inverters powering any one instrument channel share a common supply from one of the main 125 volt DC buses. The red channel inverters (1/2DY-01 and DY-0A) are powered from bus D-01 through panel D-12. The blue channel inverters (1/2DY-02 and DY-0B) are powered from bus D-02 through panel D-14. The white (1/2DY-03 and DY-0C) and yellow channel (1/2DY-04 and DY-0D) inverters are powered directly from buses D-03 and D-04, respectively.

Although normally powered from an inverter supply, each instrument channel can be powered from a backup power source. The backup power source is from non-safety-related Y-15 or Y-16 buses which are supplied from 480V bus B-09 via regulating transformer XY-08. The output of each inverter is connected to a static transfer switch that will automatically transfer the associated instrument buses to the backup power source in the event of an inverter failure, with little or no power interruption. Signals causing the transfer of the static switches include high voltage (white and yellow channels only), low voltage, current overload, and inverter failure signal (anticipatory to loss of voltage). The backup source is designed to maintain power to affected buses only until they can be manually transferred back to an operable safety
