**V C Summer
Alpha Hot Leg
Evaluation and Repair**

**Progress update
December 20, 2000**

V. C. SUMMER NUCLEAR STATION Alpha Hot Leg Evaluation and Repair

Progress report to NRC RII
12-20-2000

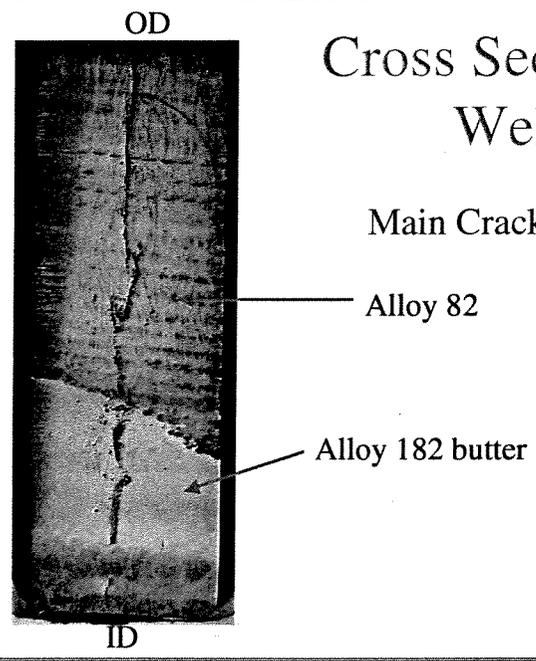
Cross Section of Weld

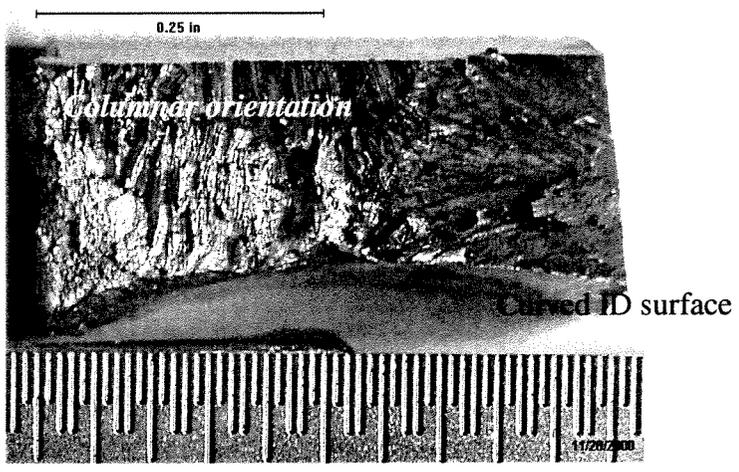
- **Crack followed interdendritic morphology**
- **Hot cracking in weld suggested by micro-fissuring**
- **Circumferential crack found intersecting main axial crack initiated in cladding and progressed to CS interface**
- **No cracking of carbon steel, minor wastage at boundary**
- **No cracking of SS pipe, some minor cracking in HAZ**
- **Only exit of main crack was through weep hole**

Interdentritic Morphology

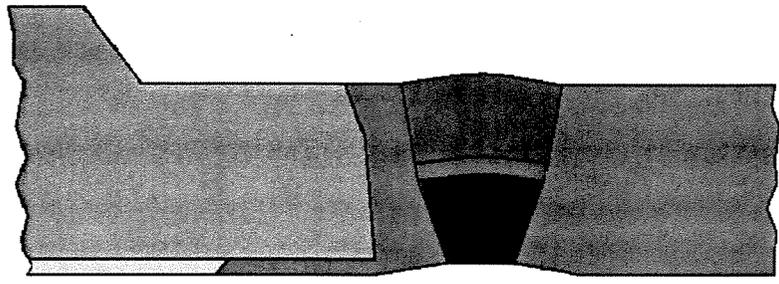
The construction weld process of grinding out the inside of the weld with a bridge pass on the VC Summer reactor vessel "A" hot leg nozzle to pipe weld created high welding residual stresses in a material (Alloy 182/82) and in an environment known to cause Pressurized Water Stress Corrosion Cracking (PWSCC).

The weld was then completed from the bridge to the OD
