**V C Summer
Alpha Hot Leg
Evaluation and Repair**

**Progress update
December 20, 2000**

V. C. SUMMER NUCLEAR STATION Alpha Hot Leg Evaluation and Repair

Progress report to NRC RII
12-20-2000

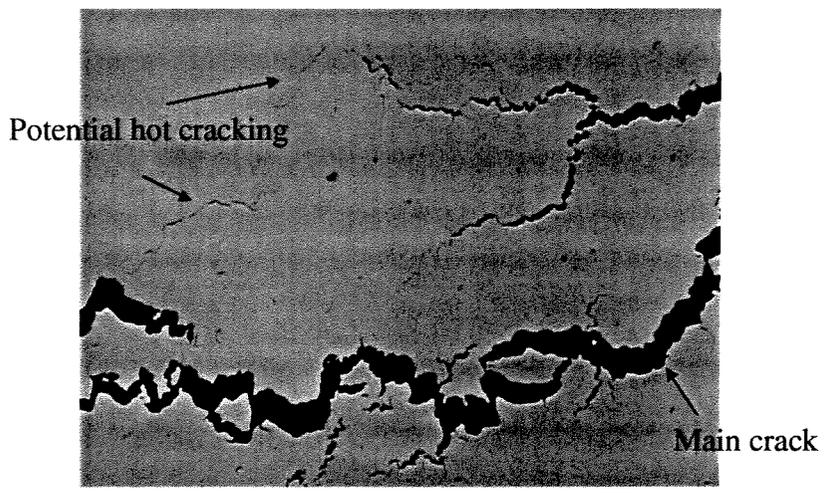
Morphology of Crack 25X

- **Crack followed interdendritic morphology**
- **Hot cracking in weld suggested by micro-fissuring**
- **Circumferential crack found intersecting main axial crack initiated in cladding and progressed to CS interface**
- **No cracking of carbon steel, minor wastage at boundary**
- **No cracking of SS pipe, some minor cracking in HAZ**
- **Only exit of main crack was through weep hole**

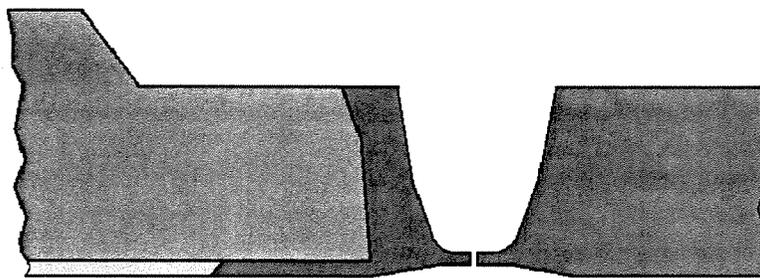
This is the start of the original weld it was designed to be filled from the ID out toward the OD

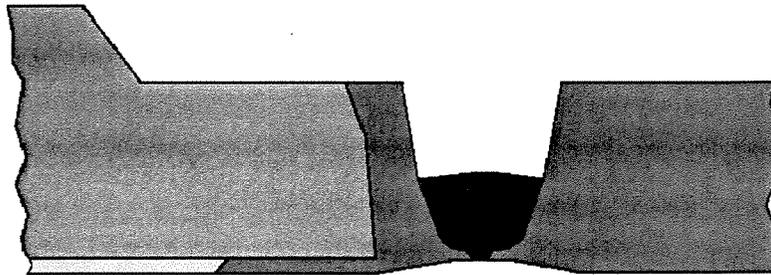
The first pass was made per design but rejected

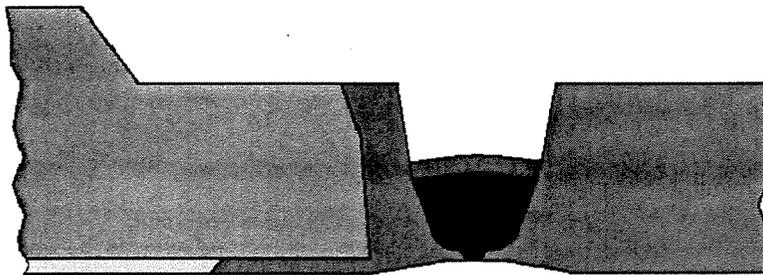
A bridge was laid in to stabilize the pipe

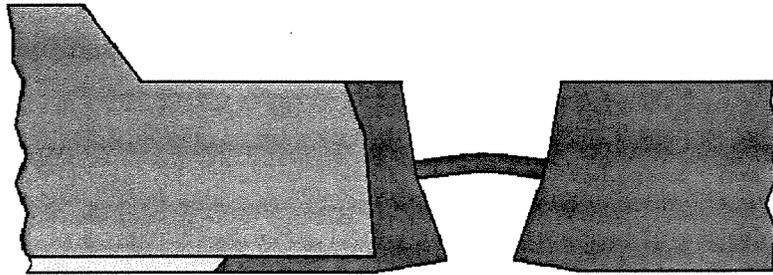
The rejected area was removed

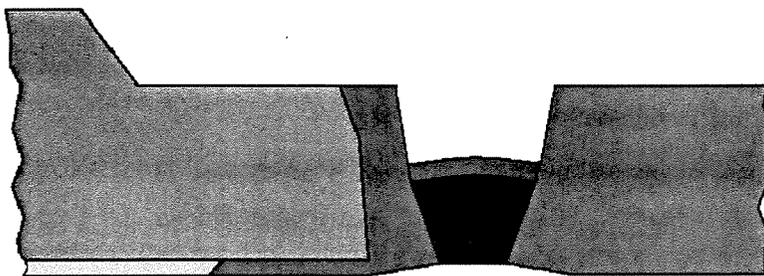
Weld was reapplied from the ID to the bridge

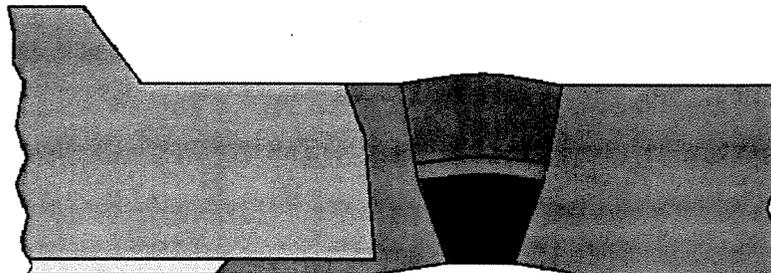
The construction weld process of grinding out the inside of the weld with a bridge pass on the VC Summer reactor vessel "A" hot leg nozzle to pipe weld created high welding residual stresses in a material (Alloy 182/82) and in an environment known to cause Pressurized Water Stress Corrosion Cracking (PWSCC).

The weld was then completed from the bridge to the OD

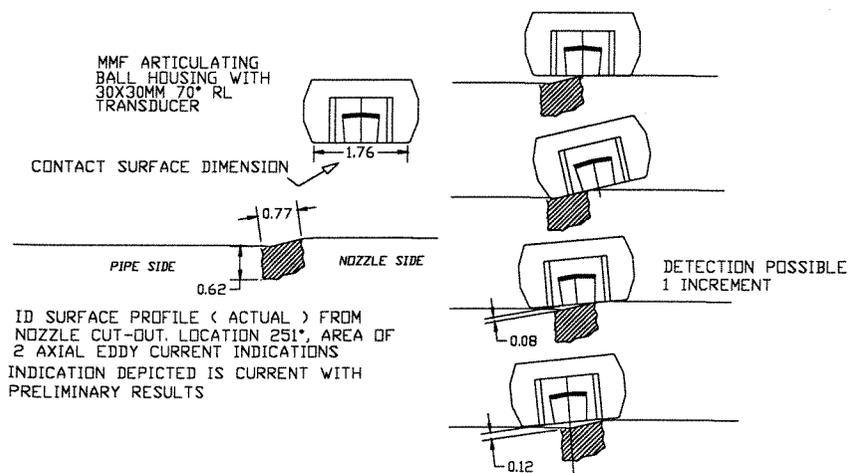
V.C. SUMER NOZZLE CUT-OUT SECTION AT 251°
UT PROBE ORIENTATION ALONG SURFACE GEOMETRY

- **Irregular surface geometry in area of interest is acceptable for small footprint spring loaded eddy current probes but not flat enough for reliable UT detection using the qualified technique.**
