Subject: 10CFR21 Reporting of Defects and Non-Compliance -
Engine Systems, Inc. Report No. 10CFR21-0080

Agastat 7000 and E7000 series time delay relays applied in Woodward 2301A
low voltage circuitry

10CFR21 REPORTING OF DEFECTS
AND NON-COMPLIANCE

COMPONENT: Agastat 7000 and E7000 series relays

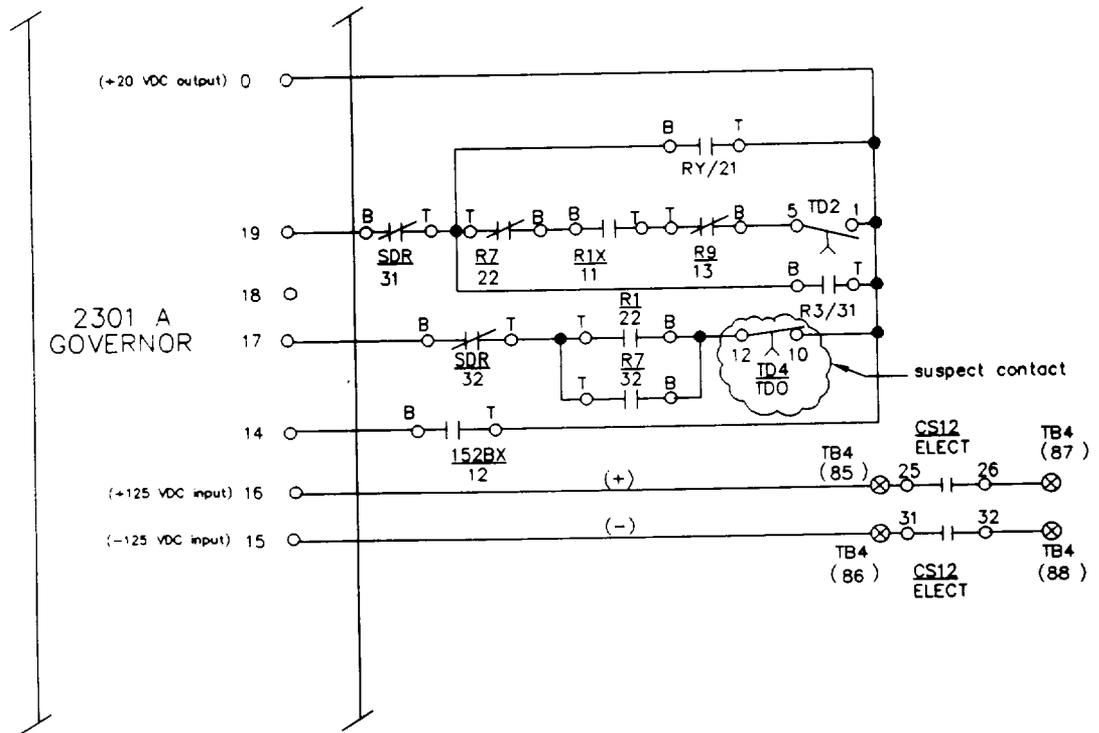
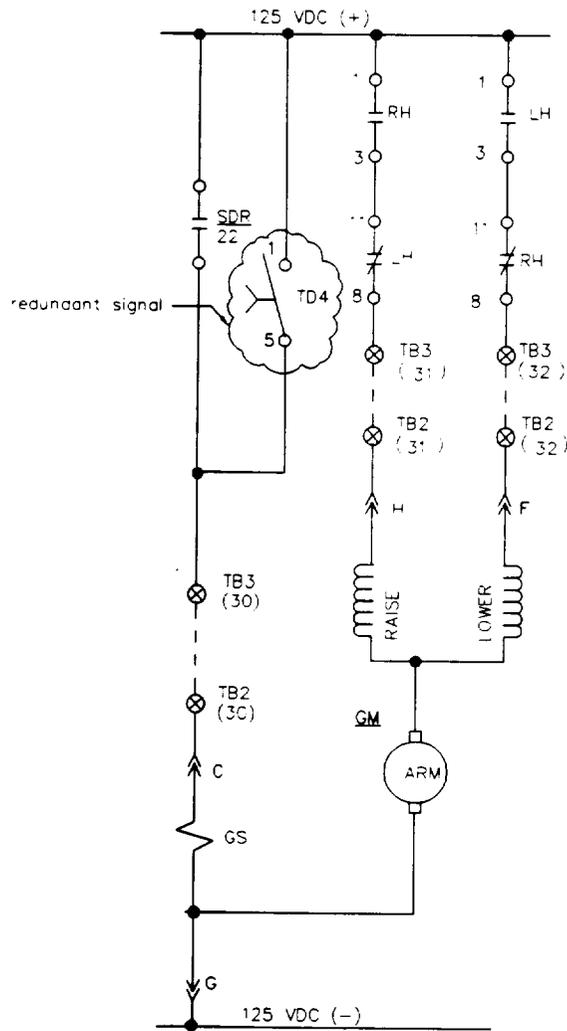
EXHIBIT 1

In some applications, ESI has utilized Agastat E7000 and 7000 series contacts in 2301 terminal 17 and terminal 19 circuits. Typical circuits are provided in Exhibit 1.

Terminal 17 is the 2301A "open for minimum fuel" input. A normally closed contact from the engine cooldown timer (designations TD4 or NST) opens to shutdown the engine after the cooldown period has elapsed. **Improper contact continuity (contact resistance greater than 1 ohm) could erroneously cause the 2301A to send a shutdown signal to the engine governor actuator during a safety event.**

Improper time delay relay contact continuity (contact resistance greater than 1 ohm) could activate the 2301A electronic governor "minimum fuel input" (shutdown) and there-by cause the diesel generator to fail-to-start or to shutdown during a safety event.

ESI recommends eliminating the suspect time delay relay contacts in the 2301A terminal 17 circuit. The diesel generators have a redundant shutdown feature via activation of the EGB governor actuator's shutdown solenoid; thus, both the 2301A and the EGB simultaneously receive a shutdown signal. The EGB shutdown signal is in a 125 VDC circuit and therefore contact continuity is not a concern in this application. Eliminating the contact in the 2301A shutdown circuit will remove the safety concern without affecting operation of the diesel generator.

The contact can be eliminated by removing the contact from the 2301A terminal 17 circuit or by simply placing a jumper across the contacts. Relay and contact designations for affected users are listed below:
