Subject: Byron Station Unit 1 Cycle 10 Steam Generator Eddy Current
Examination, 90-Day Summary Report

**Commonwealth Edison Company
BYRON STATION UNIT 1
4450 N. German Church Road
Byron, IL 61010**

STEAM GENERATOR EDDY CURRENT INSPECTION REPORT

CYCLE 10 REFUELING OUTAGE (B1R10)

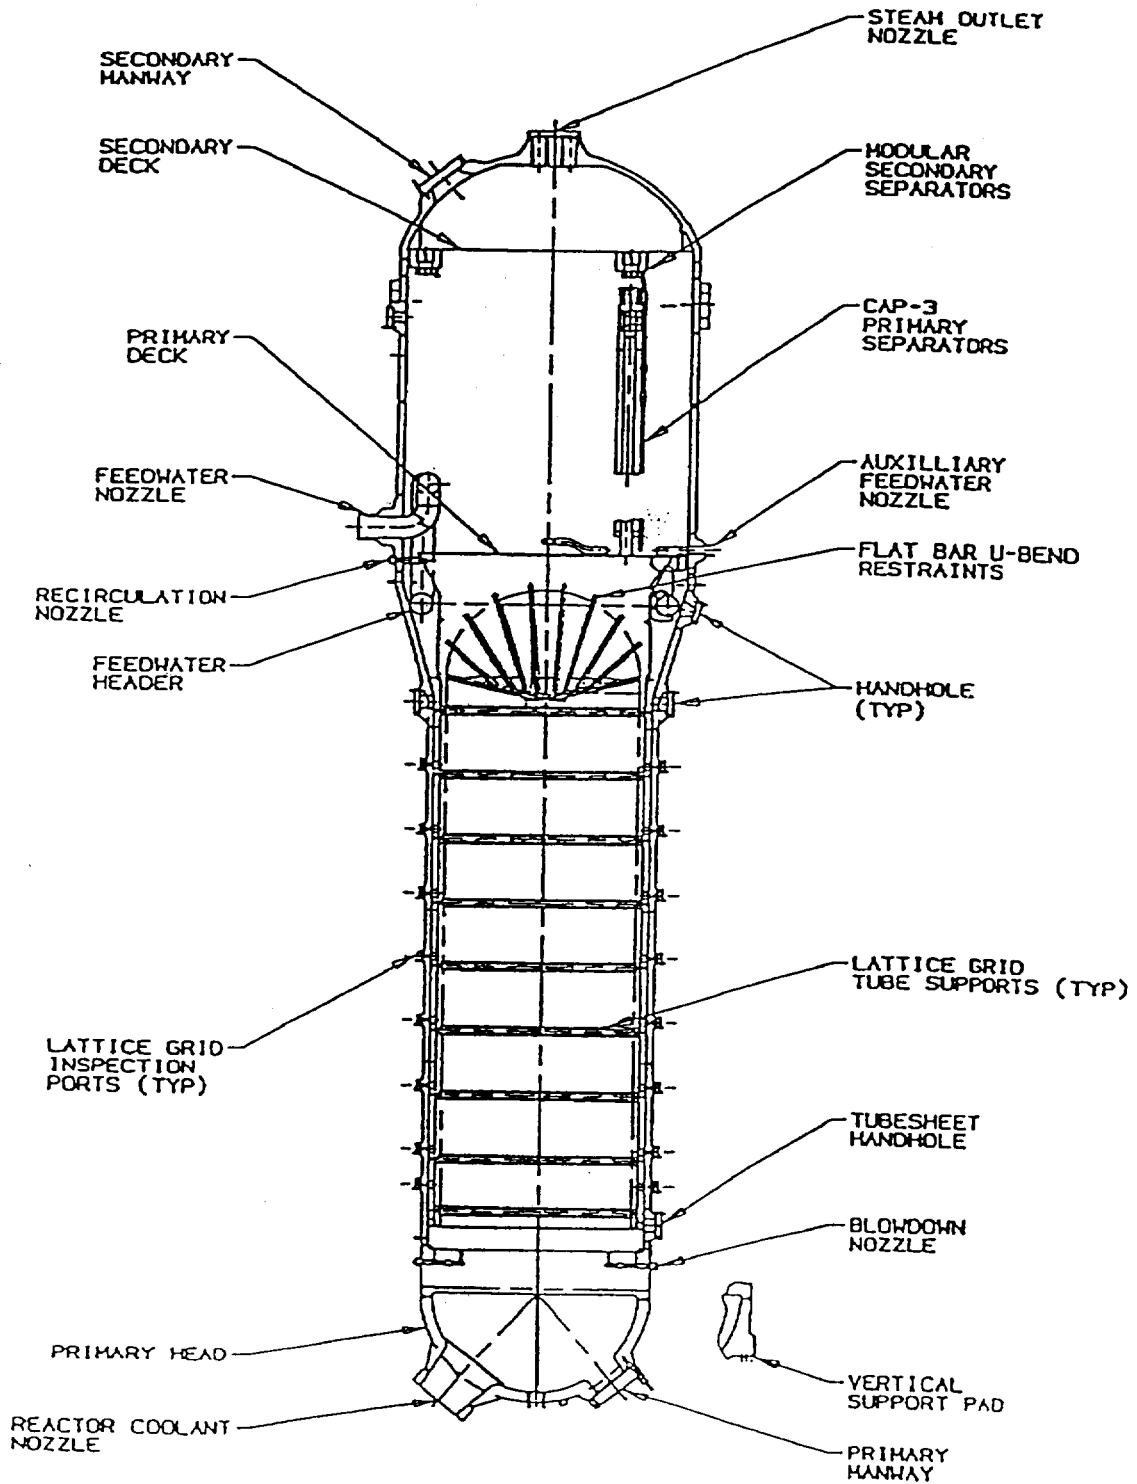
FIGURE A.1

Byron Station Unit 1 operates with four Babcock & Wilcox Replacement Steam Generators (SGs) in the four loop pressurized water reactor system. The SGs each contain 6633 thermally treated Inconel-690 U-tubes that have a nominal diameter of 0.6875 inches and a nominal thickness of 0.040 inches. The tubes are supported by stainless steel lattice grid structures and fan bars. The tubes are hydraulically expanded into the full depth of the tubesheet. Main Feedwater enters the SGs above the tube bundle through a feeding ring and J-tubes. The SG configuration is shown in Figures A.1 and A.2. The replacement SGs were installed at the end of Cycle 8.

Babcock & Wilcox Replacement Steam Generator
Byron Unit 1 Configuration
