Subject: McGuire Nuclear Station, Unit 2
Docket No. 50-370
Inservice Inspection Summary Report for Class MC
Component Examinations Conducted During Refueling Outage
EOC13

Duke Energy Corporation
McGuire Nuclear Station Unit 2
Class MC ISI Summary Report for Refueling Outage EOC13
Pages 1 through 7

McGuire Nuclear Station, Unit 2
Class MC ISI Summary Report for
Refueling Outage EOC13

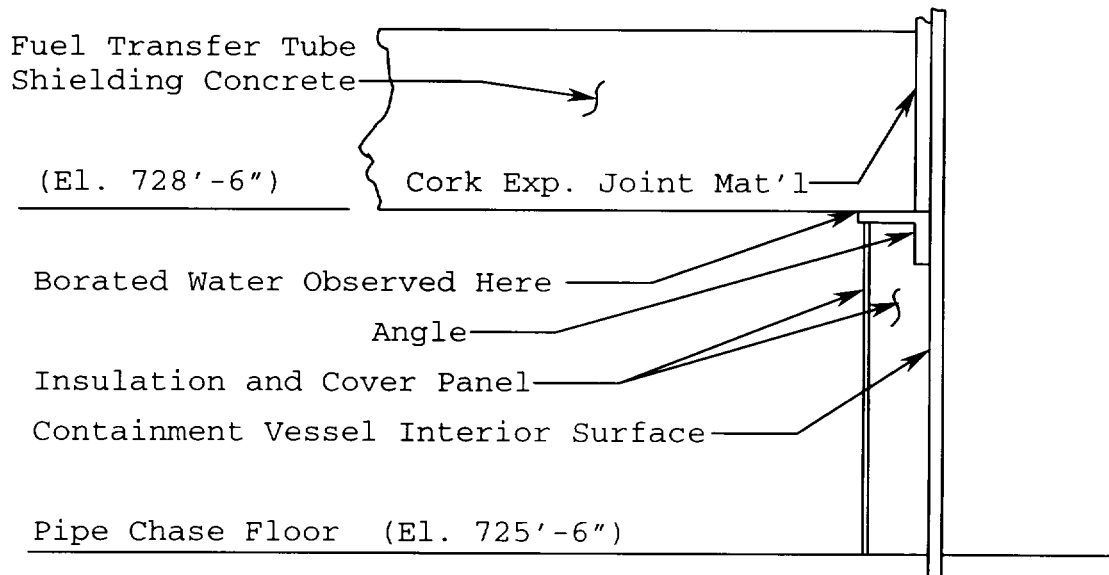
Figure 1
(Elevation View)

Top of insulation panel attached to the interior surface of the Steel Containment Vessel shell, located directly beneath the Fuel Transfer Tube Radiation Shielding Concrete at Elevation 728'-6", between Azimuths 253° and 270°. At this location, the insulation panel butts up against the underside of the shielding concrete, making the surfaces of the Steel Containment Vessel inaccessible for visual examination from the interior side. Figure 1 provides a schematic detail of this location.

Borated water was observed coming from between the top of the insulation panel and the underside of the shielding concrete at Elevation 728'-6". Water and boron crystals were observed at this joint, along the exposed face of the insulation panel, and on the Pipe Chase floor in this vicinity. Because the Steel Containment Vessel is not accessible for visual examination at this location, the condition of the steel containment vessel shell behind the insulation panel and concrete could not be readily determined. Initial estimates are that these conditions may have been present for some time and that the area has been exposed to repeated wetting and drying. The volume of water leaking from this location could not be accurately determined, but could be characterized as dripping, rather than flowing.

Because the lowest UT measurement within the examination area was 0.960" (which is well above 90% of the 1" nominal plate thickness), the condition of the Steel Containment Vessel shell plate is considered acceptable at this time. However, this area will require periodic monitoring to determine whether continued degradation is occurring. Because the surface in question on the interior side of the Containment Vessel could not be visually examined, it is not possible to determine conclusively whether any degradation is occurring and what the actual extent of degradation is between azimuths 253° and 270°.

The source of the borated water has not yet been determined. However, because of the location of the identified leakage and chemical analysis performed on a sample of the water, it is presumed that the water is reactor coolant and is most likely leaking from the refueling canal. The conditions that led to the identified leakage cannot be determined until the exact location of the leakage is identified.

1. The affected area beneath the Fuel Transfer Tube Shielding Concrete where moisture and boron was observed was cleaned, and moisture barrier material (sealant) was installed along the base of the insulation panel to prevent possible future moisture intrusion. Sealant was also installed along vertical seams between insulation cover panels.
2. The following actions were taken during refueling outage 2EOC13 to attempt to identify the source of leakage:
 - a. A visual inspection was performed on the Refueling Canal liner plate after the Refueling Canal was drained to a depth of ten feet. This inspection failed to locate the source of suspected leakage, but

3. The affected area beneath the Fuel Transfer Tube Shielding Concrete at Elevation 728'-6" will be reexamined during refueling outage 2EOC14 to confirm the presence (or absence) of continued leakage.
4. The surfaces examined from the exterior of the Containment Vessel during 2EOC13 shall be reexamined during the next refueling outage (2EOC14) in accordance with IWE-2500, Table IWE-2500-1, Examination Category E-C, Item E4.12.
5. The surfaces examined from the exterior of the Containment Vessel during 2EOC13 shall be examined for three consecutive periods in accordance with IWE-2420.
6. During refueling outage 2EOC14, additional visual inspections are to be performed on interior surfaces of the Refueling Canal liner plate.
