Subject: McGuire Nuclear Station, Unit 2
Docket No. 50-370
Inservice Inspection Summary Report for Class MC
Component Examinations Conducted During Refueling Outage
EOC13

Duke Energy Corporation
McGuire Nuclear Station Unit 2
Class MC ISI Summary Report for Refueling Outage EOC13
Pages 1 through 7

McGuire Nuclear Station, Unit 2
Class MC ISI Summary Report for
Refueling Outage EOC13

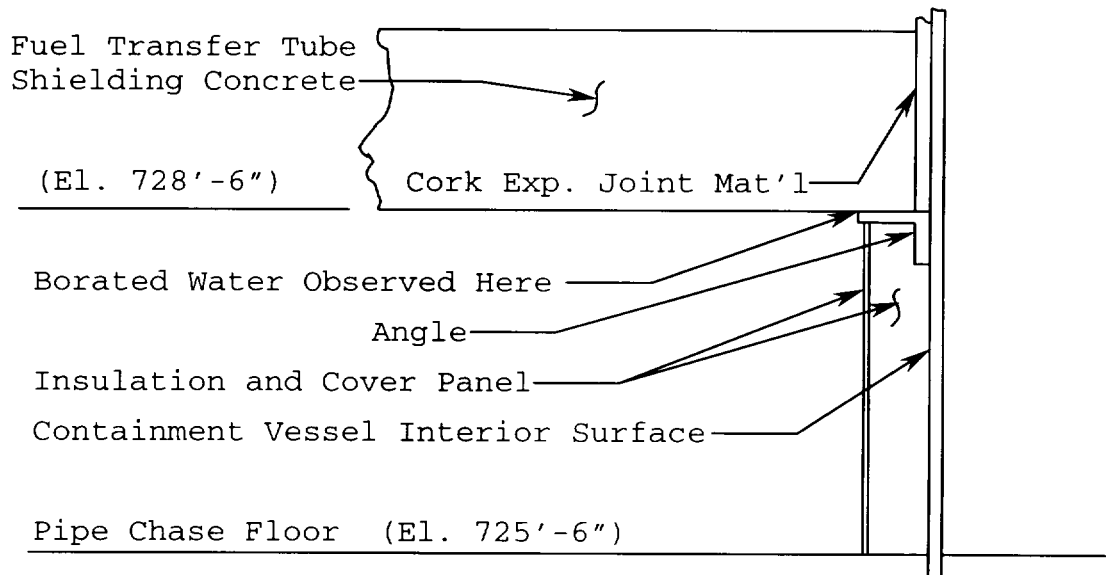
Figure 1
(Elevation View)

Top of insulation panel attached to the interior surface of the Steel Containment Vessel shell, located directly beneath the Fuel Transfer Tube Radiation Shielding Concrete at Elevation 728'-6", between Azimuths 253° and 270°. At this location, the insulation panel butts up against the underside of the shielding concrete, making the surfaces of the Steel Containment Vessel inaccessible for visual examination from the interior side. Figure 1 provides a schematic detail of this location.

Borated water was observed coming from between the top of the insulation panel and the underside of the shielding concrete at Elevation 728'-6". Water and boron crystals were observed at this joint, along the exposed face of the insulation panel, and on the Pipe Chase floor in this vicinity. Because the Steel Containment Vessel is not accessible for visual examination at this location, the condition of the steel containment vessel shell behind the insulation panel and concrete could not be readily determined. Initial estimates are that these conditions may have been present for some time and that the area has been exposed to repeated wetting and drying. The volume of water leaking from this location could not be accurately determined, but could be characterized as dripping, rather than flowing.

Because the lowest UT measurement within the examination area was 0.960" (which is well above 90% of the 1" nominal plate thickness), the condition of the Steel Containment Vessel shell plate is considered acceptable at this time. However, this area will require periodic monitoring to determine whether continued degradation is occurring. Because the surface in question on the interior side of the Containment Vessel could not be visually examined, it is not possible to determine conclusively whether any degradation is occurring and what the actual extent of degradation is between azimuths 253° and 270°.

The source of the borated water has not yet been determined. However, because of the location of the identified leakage and chemical analysis performed on a sample of the water, it is presumed that the water is reactor coolant and is most likely leaking from the refueling canal. The conditions that led to the identified leakage cannot be determined until the exact location of the leakage is identified.

Because the UT measurements indicated no significant metal loss on the interior surface of the Steel Containment Vessel shell plate, the condition of the Containment Vessel is considered acceptable at this time. This area will be reexamined in accordance with the ASME Code, Section XI, IWE-2500, Examination Category E-C, Item E4.12 to verify the continued acceptability of the Containment shell plate during the next scheduled refueling outage 2EOC14, and during subsequent inspection periods as required by IWE-2420.

1. The affected area beneath the Fuel Transfer Tube Shielding Concrete where moisture and boron was observed was cleaned, and moisture barrier material (sealant) was installed along the base of the insulation panel to prevent possible future moisture intrusion. Sealant was also installed along vertical seams between insulation cover panels.
2. The following actions were taken during refueling outage 2EOC13 to attempt to identify the source of leakage:
 - a. A visual inspection was performed on the Refueling Canal liner plate after the Refueling Canal was drained to a depth of ten feet. This inspection failed to locate the source of suspected leakage, but

3. The affected area beneath the Fuel Transfer Tube Shielding Concrete at Elevation 728'-6" will be reexamined during refueling outage 2EOC14 to confirm the presence (or absence) of continued leakage.
4. The surfaces examined from the exterior of the Containment Vessel during 2EOC13 shall be reexamined during the next refueling outage (2EOC14) in accordance with IWE-2500, Table IWE-2500-1, Examination Category E-C, Item E4.12.
5. The surfaces examined from the exterior of the Containment Vessel during 2EOC13 shall be examined for three consecutive periods in accordance with IWE-2420.
6. During refueling outage 2EOC14, additional visual inspections are to be performed on interior surfaces of the Refueling Canal liner plate.
