Subject: VIRGIL C. SUMMER NUCLEAR STATION  
DOCKET NO. 50/395  
OPERATING LICENSE NO. NPF-12  
RESPONSE TO INITIAL QUESTIONS DATED  
OCTOBER 23, 2000  
MSP 00-0244

## Responses to NRC Questions on

### A loop hot leg crack

Dated 10/23/2000

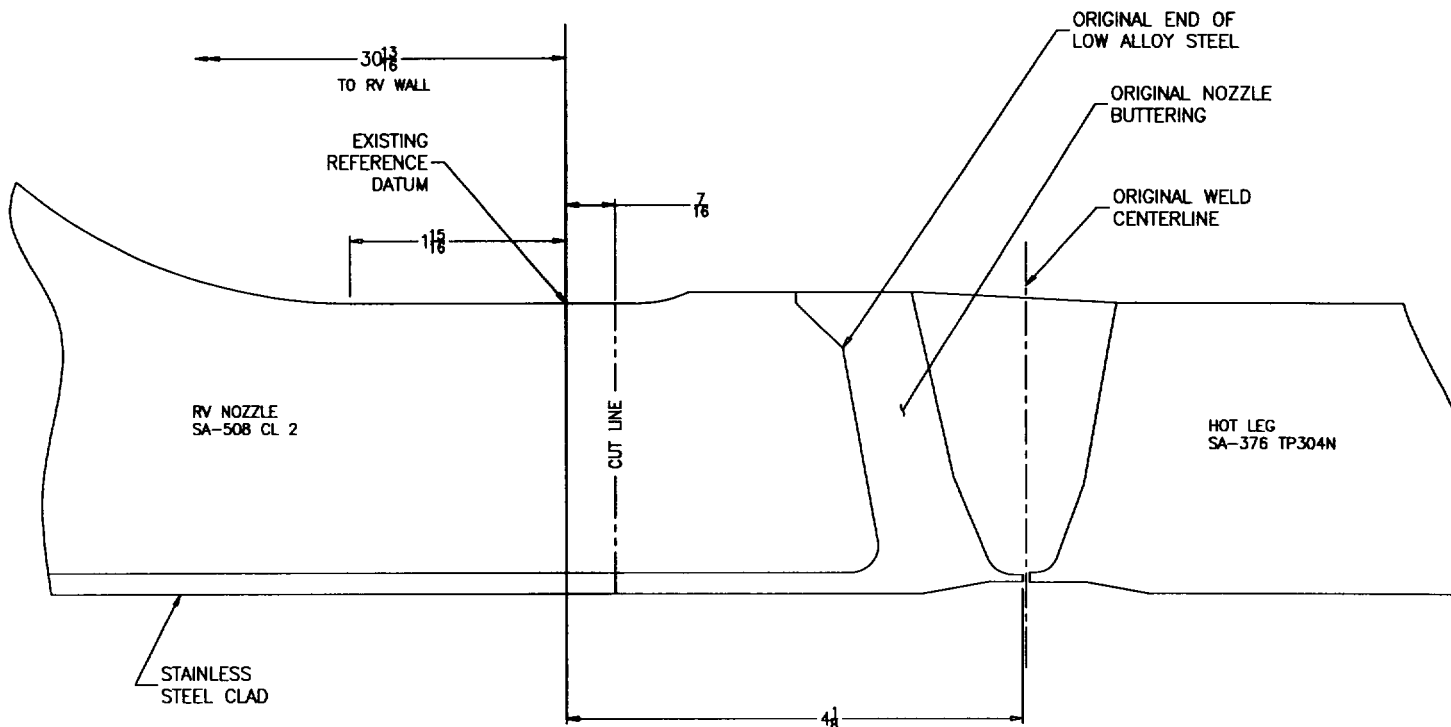
FIGURE 2  
VC SUMMER NUCLEAR STATION  
"A" LOOP HOT LEG NOZZLE  
EXISTING WELD DESIGN

The pre-existing field configuration is illustrated in Figure 2. The repair plan included the removal of the defective weld along with all of the nozzle butter and approximately 8 inches of the pipe. A stainless steel pipe spool piece was welded back in to restore the integrity of the RCS (Figure 3).
