Subject: VIRGIL C. SUMMER NUCLEAR STATION
DOCKET NO. 50/395
OPERATING LICENSE NO. NPF-12
RESPONSE TO INITIAL QUESTIONS DATED
OCTOBER 23, 2000
MSP 00-0244

Responses to NRC Questions on

A loop hot leg crack

Dated 10/23/2000

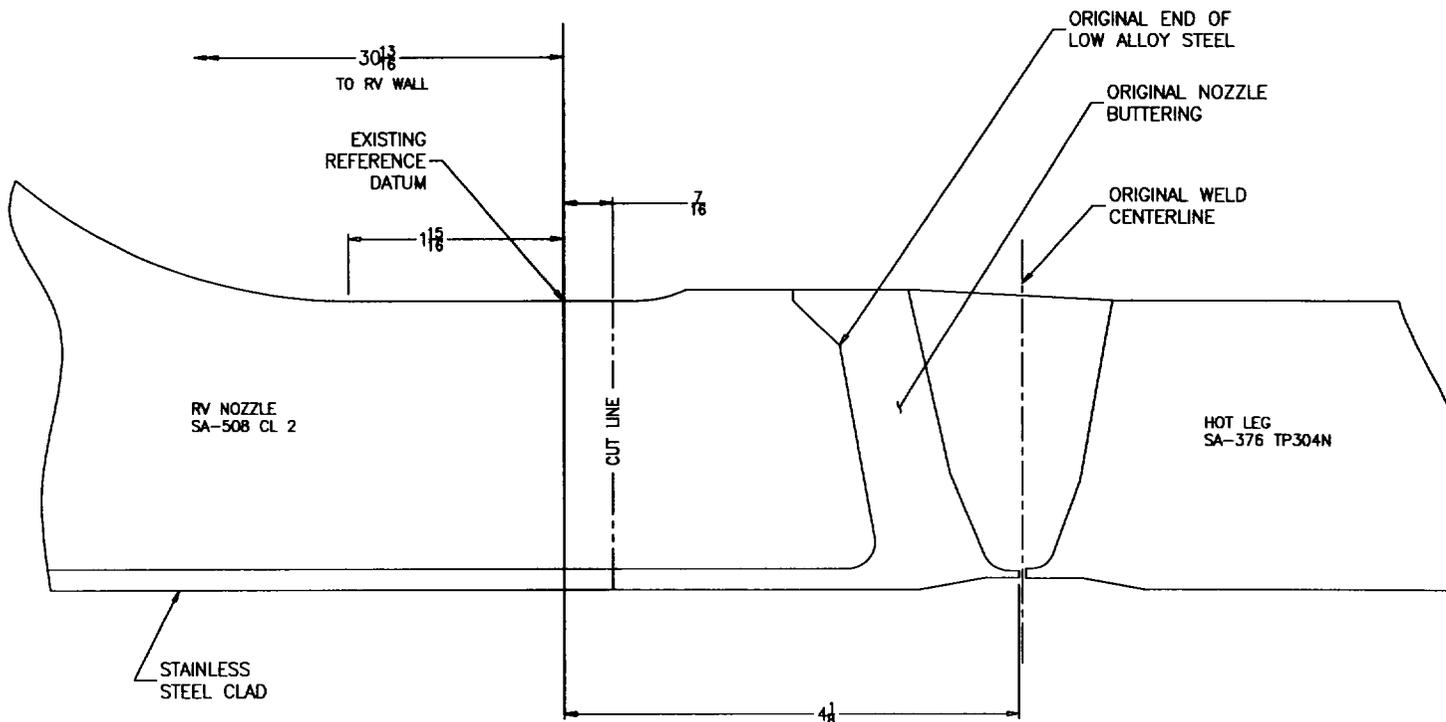
FIGURE 2
VC SUMMER NUCLEAR STATION
"A" LOOP HOT LEG NOZZLE
EXISTING WELD DESIGN

Through destructive examination, the axial crack has been determined to be approximately 2.5 inches at the inside diameter, with a 3/16 inch opening on the outside diameter at approximately 7 degrees off top dead center. This defect is contained exclusively in the Inconel weld material, in the weld buildup (buttering), closure weld and nozzle cladding. A circumferential indication has been identified as a 1.6 inch crack that intersects the axial crack in the nozzle Inconel cladding. This crack progressed only through the Inconel cladding up to the carbon steel interface.

- a. Extensive repairs on the VC Summer reactor vessel "A" hot leg nozzle to pipe weld created high welding residual stresses in a material (Alloy 182/Alloy 82) and in an environment (nuclear primary water) known to cause primary water stress corrosion cracking (PWSCC).
- b. Neither the codes, standards nor the welding process recognized or required consideration of the cumulative effect of multiple repair welding and weld grinding in the creation of high residual stresses.

The pre-existing field configuration is illustrated in Figure 2. The repair plan included the removal of the defective weld along with all of the nozzle butter and approximately 8 inches of the pipe. A stainless steel pipe spool piece was welded back in to restore the integrity of the RCS (Figure 3).
