Subject: Grand Gulf Nuclear Station
Docket No. 50-416
License No. NPF-29
Unanalyzed Condition – Turbine Control Valves May Move in
Excess of Design Assumptions
LER 2000-006-00

GNRO-2000/00076

Attached is Licensee Event Report (LER) 2000-006-00, which is a final report.

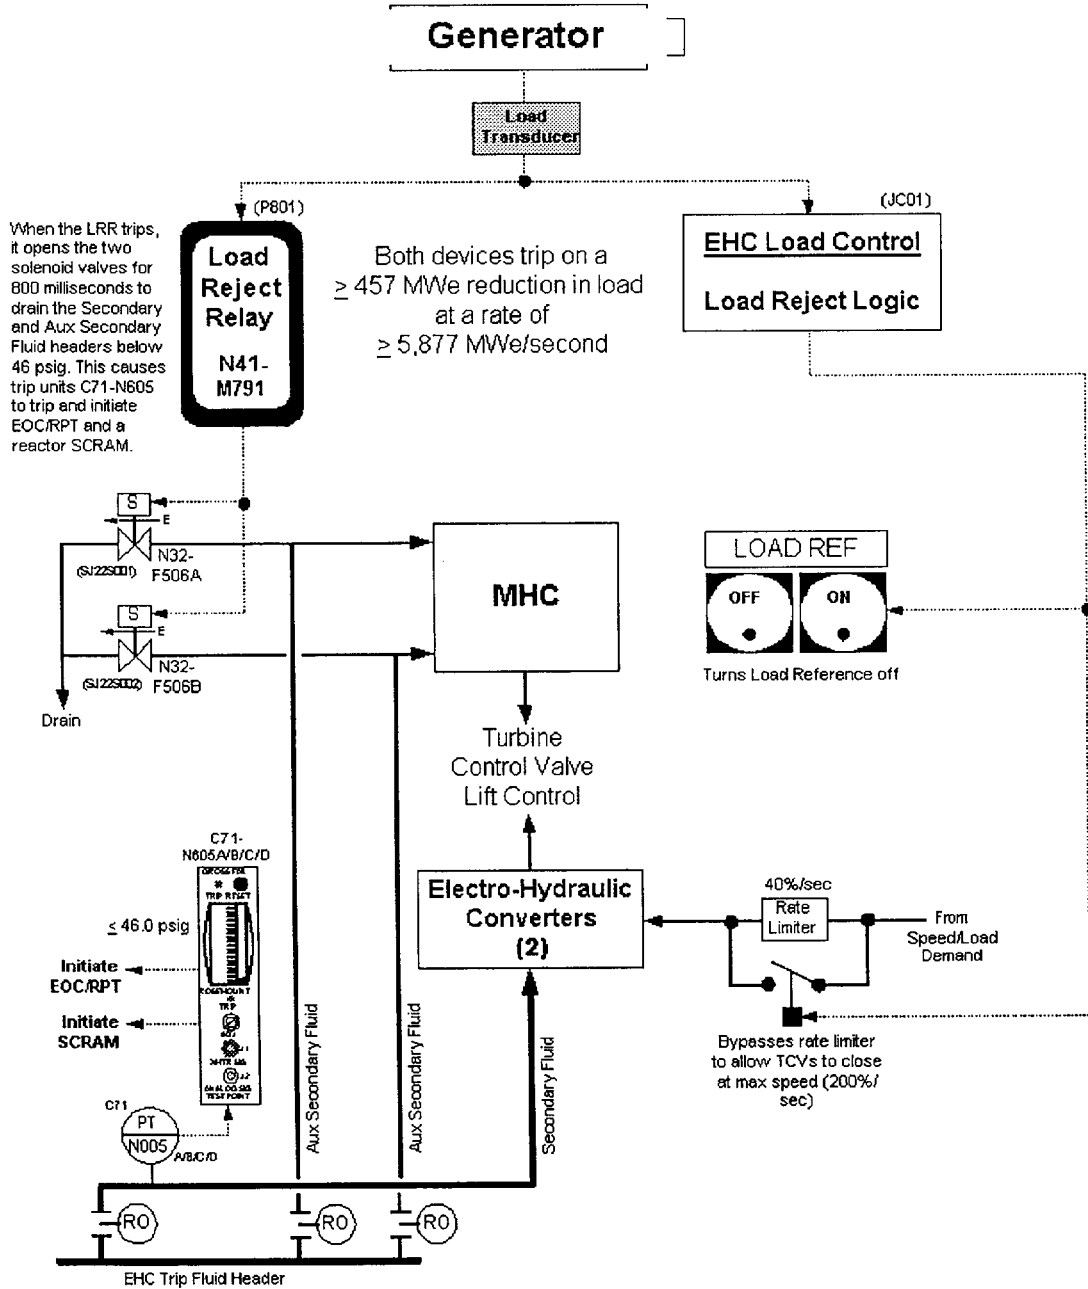
LOAD REJECT LOGIC
FOR INFORMATION ONLY
Revision Date: 9/20/00

As a result of the transient on 9/15/00, generator output power swung enough to pick up one of the two load reject circuits (JC01 was adjusted to approximately 450% power drop per second, P801 was set at approximately 600%. Both should have been set at 450%). The JC01 load reject circuit that actuated caused the following two actions:

1. The load reference signal was turned off, which left only the speed signal to the turbine. This caused the turbine control valves to close quickly to reduce generator load from 100% to about 12%.
2. The rate limiter circuit associated with the control valves was bypassed, which normally limits valve speed to 40% change in valve position per second.

The P801 load reject circuit is designed to dump all EHC pressure off of the control valves, causing them to fast close. This would have caused all 4 of the End of Cycle/Recirculation Pump Trip (EOC/RPT) secondary fluid pressure sensors to actuate, resulting in a scram and tripping the recirculation pumps. However, since it was set at approximately 600% per second and the load reject did not occur, it did not actuate. Therefore, hydraulic pressure was reduced through the Electro-Hydraulic Control (EHC) system (as set by the speed signal) rather than being dumped from actuation of the load reject solenoids (N32F506A & B)[TG]. It appears that only 2 of the 4 pressure switches actuated, which happened to be in a combination that caused a reactor scram but not an EOC/RPT.

During the scram, all safety systems responded properly (see LER 2000-005-00), except that no EOC/RPT initiation occurred as a result of TCV fast closure. It should be noted that only the JC01 logic detected a load reject signal. The P801 load reject relay N41M791 (see attached figure) did not trip, so the expected 800 msec dump of secondary fluid did not occur. This event allowed a TCV fast closure to occur for about 125 msec before EHC began to control TCVs to maintain minimum load. Data is unavailable to determine the exact reason the EOC/RPT initiation did not occur, but it appears that the EOC/RPT logic was not satisfied.

Due to differences in Reactor Protection System (RPS) and EOC/RPT logic, and calibration tolerances, it is possible to get a RPS initiation without EOC/RPT. Secondary fluid pressure of 44.3 psig or less should result in a reactor scram and EOC/RPT. For EOC/RPT initiation, channels A and B or C and D (C71-N605A/B/C/D) must trip. RPS requires channels A or C and B or D. It appears that TCV fast closure may have been sensed by only two logic channels (A and D or B and C) [IT]. Data is unavailable to confirm the specific secondary fluid pressure channels that tripped.

RPS actuation with no EOC/RPT is possibly explained by the extremely brief duration (about 125 msec) of the downward spike in secondary fluid pressure. Based on GETARS data, the load reject signal existed for about 50 msec, and TCV D began to close about 100 msec after the load reject signal was received. The start of valve movement represents the point where secondary fluid pressure is less than 44.3 psig. The rate of TCV closure began to decrease about 125 msec after start of valve movement, indicating secondary fluid pressure returned above the TCV fast closure setpoint. The lead TCV position was then maintained at about 12% open. Due to the short duration of the transient, and calibration tolerances, all four of the logic channels may not have reached the 44.3 psig setpoint before secondary fluid pressure started to recover.

The plant was restricted to operating at a level below that which would require EOC/RPT (<40% power and slow speed recirculation pump operation) until EOC/RPT operability was resolved. The N41-M791 load reject relay was recalibrated to the required setpoints. Engineering Request (ER) 2000-0770-00, Rev. 0 was issued to raise the TCV secondary fluid pressure setpoint for EOC/RPT (and RPS) from 44.3 to 46.0 psig. The purpose of this change is to ensure sufficient logic channels trip as required on TCV fast closure to initiate the reactor scram and EOC/RPT recirculation pump downshift to Low Frequency Motor Generator (LFMG).
