72-22
9902220032
2/11/99
MAP OF NORTH WALL TRENCH T-2
Private Fuel Storage Facility
Skull Valley, Utah

GEOMATRIX Project No. 4790 Plate 3

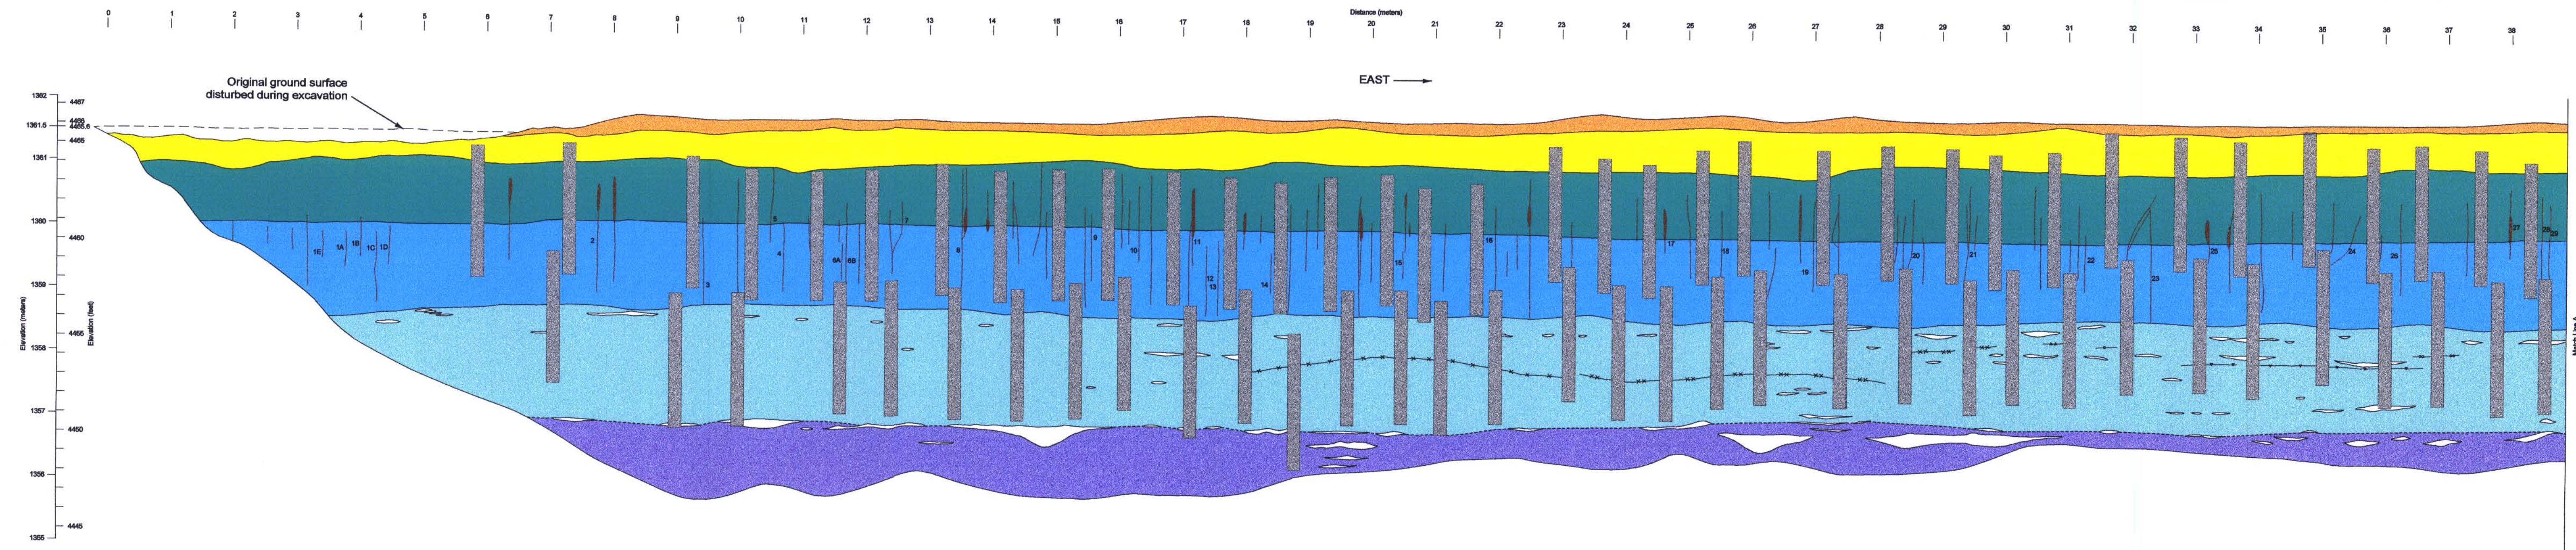
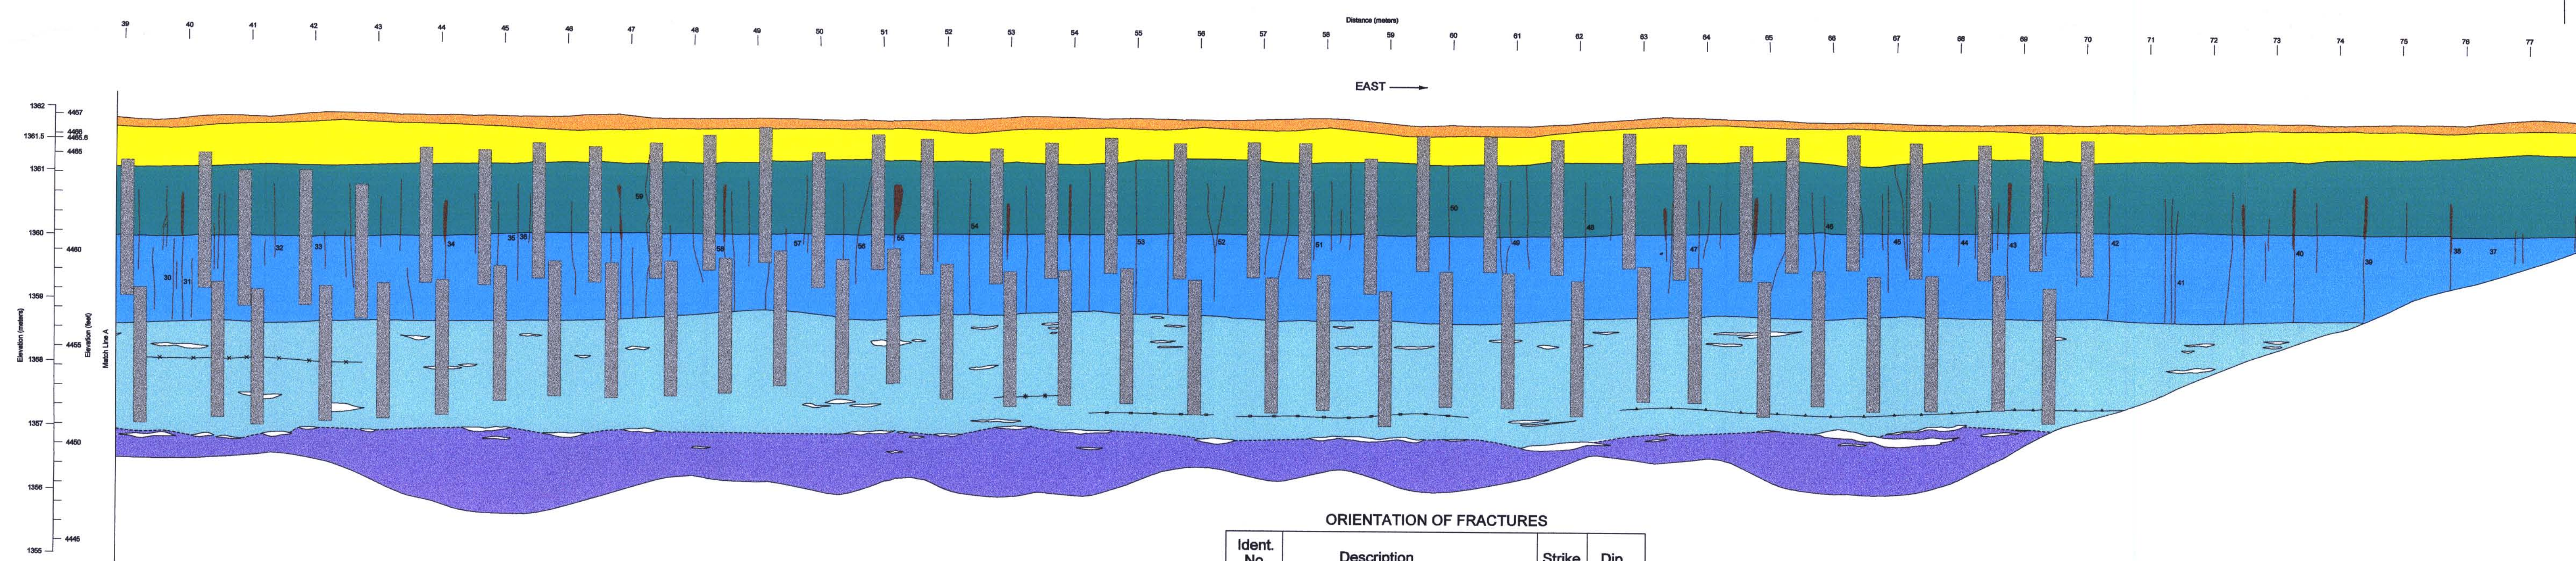
- A/E SOIL HORIZON ON POST-PROVO EOLIAN DEPOSIT**
Grayish brown (10YR5/2.5,d) silty fine SAND to fine sandy SILT; plastic, nonsticky; massive, many pores and root tubules

- EOLIAN DEPOSIT OVERLYING POST-PROVO SOIL**
Brown (10YR 5/3, m) massive, fine sandy SILT in upper part (Eolian Deposit). Lower part of unit is pale brown to brown (10YR 5.5/3, m) sandy clayey SILT; slightly redder on soil ped faces (Cambic B soil horizon developed on Bonneville deep-water sediment)

- BONNEVILLE DEEP-WATER (BLOCKY) FACIES**
Light gray to gray (10YR 6/1,m) mottled with white; very fine sandy clayey SILT; irregular coarse angular blocky structure; plastic, sticky; abundant ostracodes; manganese or iron-oxide staining along root tubules; abrupt lower contact

- BONNEVILLE DEEP-WATER (LAMINATED) FACIES**
Pale brown (10YR 6/3, m) fine sandy SILT (sandy marl); fines upwards; well bedded, thinly laminated, laminae commonly <1mm; abundant ostracodes

- POST-STANSBURY TRANSGRESSIVE FACIES**
Alternating light yellowish brown and light brownish gray silty to clayey SAND; well bedded; beds are generally 2 to 5 cm thick; crossbedded; clayey interbeds < 2 cm thick; gradational lower contact

- STANSBURY REGRESSIVE FACIES**
Lenses of light gray very fine sand with interbedded silt in upper part of unit (white); generally fines downward, thinly bedded silty and clayey sand at western end of trench below discontinuous sand lenses

Ident. No.	Description	Strike	Dip
1A	Fracture	15°	86°E
1B	Fracture	328°	85°W
1C	Fracture	52°	88°W
1D	Fracture	8°	90°
1E	Fracture	60°	90°
2	Infilled fractures	352°	84°E
3	Fracture	50°	86°E
4	Fracture	350°	90°
5	Fracture: 2 cm displacement, E-side up *	32°	90°
6A	Fracture: 2 cm displacement, E-side up *	70°	80°E
6B	Fracture: 2 cm displacement, E-side up *	332°	90°
7	Fracture: 2.5 cm displacement, E-side down *	10°	90°
8	Fracture	315°	90°
9	Fracture	48°	87°W
10	Infilled Fracture	314°	88°W
11	Fracture	60°	90°
12	Fracture	55°	90°
13	Fracture	57°	88°W
14	Fracture	34°	85°W
15	Fracture	50°	90°
16	Infilled Fracture	24°	88°W
17	Fracture	25°	85°W
18	Fracture	30°	88°W
19	Fracture	0°	88°W
20	Fracture	340°	87°W
21	Fracture	10°	90°
22	Fractures	320°	90°
23	Fracture	285°	90°
24	Fracture	76°	89°NW
25	Fracture	10°	90°
26	Fracture	315°	90°
27	Fracture: 2.5 cm displacement, E-side up *	340°	90°
28	Fracture	10°	90°
29	Fracture	345°	88°E
30	Fracture	330°	90°

31	Infilled fracture	355°	90°
32	Fractures	345°	90°
33	Fracture	20°	90°
34	Fracture: 1 cm displacement, E-side up *	350°	89°E
35	Fracture: 2 cm displacement, E-side up *	0°	88°E
36	Fracture: 1 cm displacement, E-side up *	352°	90°
37	Fracture	30°	85°E
38	Fracture: 2 cm displacement, E-side down *	345°	88°E
39	Fracture	35°	90°
40	Fracture: 1 cm displacement, E-side down *	355°	90°
41	Fracture	20°	90°
42	Fractures	340°	90°
43	Fracture	35°	85°W
44	Fracture	40°	90°
45	Fractures	345°	88°E
46	Fracture: 2 cm displacement, E-side down *	10°	90°
47	Fracture	350°	90°
48	Fractures	345°	87°E
49	Fracture	330°	82°W
50	Fracture	320°	88°W
51	Infilled fractures	5°	84°W
52	Fracture	38°	88°W
53	Fracture	310°	90°
54	Fracture	345°	90°
55	Fracture	60°	90°
56	Fracture	15°	85°
57	Fractures	350°	87°W
58	Fracture	5°	90°
59	Fracture	5°	90°

* Displacements observed only in Bonneville deep-water facies; thin clay layers and bedding in lower Stansbury regressive facies and Post-Stansbury transgressive facies show evidence of no discrete faulting at depth.
