# **Circuit Analysis - Failure Mode And Likelihood Analysis**

A Letter Report to the USNRC

Final Report

Sandia National Laboratories  
Albuquerque New Mexico 87185-0747

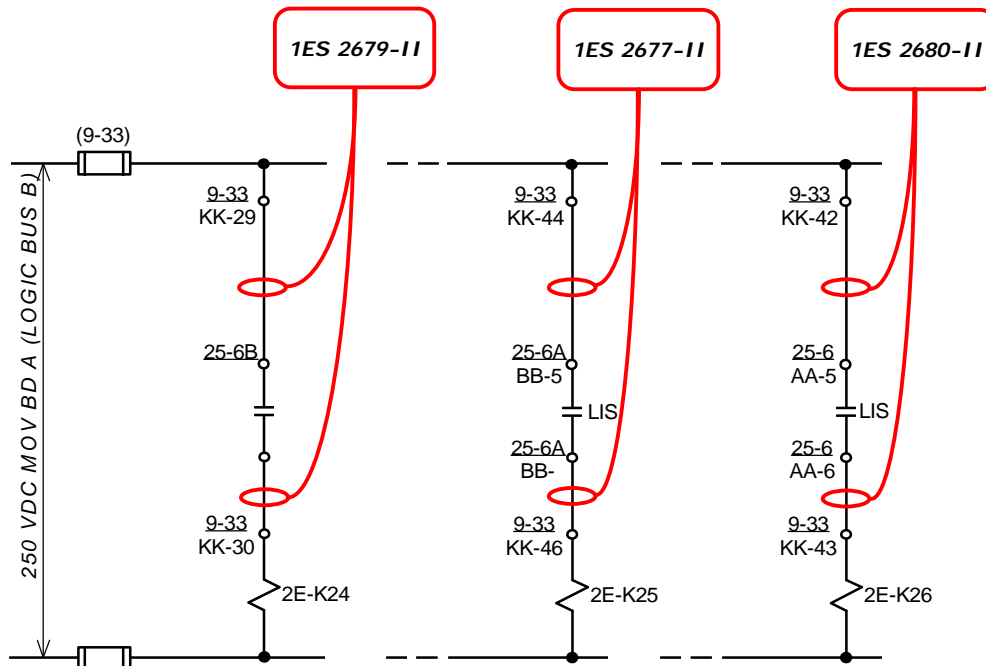
Figure C-1 Partial schematic of ABS relay logic circuit.

These particular relays are intended to initiate alarms for a low water level condition in the reactor. Sheet 2 of 730E929 is referenced in the tables of contact functions on sheet 1 but was not included in the package of electric system drawings. Figure C-1 shows a schematic of the relevant relay branches in the ABS relay logic circuit. Unfortunately, the relay IDs given on the two drawings do not match. It is possible, however, to postulate that internal conductor-to-conductor shorts within an ABS relay logic circuit cable could cause the annunciator alarm.

In addition, information gathered regarding these cables (see Figure C-1) indicates that they all were routed through the zone of fire influence as shown in Table C-4, thus giving credence to the possibility that one (or more) conductor shorts may have occurred to initiate the alarm. It is important to realize that Checkpoint 131 is in the reactor building and is the closest checkpoint to the cable penetration from the cable spreading room where the fire initiated.

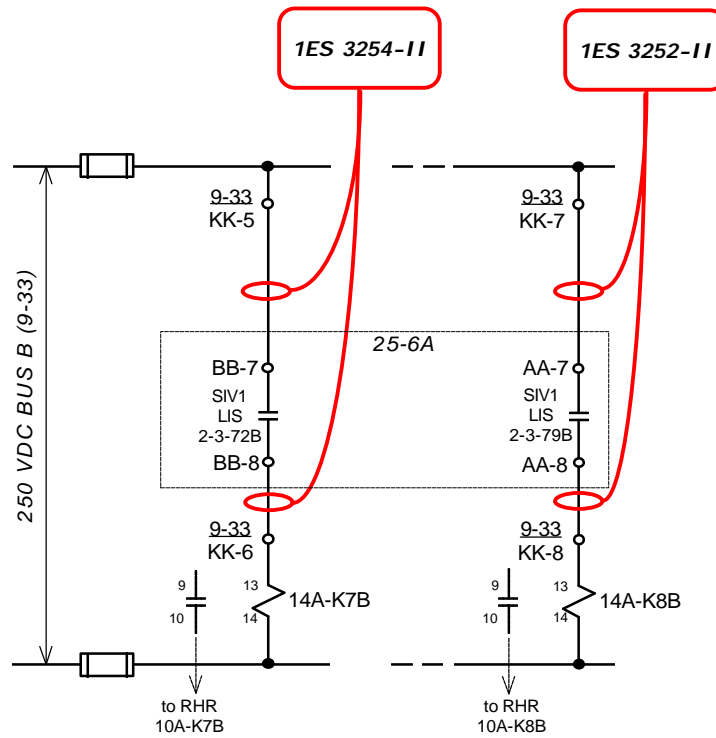
Figure C-2. Partial schematic of Core Spray relay logic circuit.

cables affecting two of these circuit annunciator relays were identified as being fire damaged. Figure C-2 shows the relevant portions of the alarm logic relay circuit for the core spray system. Table C-7 indicates the type and cable trays these cables were located in at three of the fire influence zone checkpoints. As a result of this information, it appears that a conductor-to-conductor shorting event—simulating a low level condition signal from the level switch contacts—is a very definite possibility.

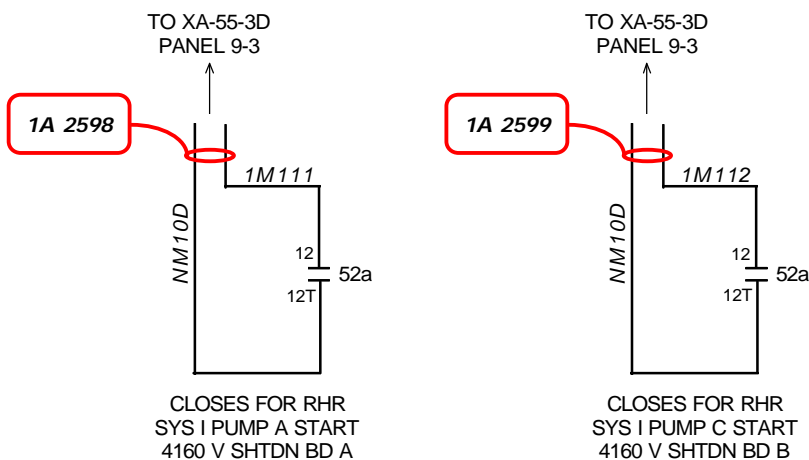
Figure C-3. Partial schematic of annunciator circuit for the RHR Pump Start alarms.

Information gathered regarding the cable routings indicates different cable identifiers for these circuits (e.g., 2A 2598 vs. 1A 2598). This discrepancy may simply be an error made during the markup of drawing 45N620-2. (Also, assuming the “2A” identifier indicates a system II component, the fact, as will be discussed later, that the drawing package includes markups of the control circuits for RHR pumps 2A and 2C makes this assumption appear to be consistent with the bulk of the available information.) Cables 2A 2598 and 2A 2599 were both routed through the zone of fire influence as shown in Table C-9.

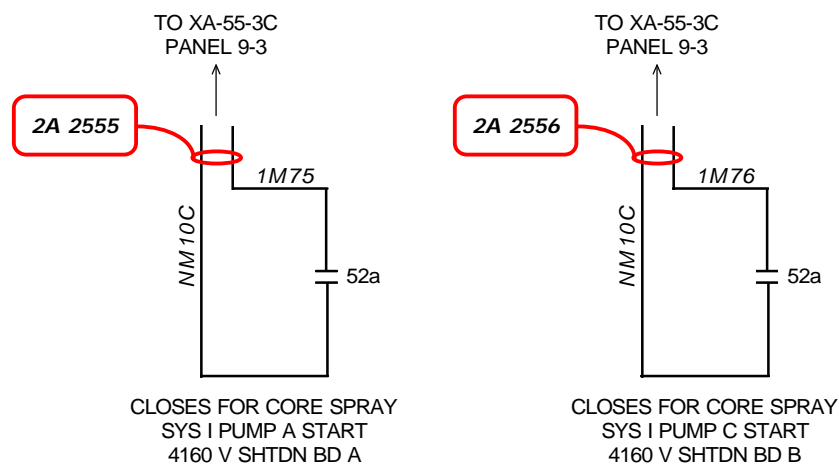
Figure C-4. Partial schematic of annunciator circuit for the Core Spray Pump Start alarms.

Figure C-4 shows a partial schematic of the Core Spray Pump Start alarm circuit. Unlike the case for the RHR pump alarm circuit markups, the CS pump alarm circuit markups indicate cables 2A 2555 and 2A 2556 as the cables of concern (i.e., no discrepancies).

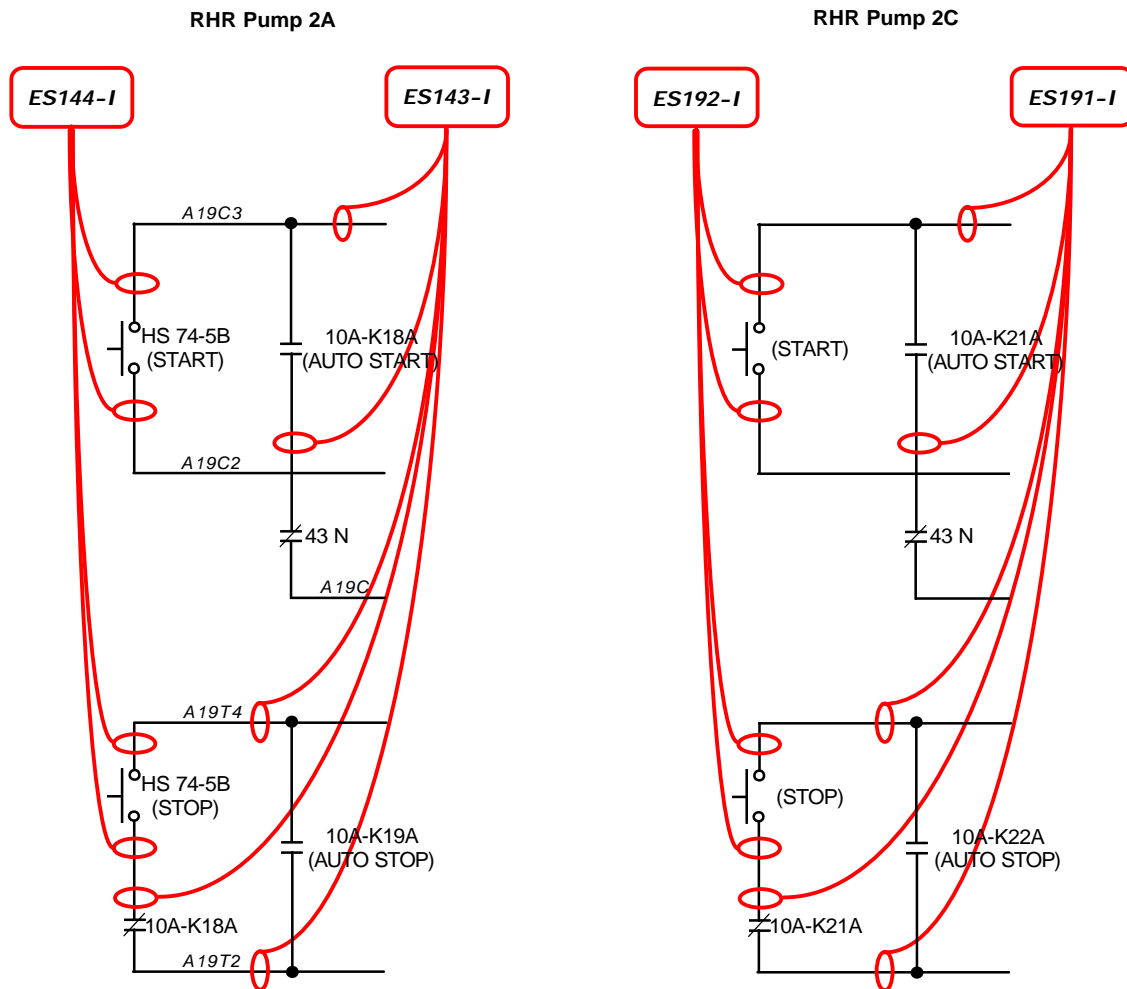
Figure C-5. Partial schematic of the relay and hand switch branches for the RHR pump

It is important to note that shorting of the two conductors going to the hand switch (START) contacts in cable ES144-I (ES190-I) or shorting of the two conductors leading to the auto-start relay in cable ES143-I (ES191-I) would have been able to initiate the pump's operation. Conductor shorting in these cables for the stop (or "trip") circuits is problematical. Shorts that bypass either the hand switch (STOP) contacts or the auto-stop relay contacts should have resulted in tripping the

power breaker for the pump motor(s). However, the events log indicates that the operator could not stop the pumps after their spurious restart at 12:44. This might be explained in one of two ways: 1) conductors leading to or from the STOP hand switch contacts may have failed in an open circuit manner (a very convenient explanation) or 2) the trip coil was a time-delay type wherein continuous shorting of the start/auto-start contact conductors could have overridden the influence of the trip coil. There is no information available to determine if one or either of these possibilities is correct.

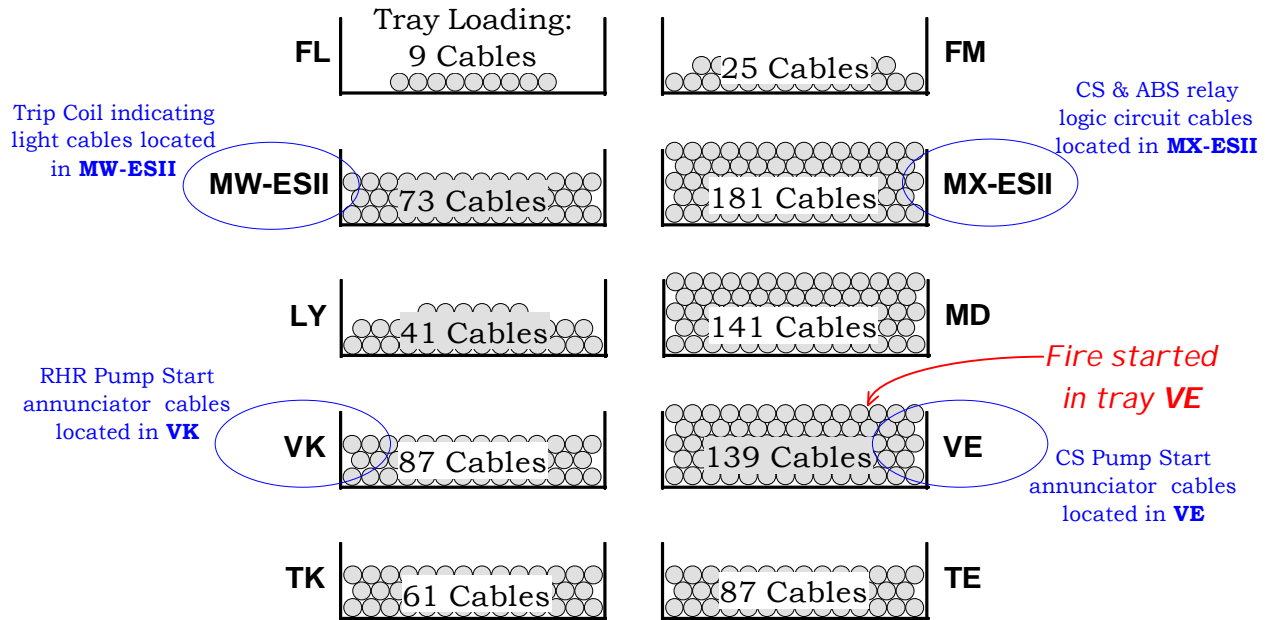
Figure C-9. Cable tray locations and contents. (Ref: Exhibit C1, pp. 30-32 of 69, *Physical Damage to Electric Cables and Raceways Involved in the Browns Ferry Nuclear Plant Fire on March 22, 1975*, contained in Regulatory Investigation Report Office of Inspection and Enforcement Region II.)

pump start alarm circuits are contained in tray VE, where the fire started, and the RHR pump start alarm circuits are contained in tray VK just next to VE. The auto-blowdown and core spray logic circuitry is located two trays above VE (in MX-ESII), and with the fuel loading of trays MX-ESII, MD, and VE it is conceivable that the fire would spread to MX-ESII very rapidly. Finally, the trip coil indicating light circuits are all contained within tray MW-ESII, further away from the ignition point than the other three trays, hence, the effects should have been noted later in the event (as indeed they were).
