Reference: Oregon State University TRIGA Reactor (OSTR)
 Docket No. 50-243, License No. R-106

Subject: Replacement of dashpot covers on OSTR control rod barrels

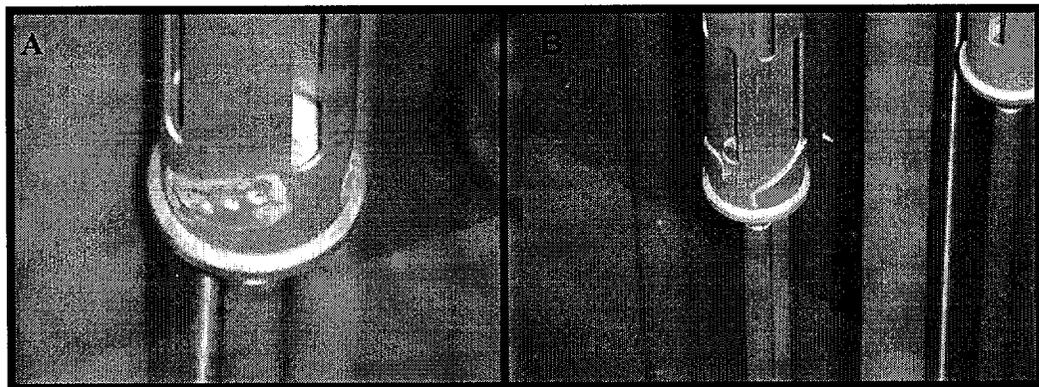
Upon completion of the biennial control rod inspection on November 13, 2000, one of our operators noticed a small piece of metal at rest on the top grid plate. It was quickly identified as one of two dashpot covers that were no longer on the shim control rod barrel. In Figure 1-A, the shim FFCR barrel is shown as it was found on that day. Evidence of an adhesive can clearly be seen surrounding the dashpots. In Figure 1-B, the safety FFCR barrel is shown with the dashpot covers still intact. Per our own procedures, reactor operations were suspended pending resolution of the situation.

Figure 1 - (A) Evidence of epoxy and missing dashpot cover on the shim barrel; (B) Intact dashpot covers on the safety barrel.

The shim and safety FFCR barrels have three sets of dashpots. Each set consists of four holes of increasing diameter placed in a diagonal pattern on the bottom of each barrel. The safety FFCR barrel was found with both dashpot covers intact. The shim FFCR barrel was found with no covers but evidence of adhesive suggests that two of the three had previously been covered. The OSTR has two other control rods. However, they are both different than the shim and safety. The regulating FFCR barrel has only one set of dashpots and they are not covered. The

On November 15, the metal piece found on the top grid plate was retrieved and inspected. It was clear that the adhesive used was an epoxy of some kind. However, this left one of the dashpot covers unaccounted for. Using an underwater camera, all accessible areas surrounding the core were videotaped in an effort to find the missing cover. These areas included the top grid plate, any vacant lattice positions, and underneath the core itself. On November 16, our USNRC Program Manager was informed of the situation.

On November 14, we contacted General Atomics. They stated that they were aware of this happening to other facilities and their recommendation was to weld on new dashpot covers.

On the morning of November 17, a Reactor Operations Committee meeting was held. A 10 CFR 50.59 Safety Evaluation was performed which approved welding aluminum covers over the previously covered dashpots. Welding the covers would return the barrels to their original condition, allow the use of the 10 CFR 50.59 process, and preclude the possibility of this problem from reoccurring. Later that afternoon, a series of fuel movements were performed to investigate the possibility that the missing dashpot cover had inadvertently worked its way onto the bottom grid plate. As a fuel element was raised above the top grid plate, a video camera was lowered to look at the bottom grid plate. The missing dashpot cover was not found. After the video search of the bottom grid plate was completed, the shim and safety barrels were removed. The two dashpot covers that were intact on the safety barrel came off with relative ease.

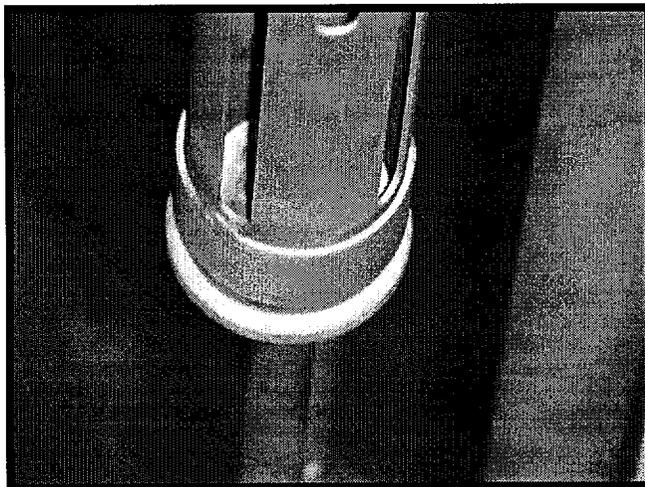
Figure 2 – Repaired dashpot cover on the shim barrel.

On November 20, both barrels were repaired and reinstalled. A picture of the repaired Safety FFCR barrel is shown in Figure 2. The rod up travel time, rod down travel time, and rod scram time for all four rods were measured and verified to be within the normal range of values observed in the past. On November 21, suspension of reactor operations was lifted, and normal operations resumed.

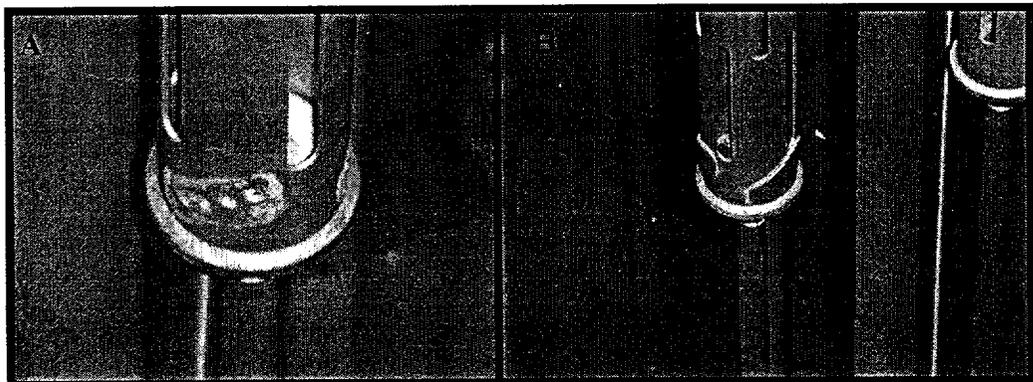
Upon completion of the biennial control rod inspection on November 13, 2000, one of our operators noticed a small piece of metal at rest on the top grid plate. It was quickly identified as one of two dashpot covers that were no longer on the shim control rod barrel. In Figure 1-A, the shim FFCR barrel is shown as it was found on that day. Evidence of an adhesive can clearly be seen surrounding the dashpots. In Figure 1-B, the safety FFCR barrel is shown with the dashpot covers still intact. Per our own procedures, reactor operations were suspended pending resolution of the situation.

Figure 1 - (A) Evidence of epoxy and missing dashpot cover on the shim barrel; (B) Intact dashpot covers on the safety barrel.

The shim and safety FFCR barrels have three sets of dashpots. Each set consists of four holes of increasing diameter placed in a diagonal pattern on the bottom of each barrel. The safety FFCR barrel was found with both dashpot covers intact. The shim FFCR barrel was found with no covers but evidence of adhesive suggests that two of the three had previously been covered. The OSTR has two other control rods. However, they are both different than the shim and safety. The regulating FFCR barrel has only one set of dashpots and they are not covered. The

On November 15, the metal piece found on the top grid plate was retrieved and inspected. It was clear that the adhesive used was an epoxy of some kind. However, this left one of the dashpot covers unaccounted for. Using an underwater camera, all accessible areas surrounding the core were videotaped in an effort to find the missing cover. These areas included the top grid plate, any vacant lattice positions, and underneath the core itself. On November 16, our USNRC Program Manager was informed of the situation.

On November 14, we contacted General Atomics. They stated that they were aware of this happening to other facilities and their recommendation was to weld on new dashpot covers.

On the morning of November 17, a Reactor Operations Committee meeting was held. A 10 CFR 50.59 Safety Evaluation was performed which approved welding aluminum covers over the previously covered dashpots. Welding the covers would return the barrels to their original condition, allow the use of the 10 CFR 50.59 process, and preclude the possibility of this problem from reoccurring. Later that afternoon, a series of fuel movements were performed to investigate the possibility that the missing dashpot cover had inadvertently worked its way onto the bottom grid plate. As a fuel element was raised above the top grid plate, a video camera was lowered to look at the bottom grid plate. The missing dashpot cover was not found. After the video search of the bottom grid plate was completed, the shim and safety barrels were removed. The two dashpot covers that were intact on the safety barrel came off with relative ease.

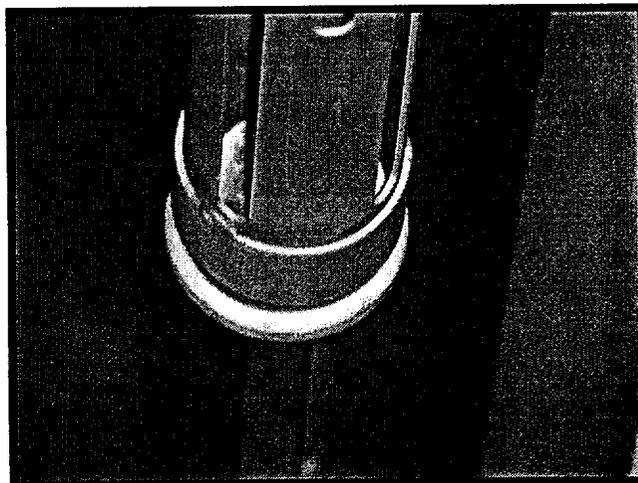
Figure 2 – Repaired dashpot cover on the shim barrel.

On November 20, both barrels were repaired and reinstalled. A picture of the repaired Safety FFCR barrel is shown in Figure 2. The rod up travel time, rod down travel time, and rod scram time for all four rods were measured and verified to be within the normal range of values observed in the past. On November 21, suspension of reactor operations was lifted, and normal operations resumed.
