**Clinton Power Station**

Subject: Clinton Power Station  
Licensee Event Report No. 2000-002-01

**TITLE (4)**  
Out-of-Phase Synchronization Results in Damage to Division 3 Emergency Diesel Generator and Inadequate Design of Static VAR Compensator Freeze Circuit Results in Overvoltage of Class 1E Divisional Bus

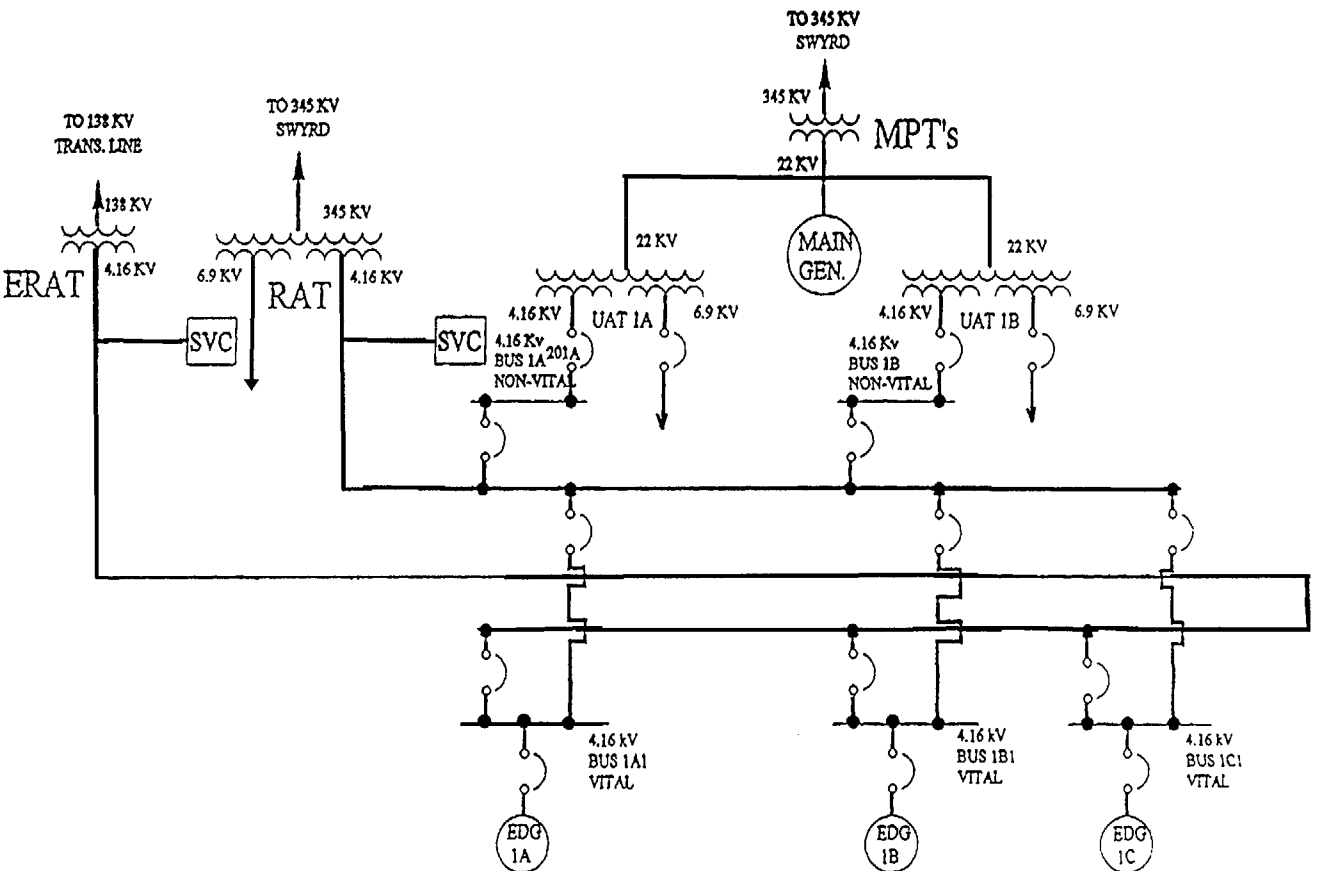
Figure 1

The Clinton Power Station (CPS) Class 1E 4160 VAC electric power system consists of three electrically and physically independent distribution divisions, i.e., the 1A1, 1B1 and 1C1 electrical buses. Each of the three distribution divisions can be supplied with electric power from either of two offsite sources via two physically independent circuits or an EDG that serves as a standby power source, independent of the offsite source. The two physically independent offsite source circuits are the 345 kilovolt (kV) circuit through the Reserve Auxiliary Transformer (RAT) and the 138 kV circuit through the Emergency Reserve Auxiliary Transformer (ERAT). A Static VAR Compensator (SVC) is installed on each of the secondary sides of the RAT and ERAT to assist in maintaining acceptable voltages to the 4160 VAC distribution divisions during normal plant operating conditions and / or accident conditions. Each SVC is rated at +28.5/-14.0 MVAR and includes a thyristor-controlled reactor bank rated at 21.5 MVAR, a thyristor switched capacitor bank rated at 21.0 MVAR, and a capacitive harmonic filter bank rated at 7.5 MVAR. (Figure 1 on page 10 contains a simplified diagram of the 4160 VAC electrical power system.)
