Duke Energy

Subject: Oconee Nuclear Station, Unit 1
Docket No. 50-269
Licensee Event Report 269/2000-006, Revision 1
Problem Investigation Process No.: O-00-04134

LICENSEE EVENT REPORT (LER)

TITLE (4)
Reactor Coolant System Pressure Boundary Leakage Due To Cracks Found in Several Small Bore Reactor Vessel Head Penetrations

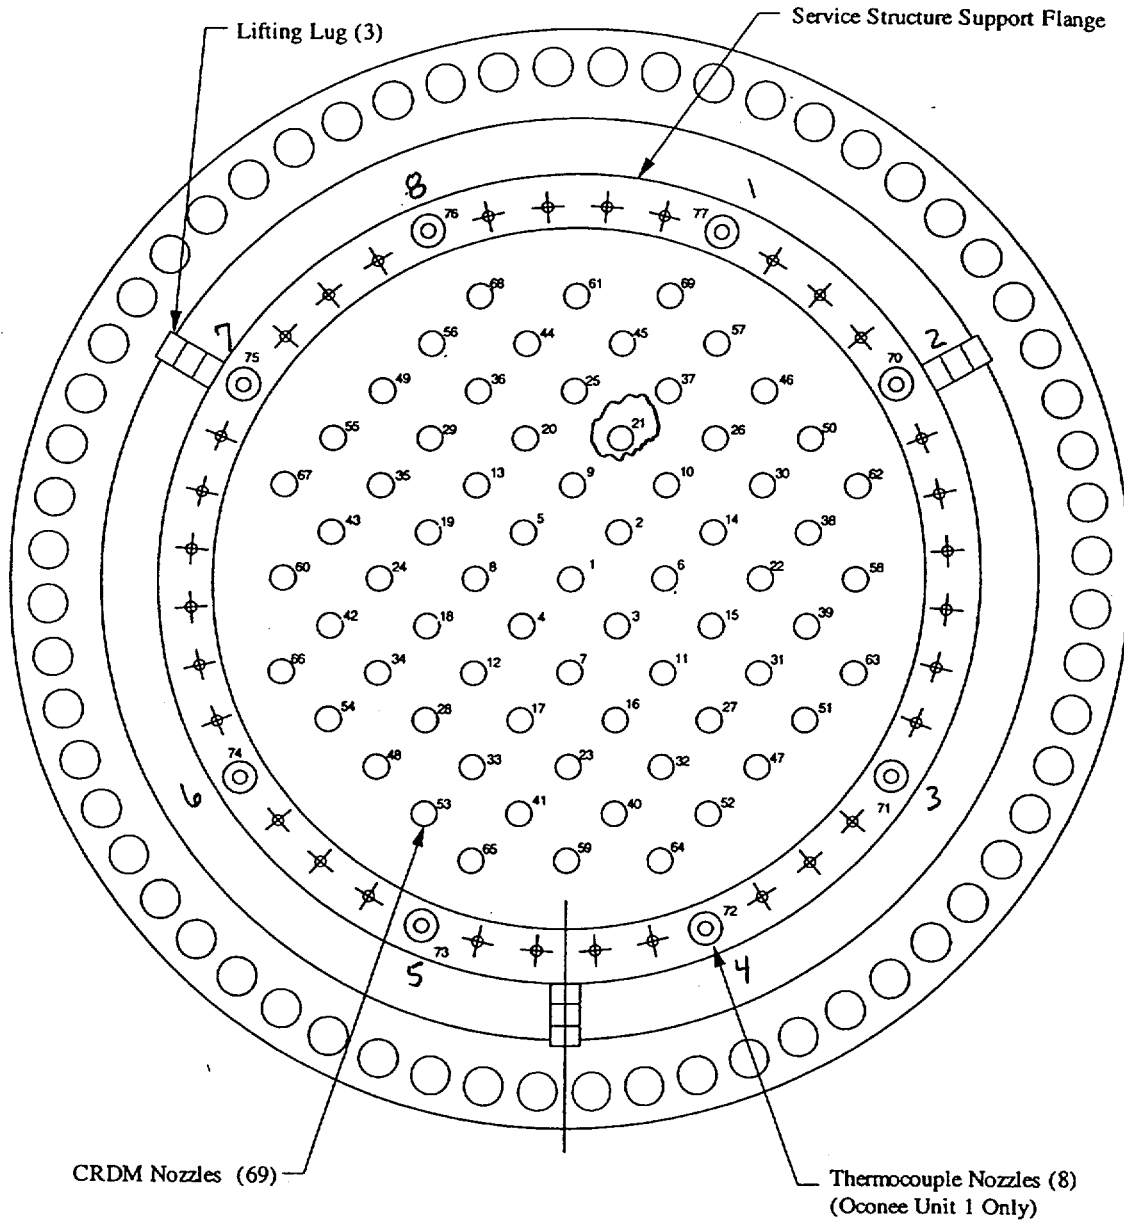
Figure 1

Boric acid deposits appeared to be located at the base of 5 (of the 8) unused thermocouple (T/C) nozzles and 1 (of 69) Control Rod Drive Mechanism (CRDM) nozzle at points where they penetrate the RPV head surface. A more detailed video inspection, performed on December 1, 2000, confirmed the presence of the boric acid crystals around the base of T/C nozzles #1, #2, #3, #4 and #5. The maximum volume of boric acid observed was around the base of CRDM #21 and was estimated to be approximately 0.5 cubic inches. The amounts around the T/Cs were much less.

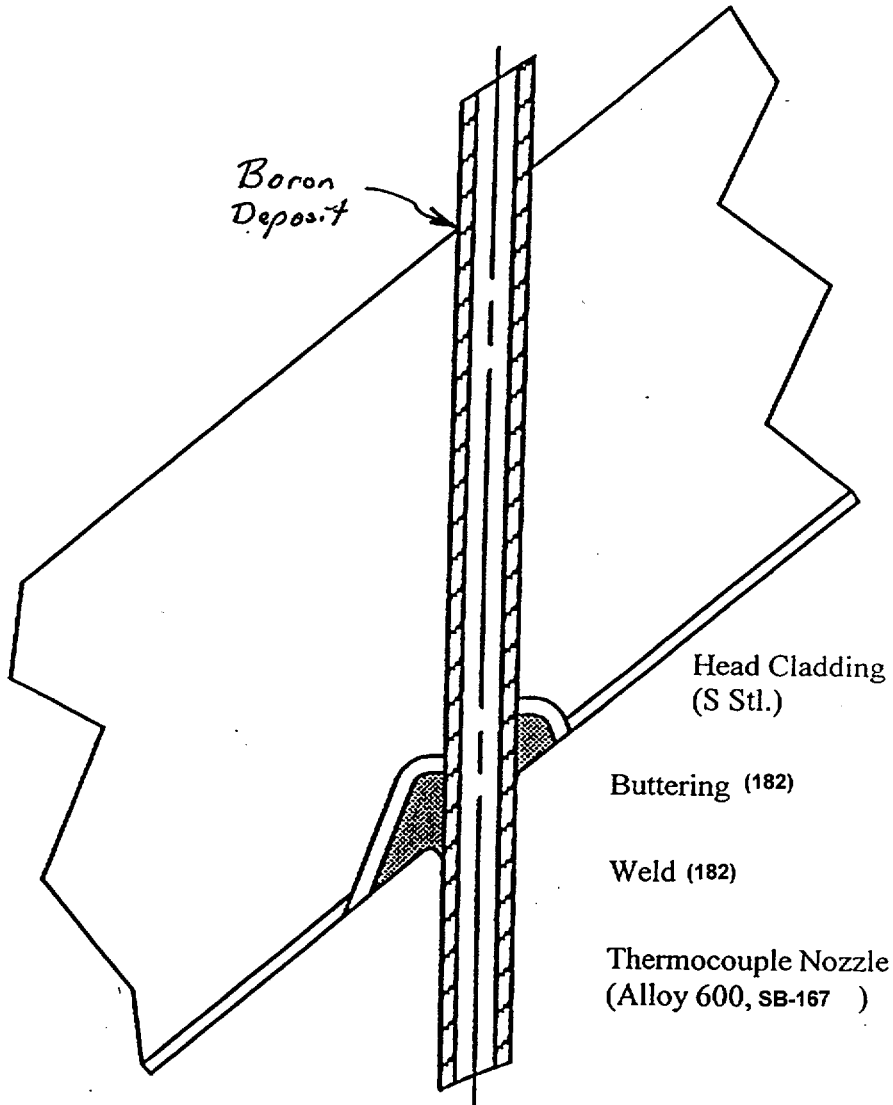
Figure 2

A typical T/C head penetration (See Figure 2) consists of a 1.03-inch outside diameter (OD) by 0.218-inch nominal wall alloy 600 pipe that is inserted vertically into the RPV head and connected to the inside diameter (ID) surface by a J-groove partial penetration weld. All 8 thermocouple penetrations have an overall length of approximately 62-inches. Approximately 8 inches of each penetration extends past the ID surface of the J-groove weld located on the inside surface of the RPV head. Each thermocouple penetration has a flange welded to the top of the pipe that extends the penetration length by approximately 2-inches.

On December 6, 2000, ultrasonic Test (UT) examinations from the inside surface of the T/C nozzles allowed the weld size to be determined and the axial crack-like indications (as determined by the prior EC examination) to be located relative to the welds. This work showed that most welds: (a) were significantly larger than specified on the design drawings, (b) lacked weld symmetry, (c) contained small areas of possible slag inclusions at the interface between the nozzles and welds, and (d) were undercut at the toes of the fillets where the weld joins the nozzle outside diameters.

Liquid penetrant (LP) examinations of the J-groove welds (after boring out the nozzles), showed that some cracks had penetrated through the nozzle walls and that the orientation of these cracks was predominantly axial at the plane where the cracks penetrated into the welds. Four T/C nozzles (#4, #6, #7 and #8), had crack depths less than 0.163 inches into the 182-weld metal. Two other T/C nozzles (#1 and #3), had crack depths less than 0.288 inches into the weld. The remaining two nozzles (#2 and #5), had some cracks penetrating completely through the J-groove weld, the Inconel buttering and up to the vessel head low alloy steel. After all crack indications had been removed, the total exposed low alloy material was about 1.75 square inches for T/C #2 and 2.5 square inches for T/C #5.

Metallurgical lab testing of the two removed nozzle pieces (T/Cs #7 and #8), confirmed the presence of an axial through-wall intergranular crack on the piece removed from above the weld on nozzle #8. An axial partial through-wall intergranular crack was found on the piece removed below the weld on nozzle #7.

Eddy current, Ultrasonic (UT) and LP examinations revealed that the predominately axial cracks found fall within the weld region where finite element stress analyses (including the effects of welding residual stresses and operating conditions) predict high hoop stresses. The axial cracks are consistent with the fact that the analysis shows the hoop stress (that drives cracks in the axial orientation) to be higher than the axial stress (that drives cracks circumferentially) at high stress locations. The fact that the axial cracks have grown through the nozzle wall and into the J-groove weld is also consistent with analysis predictions that the high hoop stresses extend through the nozzle wall and into the weld metal. In summary, the deep and predominantly axially oriented

- All eight thermocouple nozzles were removed by boring them out from the underside of the vessel head and cutting a 4-inch long, 1.375-inch diameter counter bore in the lower head region. The counter bore diameter was larger than the nominal 1.035-inch diameter of the original hole in the vessel head.

- For nozzle locations #1, #3, #4, #6, #7 and #8, all remaining indications in the partial penetration welds were removed, and 4-inch long alloy 690 plugs were welded to the existing J-groove weld metal from the underside of the head. The plugs fit the counter bore diameter and are thus larger than the original hole in the vessel head so that the plugs cannot be ejected if the repair welds fail.

- For nozzles #2 and #5, the cracks extended up to the low alloy, steel base metal of the reactor vessel head. It was undesirable to perform an under-the-head temper bead weld repair at this location. These nozzles were repaired using a 9-inch long alloy 690 plug installed from the underside of the vessel head and welded to the top surface of the vessel head using a temper bead technique. The bottom portions of these plugs also fit the counter bore diameter and are therefore larger in diameter than the original holes through the vessel head such that they cannot be ejected if the repair welds fail.

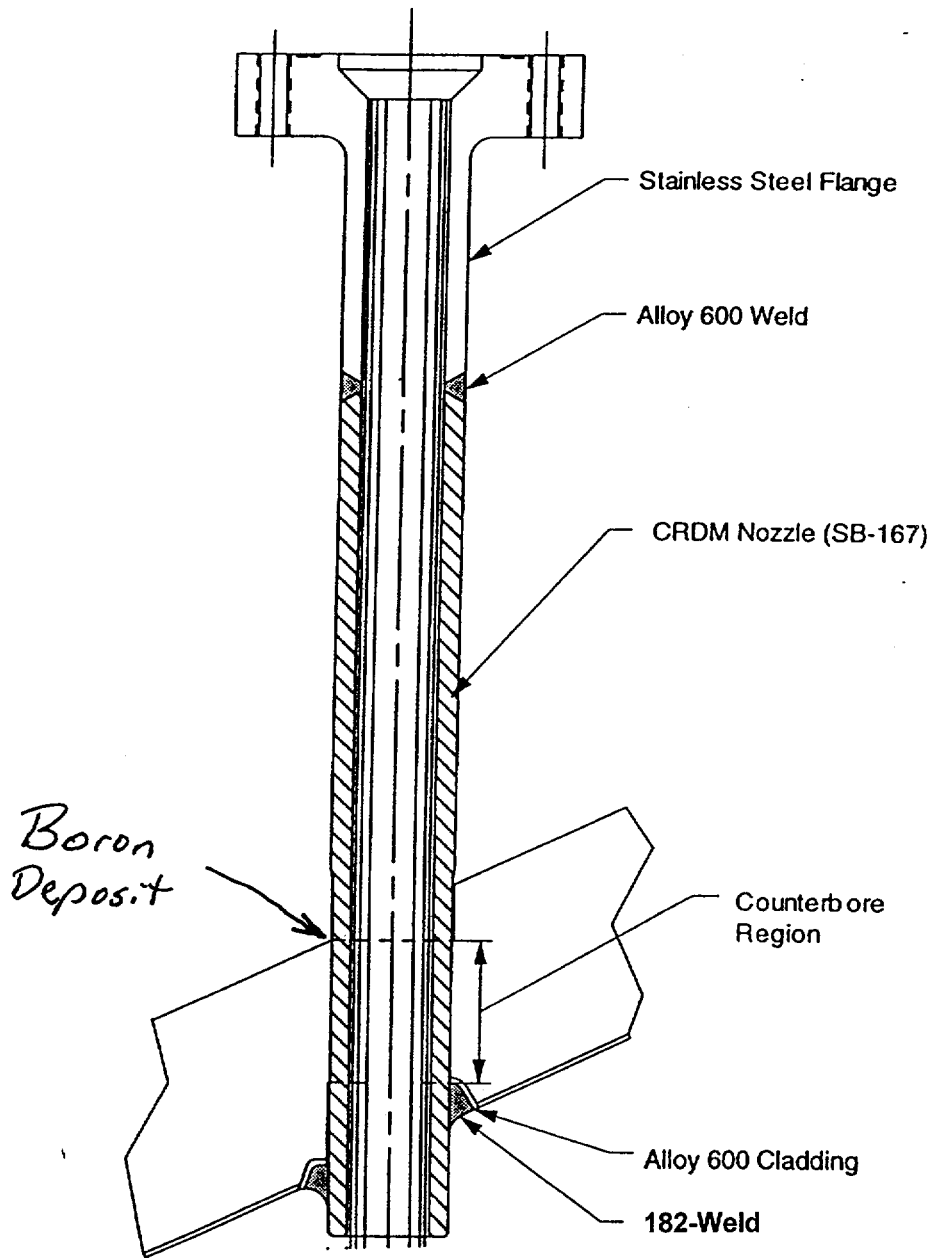
Figure 3

An EC inspection of CRDM Nozzle 21 on December 7, 2000 did not identify any significant indications that suggested a through-wall leak. Following wire brushing of the CRDM nozzle weld and an area of approximately 2 inches around the nozzle, a liquid penetrant inspection of the nozzle, fillet weld cap and partial penetration J-groove weld was performed on December 9, 2000. Results of this test revealed two non-recordable rounded indications, less than 0.05 inch in diameter, on the face of the fillet weld. The indications were located at approximately the 7 o'clock position on the circumference of the nozzle weld (note that the 12 o'clock position is the uphill orientation and 6 o'clock the downhill). No other indications were noted either on the weld or on the surrounding nozzle base metal.

Following light metal removal in the area of the two rounded indications, a second LP inspection that expanded the examination area around the nozzle to 3-inches was performed on December 12, 2000. This test revealed no indications in the outer perimeter area, but clearly showed the two rounded indications and a new rounded indication approximately the same size as the other two. The new indication was aligned with the first two and was on the nozzle side of the fillet weld face. The spacing between the three indications was approximately equal. The decision was made to perform additional metal removal in the area of the three rounded indications and to perform another PT test. This test revealed a linear indication that was oriented transverse to the direction of the fillet weld and was approximately 0.75 inches long.

A boat sample of the weld from CRDM Nozzle 21 was taken on December 24, 2000 and sent to the Duke Engineering & Services Metallurgical Lab for analysis. The lab analysis concluded the cracking in the 182-weld metal was due to Primary Water Stress Corrosion Cracking (PWSCC).

After sample removal, the crack was ground out of the CRDM weld and nozzle material exposing a small area of low alloy, steel base metal. One branch of the crack grew from the root of the fillet weld into the nozzle itself, then grew axially along the alloy 600

nozzle material (no more than 0.4 inch depth) and finally, back into the J-groove to the nozzle/weld annulus interface. It was subsequently concluded from the root cause investigation that this branch was likely the source of the CRDM #21 leak.

5. The CRDM #21 nozzle weld cracks and its branches were ground out and the final weld repair performed in accordance with the ASME Code using the temper bead technique. This repair was completed prior to unit restart.
