Subject: 10CFR21 Reporting of Defects and Non-Compliance -
Engine Systems, Inc. Report No. 10CFR21-0081

Refurbished Woodward EGB governor/actuators

10CFR21 REPORTING OF DEFECTS AND NON-COMPLIANCE

COMPONENT: Refurbished Woodward EGB governor/actuators

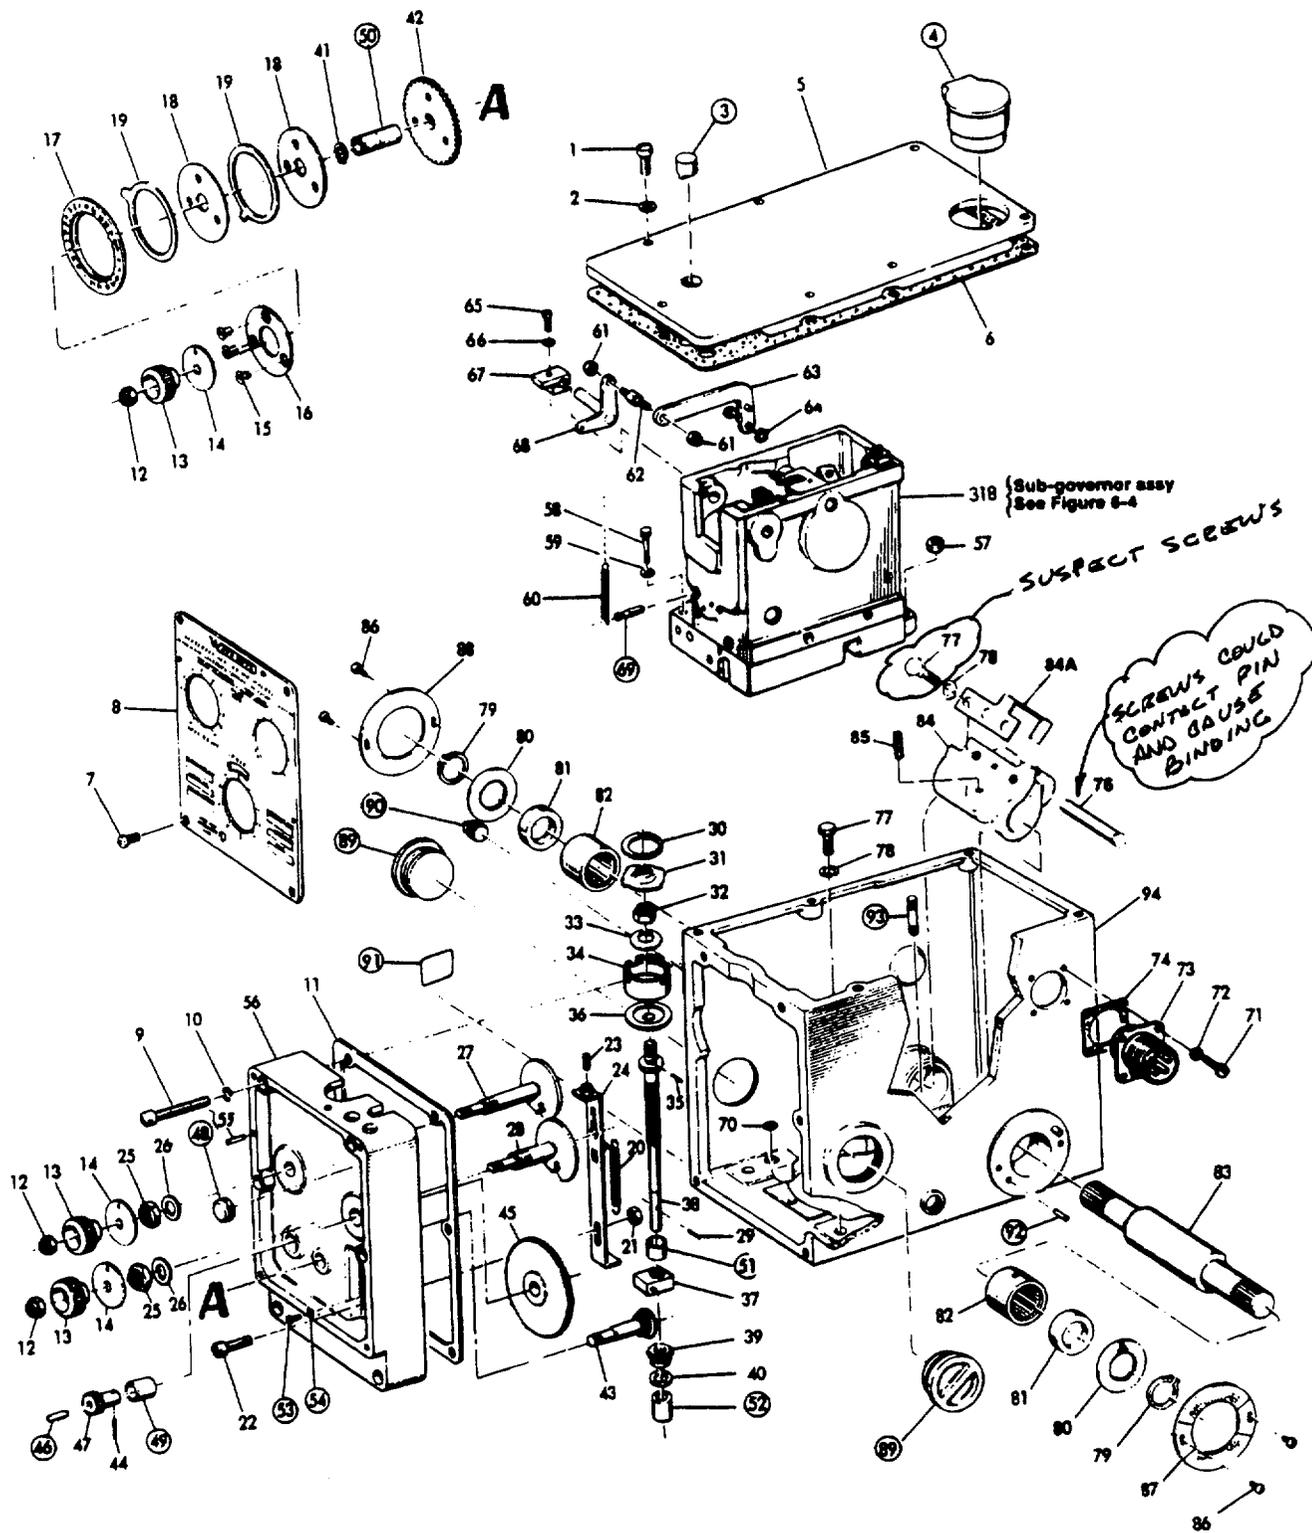
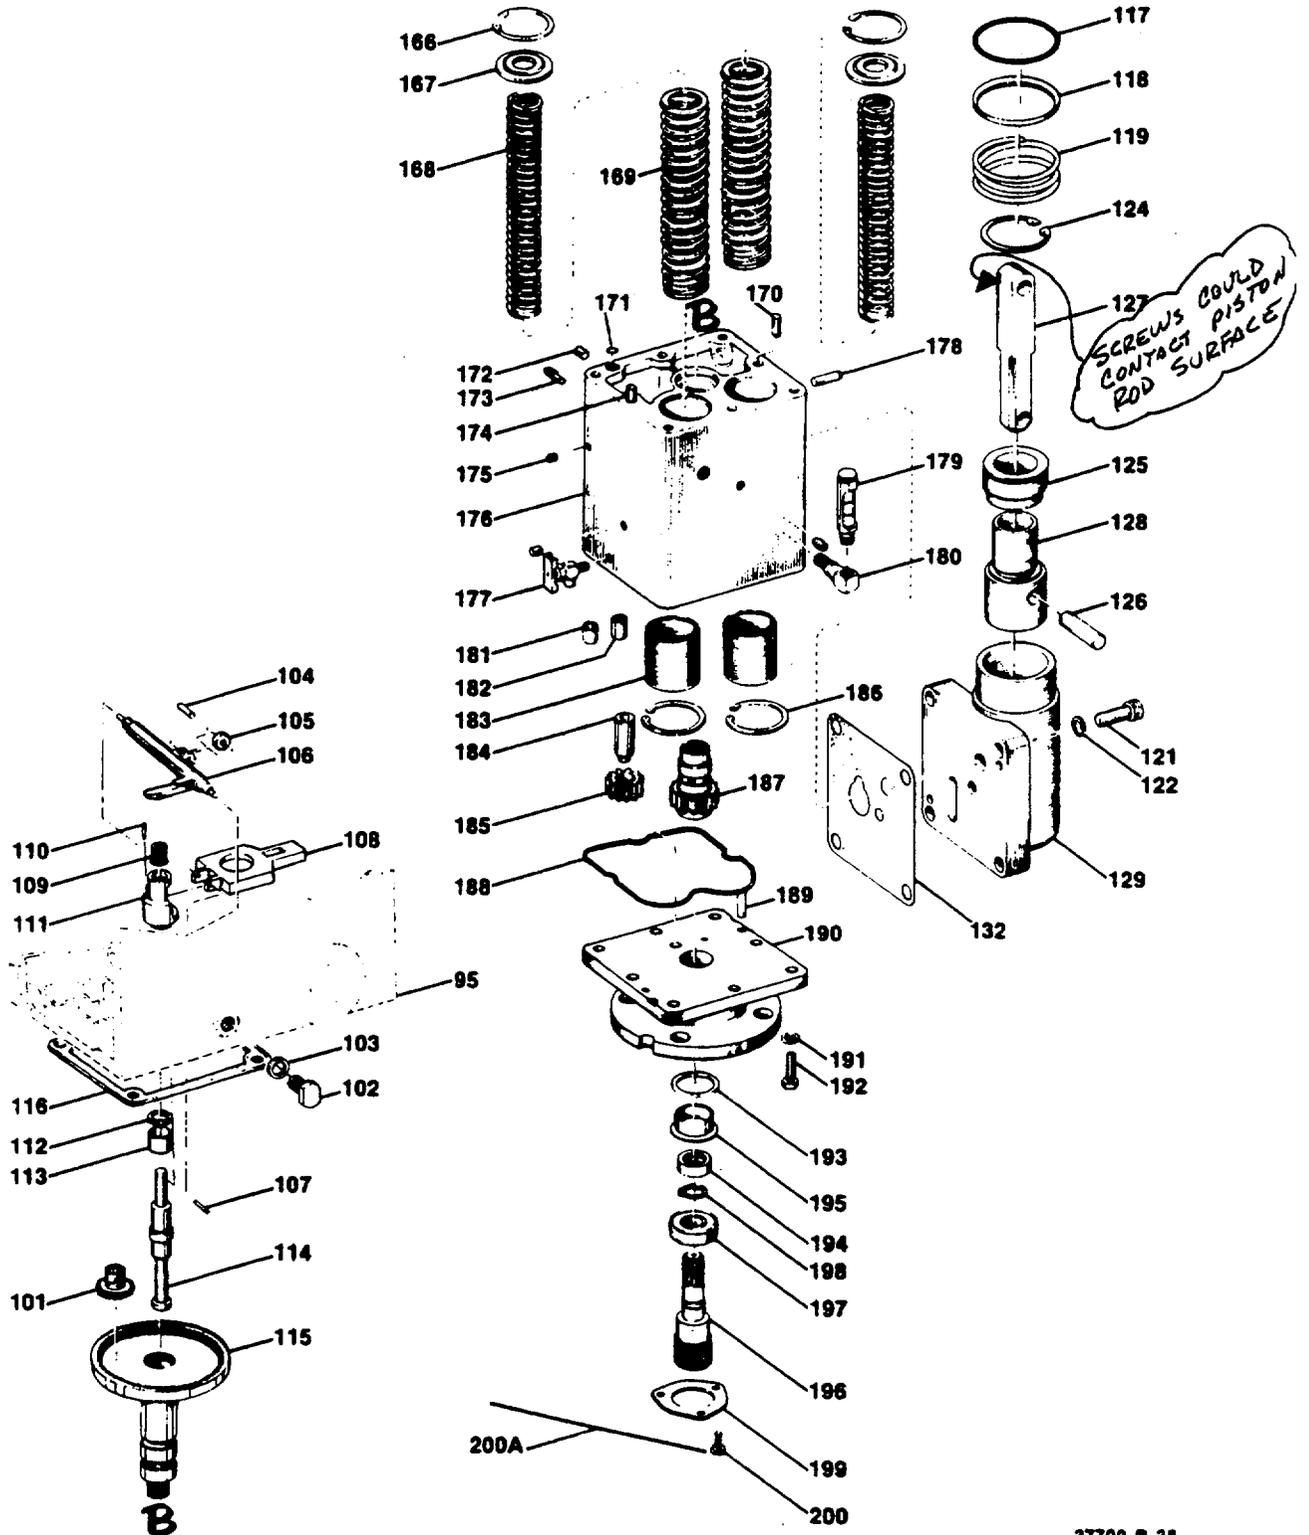
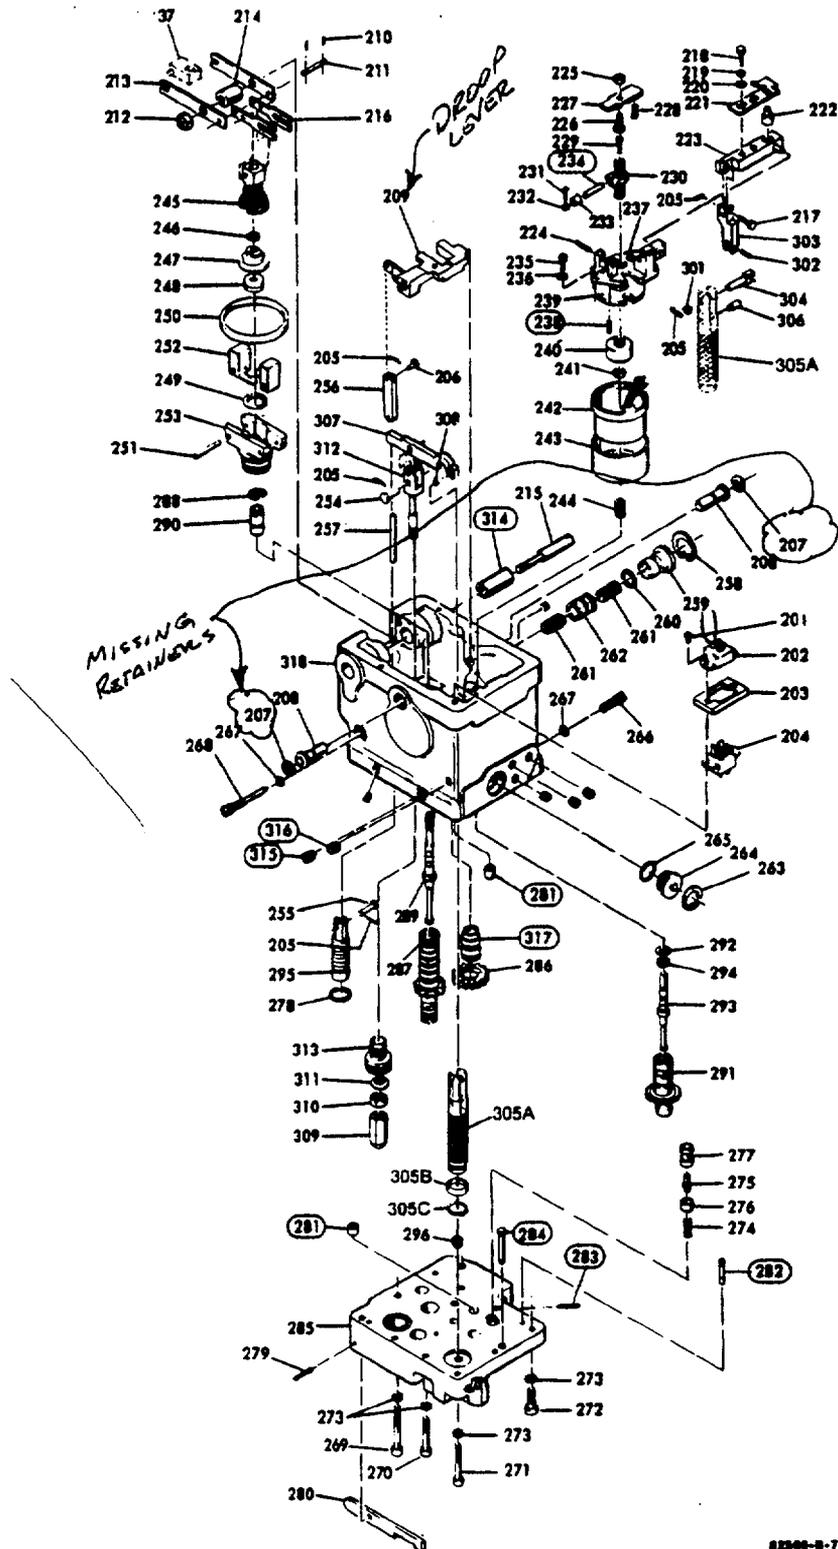
EXHIBIT 1

Engine Systems Inc. (ESI) has received notification about a potential problem with some refurbished Woodward EGB governor actuators. One problem was recently reported by V.C. Summer Nuclear Station, via Power Reactor Event Number 37788. Apparently, a governor experienced binding of the terminal shaft due to incorrectly applied clamping screws. ESI was not notified about this occurrence until after the Event Report was issue; therefore, ESI was not able to verify/evaluate the actual components involved. Another problem was also reported by J.A. Fitzpatrick Nuclear Plant with this governor. Operability problems were observed and an investigation revealed that the droop lever pivot pin retaining rings were omitted during reassembly of the governor. Due to the missing retaining rings, the pins eventually backed out, releasing the droop lever. This caused the mechanical speed setting to drop and interfere with electric governor operation (limited load carrying capability). A parts breakdown for the EGB is provided in Exhibit 1 with the above parts annotated.

ESI recommends returning the suspect governors to ESI for a completed tear-down inspection. ESI will reassemble and functionally test to Woodward specifications. NOTE: Even though the V.C Summer governor screw length issue was corrected, we still recommend a complete tear-down to verify all refurbishment activity is within specifications. The Fitzpatrick unit (s/n 2185499) was recently returned to ESI to replace the missing terminal shaft retaining rings. A complete tear-down inspection was performed at that time; no further action on this governor is required. Contact ESI's Customer Service Department for return instructions.
