Nebraska Public Power District
Nebraska's Energy Leader

Subject: Licensee Event Report No. 2001-001
Cooper Nuclear Station, NRC Docket 50-298, DPR-46

FACILITY NAME (1) Cooper Nuclear Station					TITLE (4) Confusing or Incomplete Standards and Administrative Controls Resulted in Failure to Test an Excess Flow Check Valve						
EVENT DATE (5)			LER NUMBER (6)			REPORT DATE (7)			OTHER FACILITIES INVOLVED (8)		
MO	DAY	YEAR	YEAR	SEQUENTIAL NUMBER	REV NO	MO	DAY	YEAR	FACILITY NAME	DOCKET NUMBER	
01	17	2001	2001	- 001 -	00	03	12	2001	FACILITY NAME	DOCKET NUMBER	
OPERATING MODE (9)		1	THIS REPORT IS SUBMITTED PURSUANT TO THE REQUIREMENTS OF 10 CFR §: (Check all that apply) (11)								
POWER LEVEL (10)		100	20.2201(b)			20.2203(a)(3)(ii)			50.73(a)(2)(ii)(B)		50.73(a)(2)(ix)(A)

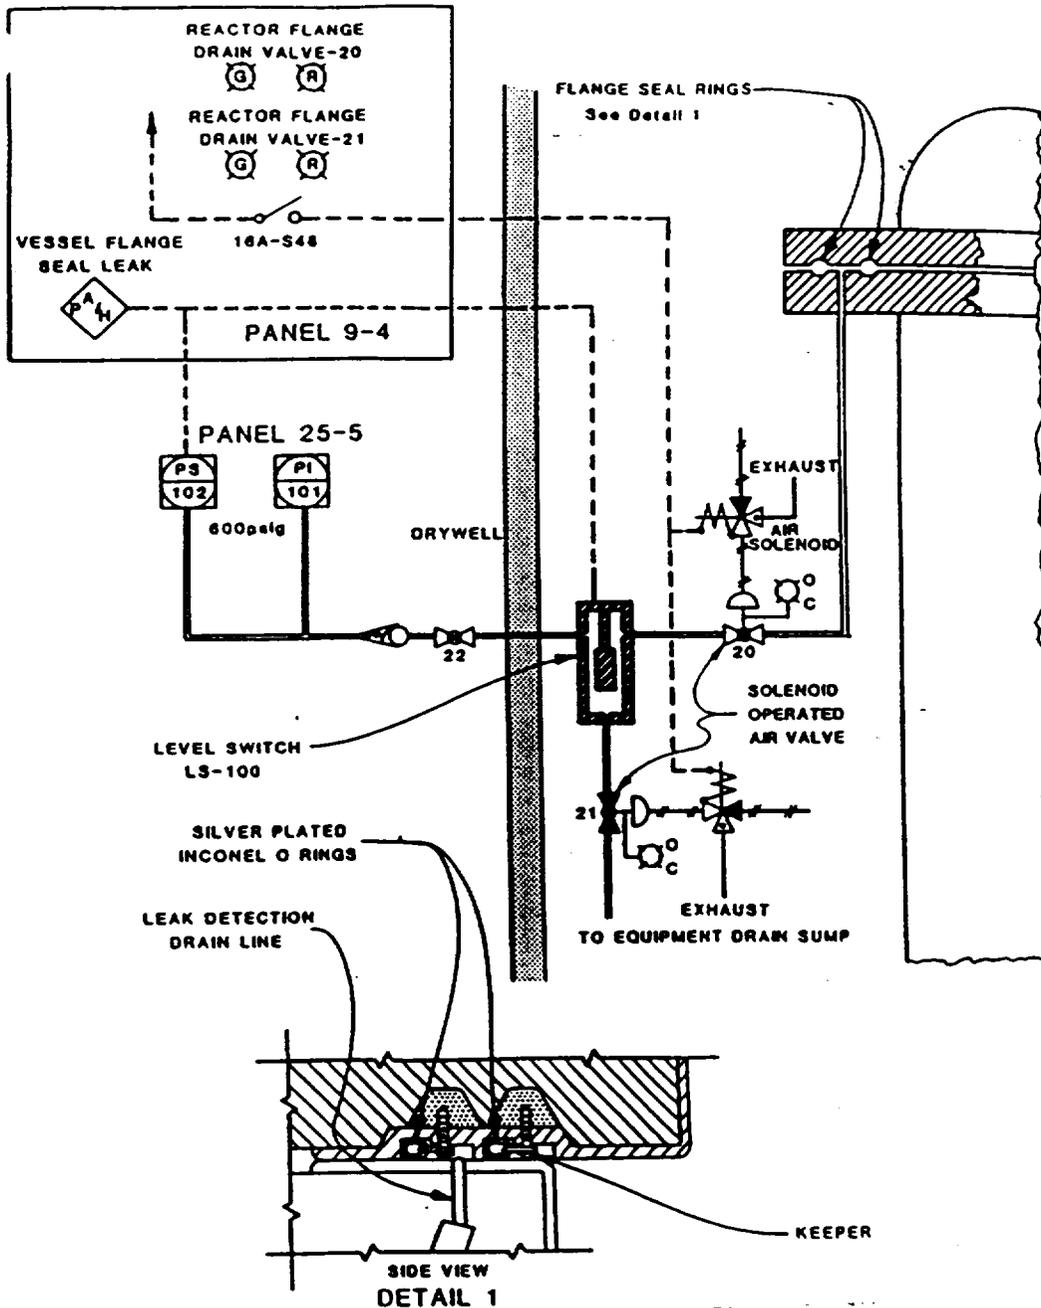
SIMPLIFIED ILLUSTRATION OF REACTOR VESSEL HEAD SEAL LEAK DETECTION SYSTEM

The reactor vessel head seal leak detection system (EISS: IJ) provides the operator with sufficient indication of reactor vessel top head flange leakage during planned operations. Page 6 of this LER provides a simplified illustration of the system and major components.

A connection on the reactor vessel flange is provided into the annulus between the two metallic seal rings used to seal the reactor vessel and top head flanges. This connection permits detection of leakage from inside of the reactor vessel past the inner seal ring. The connection is piped, via a 1.0 inch carbon steel pipe, to a collection chamber installed between two a-c solenoid-operated valves. The upstream valve is normally open, the downstream valve normally closed. A level switch is provided to detect the accumulation of water in the collection chamber. This level switch actuates an alarm in the main control room. A pressure switch is also provided to actuate the alarm in the main control room as pressure in the leakage collection piping becomes abnormally high. A pressure indicator is provided to indicate the pressure inside the piping arrangement. The level switch is located inside the primary containment, and the pressure instruments are located outside the drywell but inside the reactor building. The instrument pipeline (1.0 inch carbon steel line with a 1/4 inch restricting orifice) for the pressure instruments is provided with one manual isolation valve and one excess flow check valve (EFCV)(NBI-CV-48BCV)(EISS: JM). The two solenoid valves are controlled by a switch in the main control room. The positions of the valves are indicated by lights. If leakage past the inner seal ring is indicated, the upstream valve can be closed and the downstream valve can be opened by remote-manual operation from the main control room. This action routes the accumulated leakage to the drywell equipment drain sump. After the collection chamber is drained, the solenoid-operated valves can be returned to their normal positions. The leakage rate can be determined by timing the period until the level alarm is reactivated.

The safety function of the excess flow check valve (NBI-CV-48BCV) is to close on excess flow to maintain the reactor coolant pressure boundary in the event of a leak from the reactor vessel flange inner seal (note the outer seal is assumed to be still intact), coincident with a break in the pressure instrument line downstream of the check valve. The open function of the valve (normally open valve remains open) is not a safety function. In the unlikely event that the EFCV is stuck closed, adequate indication of seal leakage remains available to the operator by utilizing the collection chamber referenced above.
