Subject: 10CFR21 Reporting of Defects and Non-Compliance -  
Engine Systems, Inc. Report No. 10CFR21-0081, rev.1

Refurbished Woodward EGB governor/actuators

### 10CFR21 REPORTING OF DEFECTS AND NON-COMPLIANCE

COMPONENT: Refurbished Woodward EGB governor/actuators

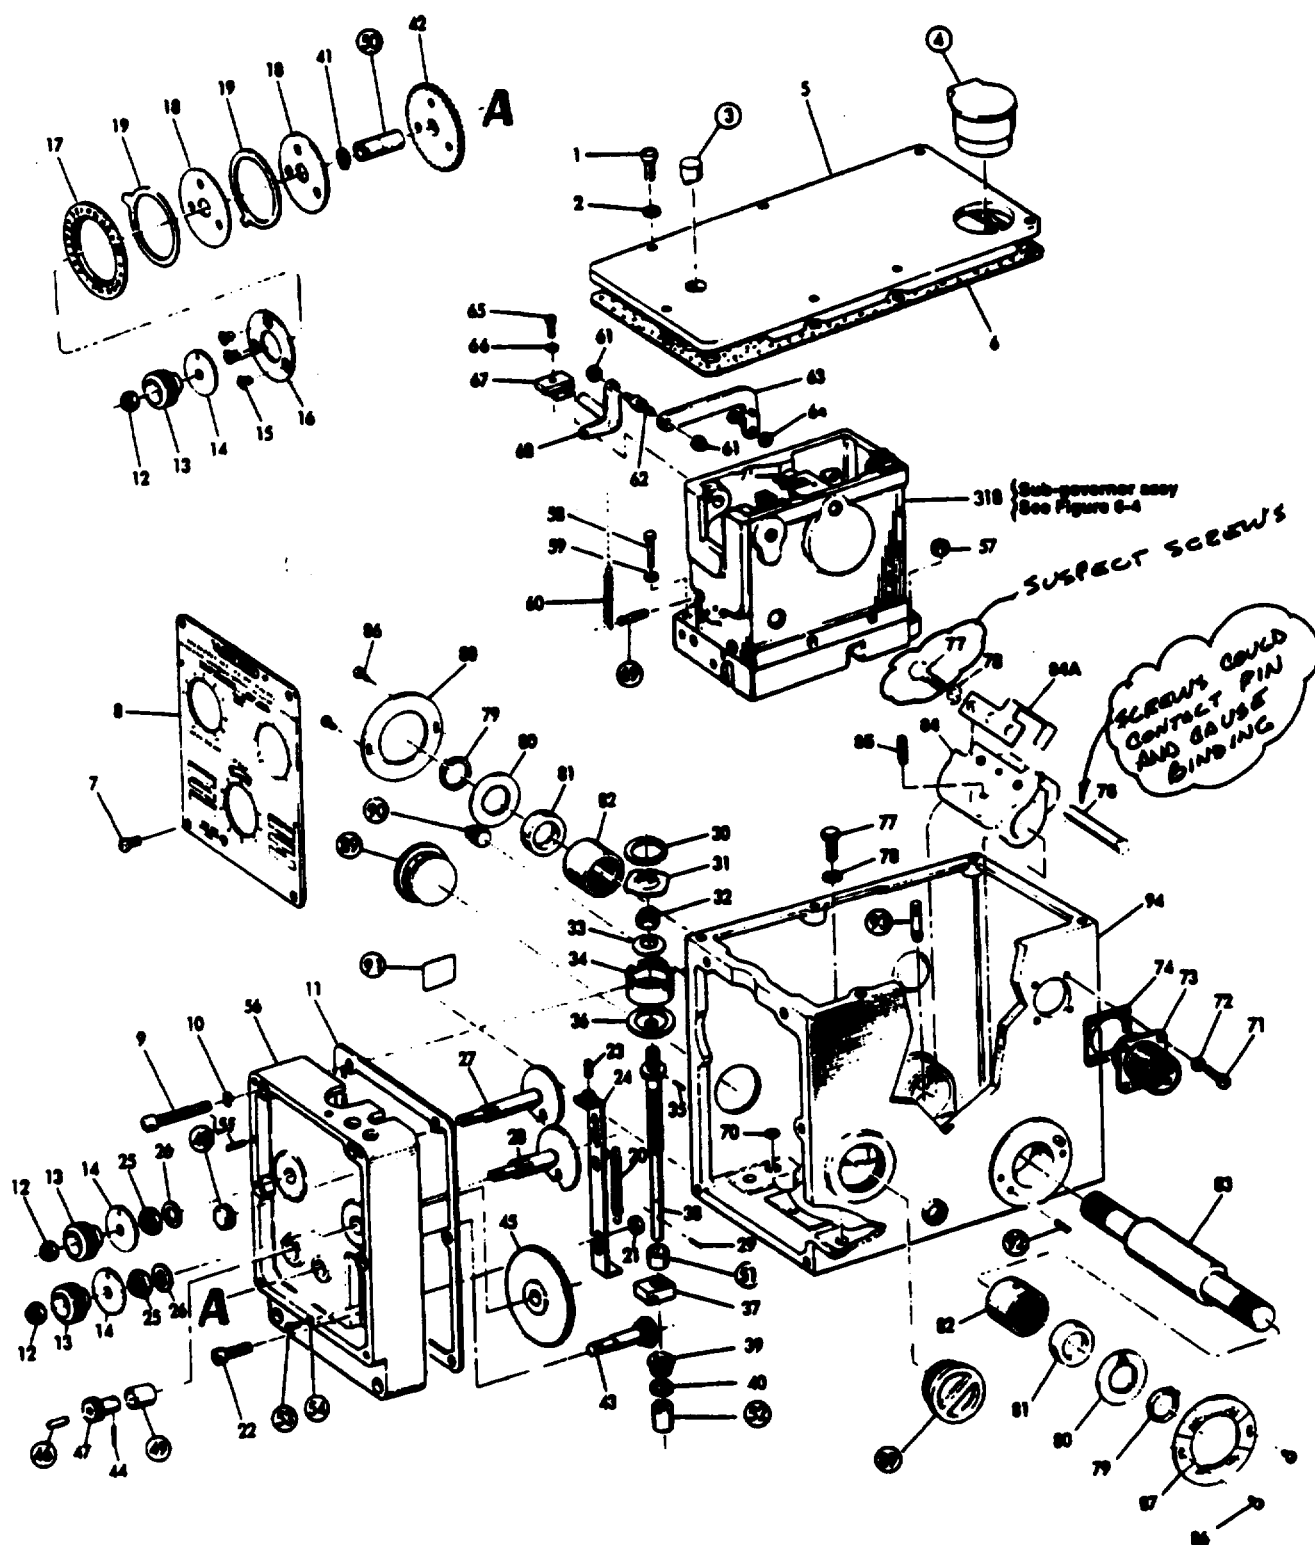
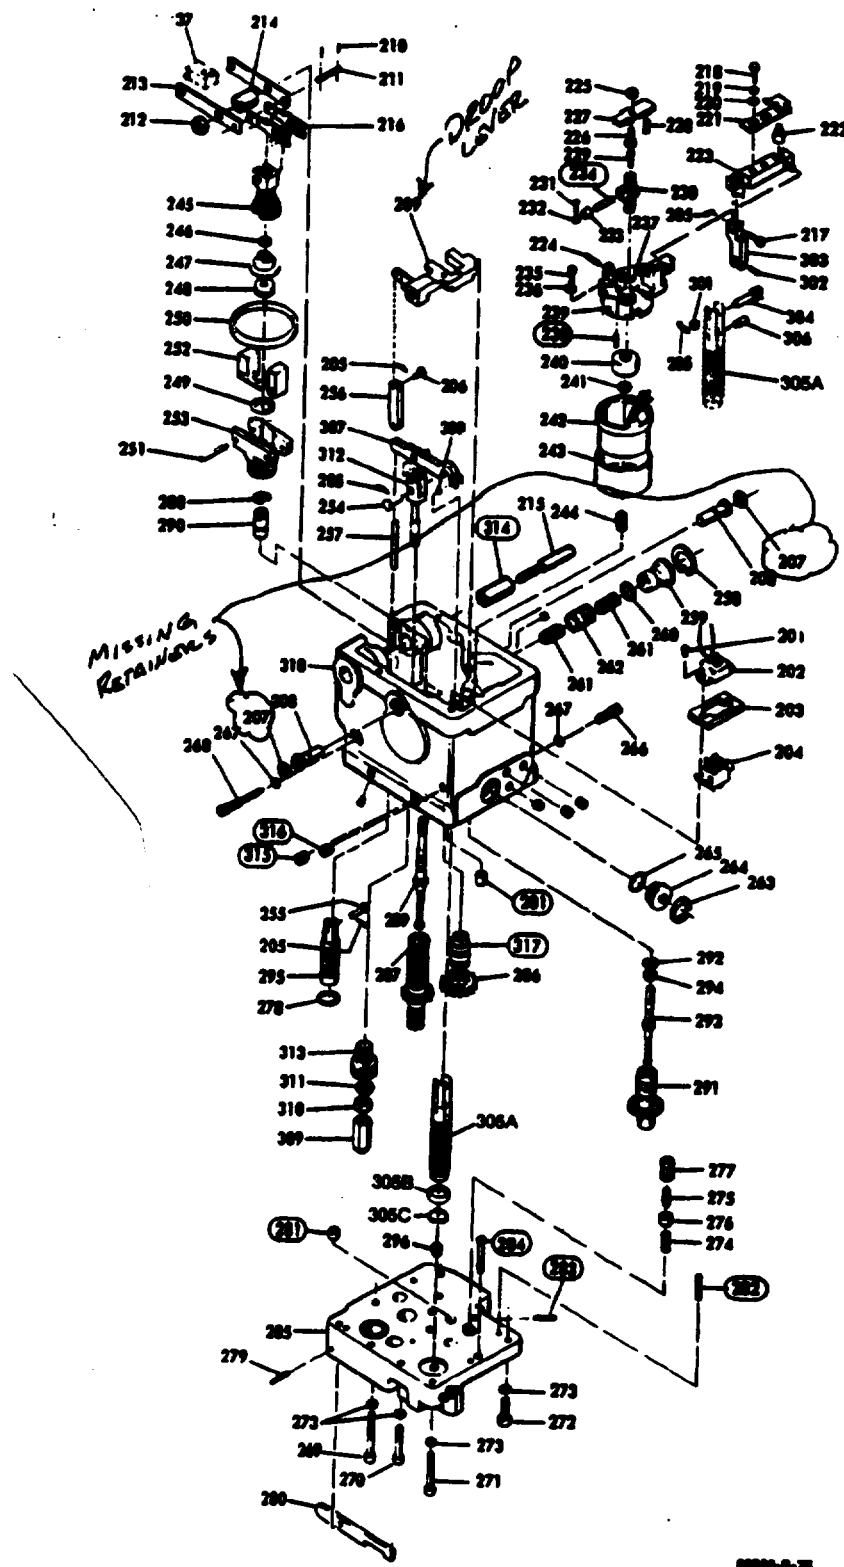
**EXHIBIT 1**

Engine Systems Inc. (ESI) has received notification about a potential problem with some refurbished Woodward EGB governor actuators. One problem was recently reported by V.C. Summer Nuclear Station, via Power Reactor Event Number 37788. Apparently, a governor experienced binding of the terminal shaft due to incorrectly applied clamping screws. ESI was not notified about this occurrence until after the Event Report was issue; therefore, ESI was not able to verify/evaluate the actual components involved. Another problem was also reported by J.A. Fitzpatrick Nuclear Plant with this governor. Operability problems were observed and an investigation revealed that the droop lever pivot pin retaining rings were omitted during reassembly of the governor. Due to the missing retaining rings, the pins eventually backed out, releasing the droop lever. This caused the mechanical speed setting to drop and interfere with electric governor operation (limited load carrying capability). A parts breakdown for the EGB is provided in Exhibit 1 with the above parts annotated.

ESI recommends returning the suspect governors to ESI for a completed tear-down inspection. ESI will reassemble and functionally test to Woodward specifications. NOTE: Even though the V.C Summer governor screw length issue was corrected, we still recommend a complete tear-down to verify all refurbishment activity is within specifications. The Fitzpatrick unit (s/n 2185499) was recently returned to ESI to replace the missing terminal shaft retaining rings. A complete tear-down inspection was performed at that time; no further action on this governor is required. Contact ESI's Customer Service Department for return instructions.
