Potential Loss of Redundant Safety- Related Equipment Because of the Lack of High-Energy
Line Break Barriers (NRC Information Notice 2000-20)

NRC INFORMATION NOTICE 2000-20: POTENTIAL LOSS OF REDUNDANT SAFETY-RELATED EQUIPMENT BECAUSE OF THE LACK OF HIGH-ENERGY LINE BREAK BARRIERS

Detached Check Valve Disc Not Detected by Use of Acoustic and Magnetic Nonintrusive Test Techniques (NRC Information Notice 2000-21)

NRC INFORMATION NOTICE 2000-21: DETACHED CHECK VALVE DISC NOT DETECTED
BY USE OF ACOUSTIC AND MAGNETIC
NONINTRUSIVE TEST TECHNIQUES

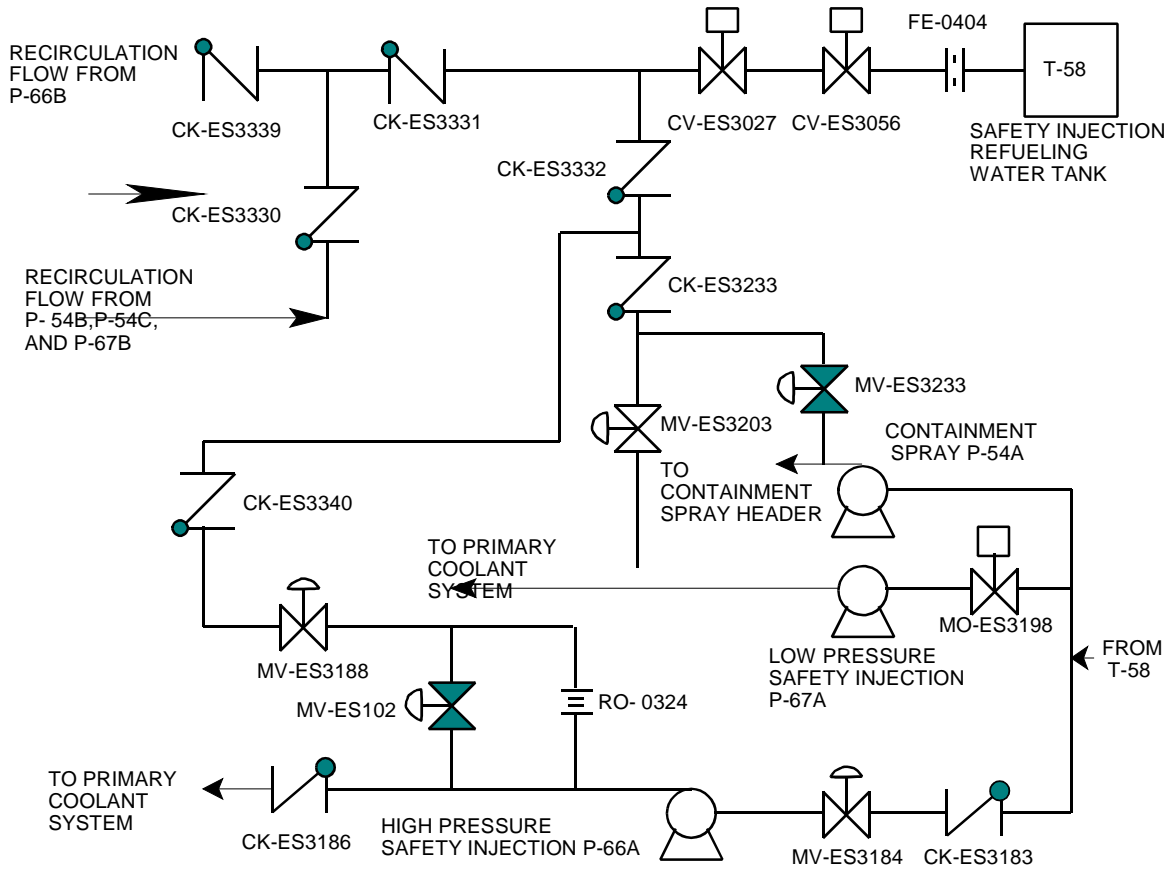
Palisades Safety Injection System Simplified Diagram

During an inservice test of high-pressure safety injection pump P-66A at the Palisades Plant on June 21, 2000, the pump failed to achieve its hydraulic reference values. The probable cause of this condition was that piston check valve CK-ES3340 in the P-66A recirculation line was stuck in mid-position. A simplified system diagram of the Palisades safety injection system is included as Attachment 2.
