**USNRC/PPL Susquehanna, LLC
Regulatory Conference:
Potential White Finding Regarding
Radioactive Particles**

March 1, 2001

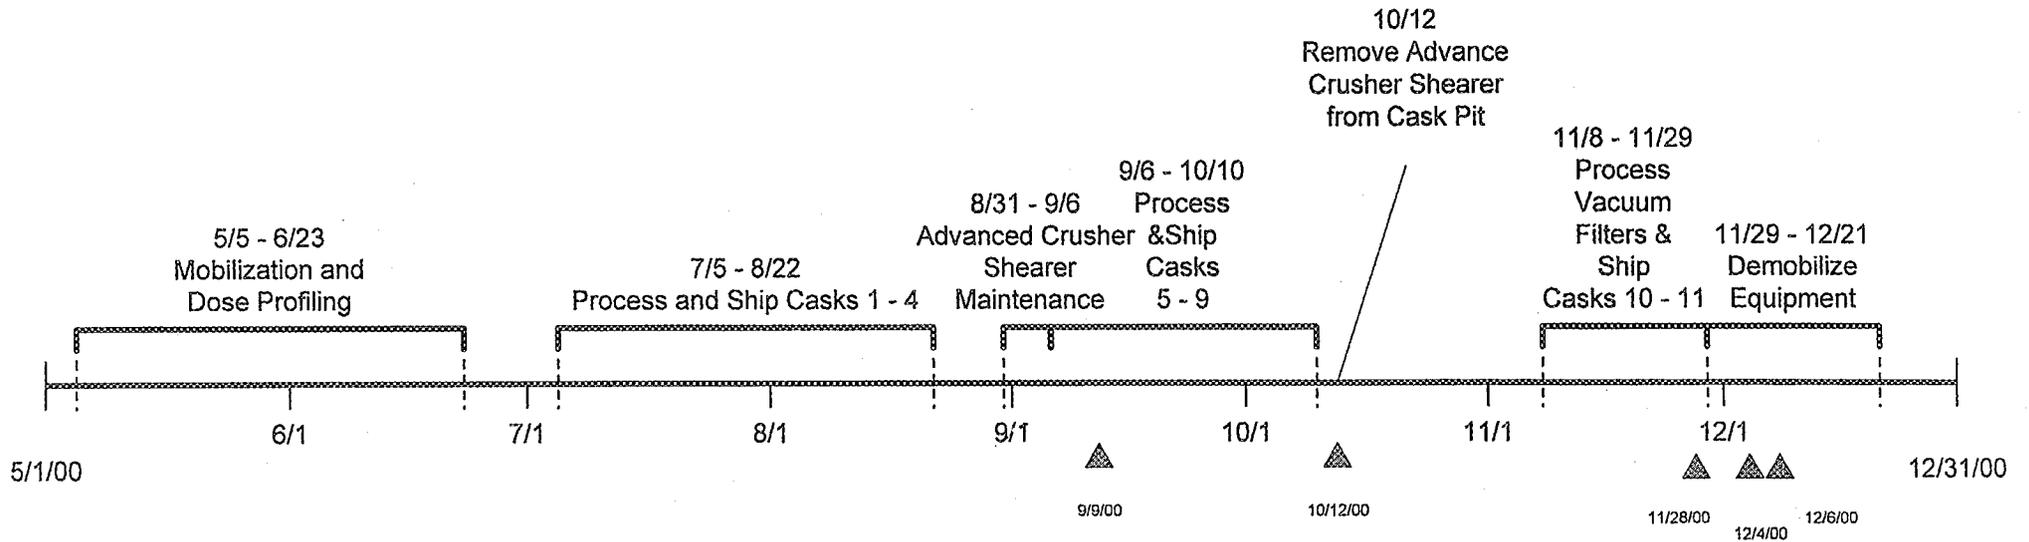
2000 FUEL POOL CLEANOUT PROJECT TIMELINE

▲ Significant particle (as identified in NRC report)
