Pt 21 85-029
Publicly Available

SUBJECT: TELECON - GERMANE TO SAFETY - SCRAM DISCHARGE VOLUME DRAIN VALVE
COUPLING FAILURE

SUBJECT: SCRAM DISCHARGE VOLUME DRAIN VALVE COUPLING FAILURE

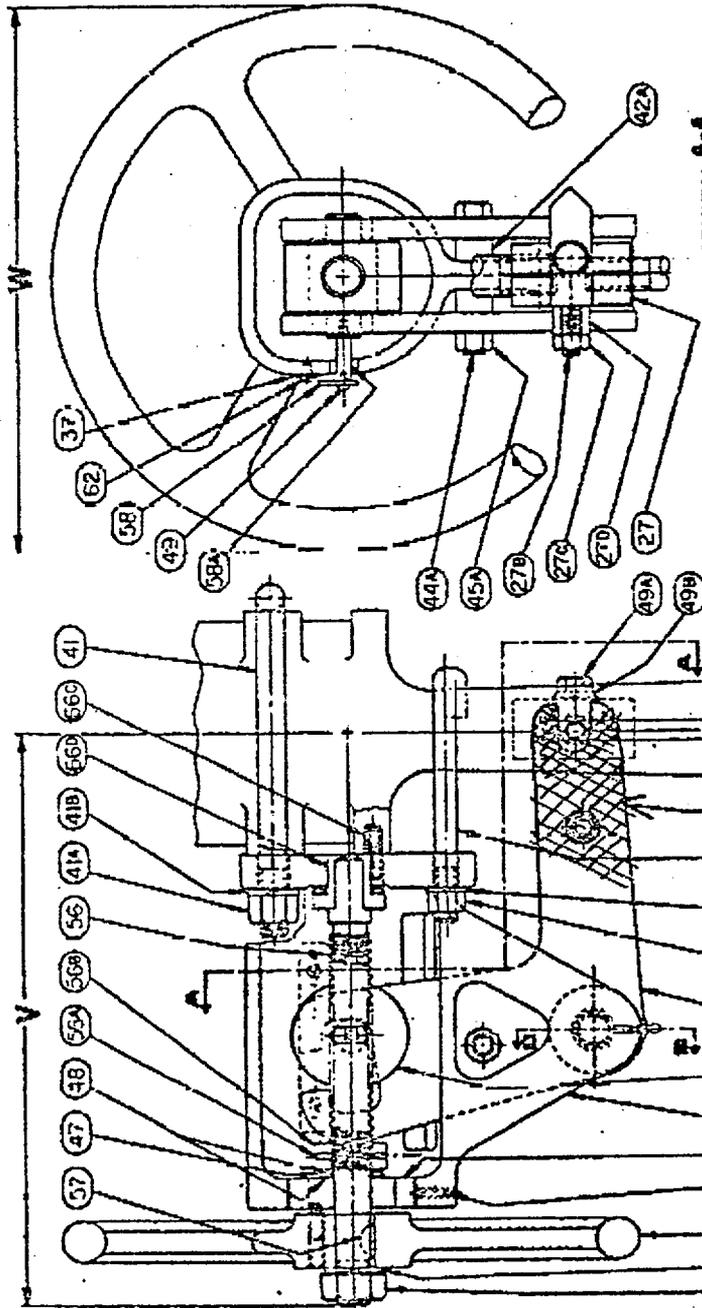
The coupling failure occurred during a five-second delay test at Wyle Laboratory. The cause of failure was determined to be inadvertent engagement of the valve hand wheel during valve setup for test purposes. On valve actuation during the test, coupling loads exceeded design loads. The stem connector deformed allowing disengagement between the stem connector and valve stem.

this is the fork that can cause a problem if left unadjusted
