COOPER-BESSEMER RECIPROCATING

July 21, 1986
QCG-3072

REPORT

NIAGARA MOHAWK POWER CORPORATION
Nine Mile Point (Unit 2)
KSV-16-T S/N MO-7190
Starting Air Valve, Valve Seat Insert

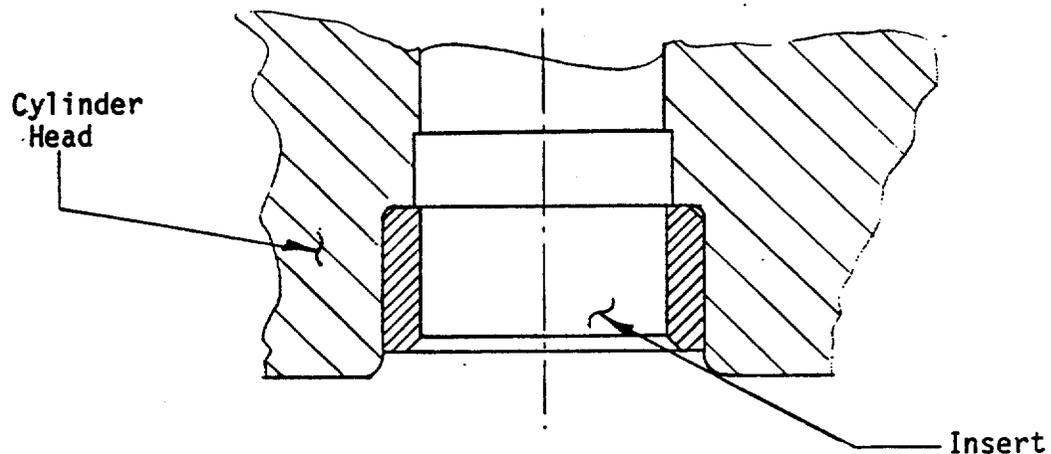
2.1 The sketch below shows the valve insert assembly (Approx. full size)

- 2.2 The insert bore is required to be held within a tolerance of .003". Inserts are selectively fitted to ensure a .001" to .0025" interference fit. Six part numbers of inserts are available, three of which are available as "standard" for production use. Each is bigger in diameter than the next smallest by .0005". The counterbore is measured and the required insert part no. is selected. This number is stamped on the cylinder head. After a complete inspection, the selected insert is frozen and shrunk into the head counterbore.

- 3.1 Inspection records indicate that the insert counterbore was machined oversize, and that it was brought back to size by copper plating. The process used has a wide industrial application and is known by the trade name "Dalic". It is incorporated in the design of many components as well as used for salvage. Various materials such as copper, cobalt, nickel, etc. may be deposited by the process.

- 3.2 Invariably a finished valve seat insert counterbore is matched with a suitable insert (within drawing tolerance) due to the range of inserts available (see para. 2.2). Rarely is a counterbore machined oversize, but if it is, it is brought back to size by plating. Until recently we considered copper to be a suitable material for such an application. We now use iron. The reason for not using copper is that its coefficient of expansion is incompatible with that of cast iron. The coefficients of expansion are:

The starting air valve insert is located in an area subject to thermal cycling. Although residual temperatures would be between 300 and 400°F there would be expansion of the insert, copper plating and cast iron head. The copper being trapped between the head and the insert would have nowhere to go and so would yield in compression and ultimately would lose its fit, and loosen. The sensitivity of an insert to loosen under such circumstances would be a function of the thickness of the copper plating and the temperature to which the assembly would be subjected. Higher than normal temperatures for example, would increase this sensitivity.

- 8.1 No. 3 left air starting valve insert came loose because of the use of copper plating - the copper yielded due to thermal changes.
- 8.2 No. 7 left air starting valve insert did not have the correct fit because of a misapplication.
- 8.3 The engine "locked" in one certain position because the number 3 left valve insert moved down with the valve and blocked off the air supply to that cylinder, aggravated by the valve timing being too early.

- 3.3 We therefore understand why this particular insert loosened. It was removed, the copper bored out and a .030" oversize insert shrunk into place.
