Subject: Supplement to Licensee Event Report (LER) Unit 1-2000-003-00

Enclosure: Byron Station Unit 1 LER 2000-003-01

TITLE (4) Unintentional Violation of Low Temperature Over Pressure Protection System Technical Specification Due to Operator Error

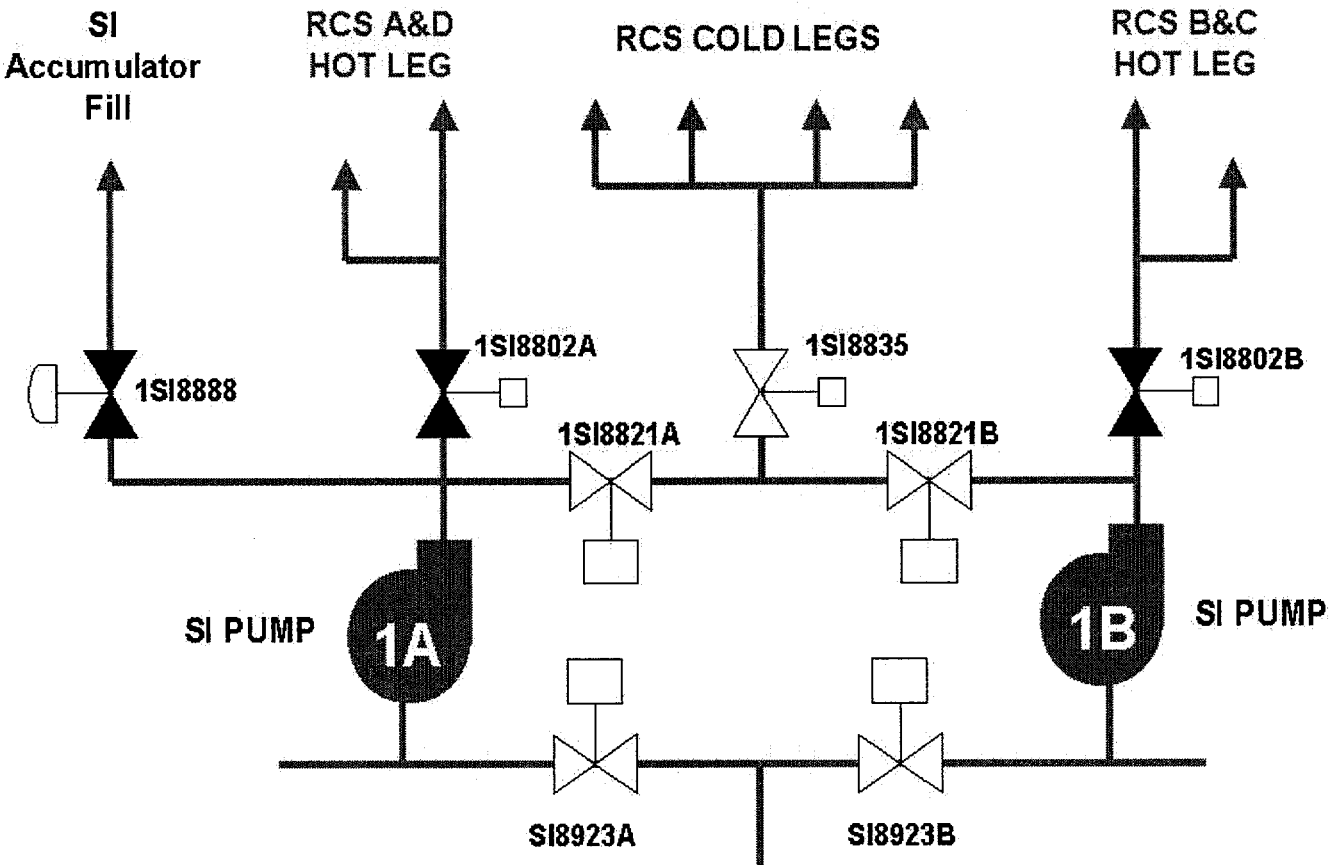
FIGURE 1 - Simplified Diagram of SI Flowpaths to the RCS

BOP-SI-5 ensured LTOP compliance for the 1A SI pump by closing and de-energizing valves 1SI8835, 1SI88802A, and 1SI8802B (refer to Figure 1). However, LTOP compliance for the 1A SI pump could be also be ensured by only closing and de-energizing 1SI8802A and 1SI8821A. In addition, a similar procedure change to improve LTOP flexibility was successfully used to the same procedure a few days before while attempting to fill the SI Accumulators. The U1 SRO and Shift Manager concurred and authorized a procedure change to allow, but not require, the option to substitute 1SI8821A for 1SI8835 and 1SI8802B. The change did not address the restoration. The U1 SRO later stated that he intentionally did not address 1SI8821A in the restoration step to ensure it would remain closed and de-energized. This possibility of changing the procedure was not discussed at the pre-job brief.

At approximately 2125 hours when 1SI8821A was opened, a direct flow path existed from the 1A SI pump to the RCS cold legs. With the 1A SI pump's motor breaker racked in and the control switch in PTL, two independent means to prevent a mass addition into the RCS did not exist. This condition is in non-compliance with Technical Specifications 3.4.12. On October 9, 2000, at 0129 hours while performing a routine Unit 1 Main Control Board walkdown, another licensed operator not involved in the Accumulator fill evolution discovered the non-compliant situation. 1SI8821A was immediately closed, which restored compliance to Technical Specification 3.4.12. This condition existed for approximately 4 hours and is a condition prohibited by Technical Specification and accordingly, reportable to the NRC in accordance with 10 CFR 50.73(a)(2)(i)(B).
