March 28, 2001  
NOC-AE-01001064  
File No. G26  
10CFR50.73

South Texas Project  
Unit 2  
Docket No. STN 50-499  
Special Report on Steam Generator Tube Inspection Results

## **Special Report on Steam Generator Tube Inspection Results**

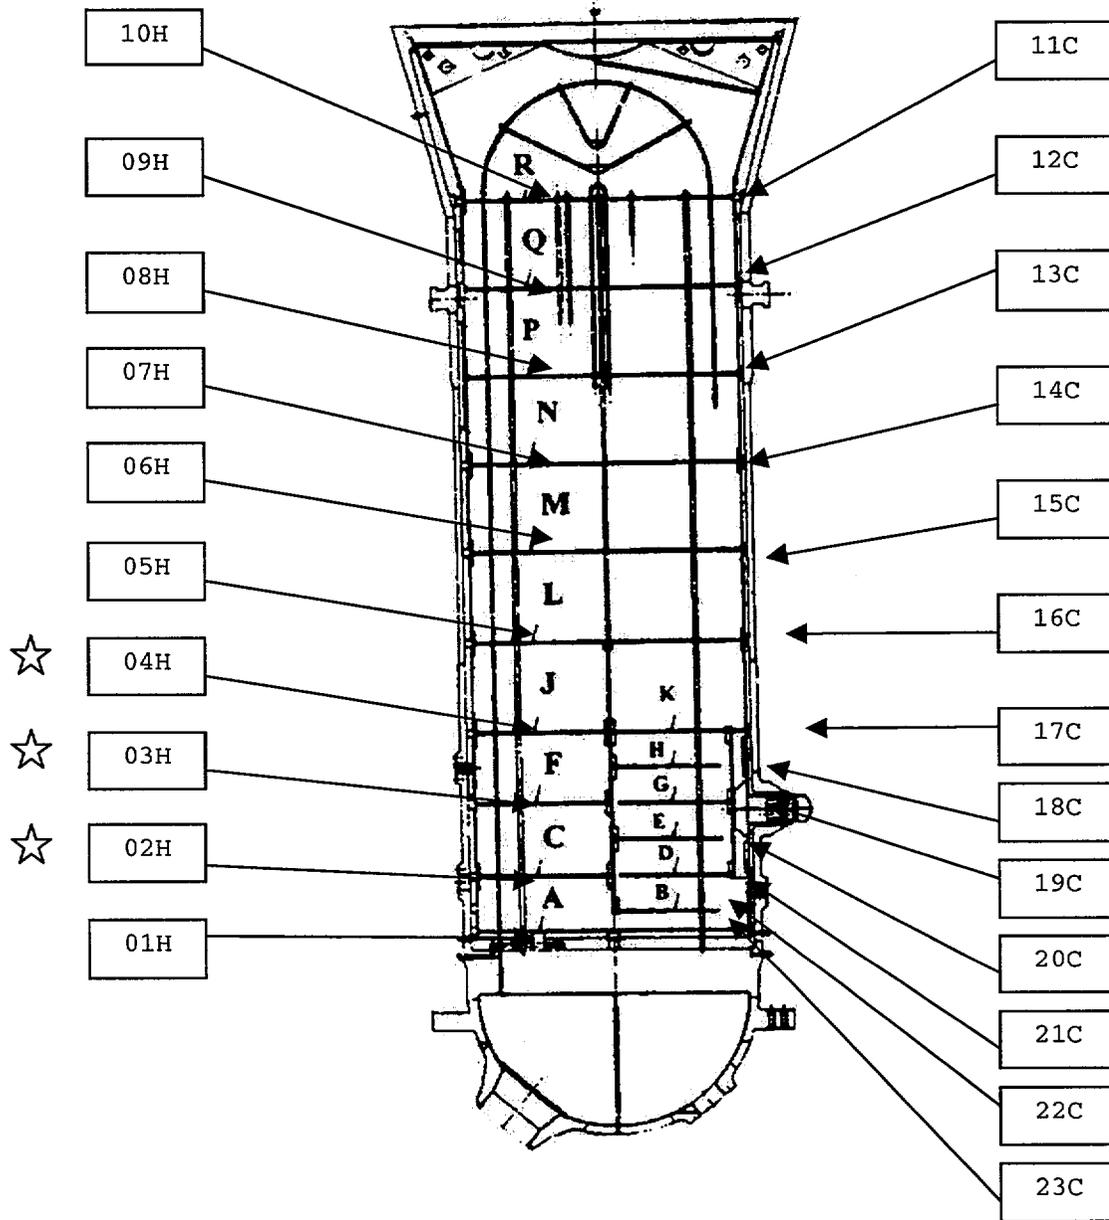
**FIGURE 1**  
**TUBE SUPPORT PLATE IDENTIFICATION IN MODEL E SGs**

NOTE: Plate A (01H/23C) is also known as the Flow Distribution Baffle.

☆ Three Volt ARC applies at these plates only.
