SUBJECT: Oconee Nuclear Station - Unit 3
Docket No. 50-287
Request to use an Alternative to ASME Boiler and
Pressure Vessel Code, Section XI in accordance with
10 CFR 50.55a(a)(3)(ii)

DUKE ENERGY CORPORATION
Oconee Nuclear Station, Unit 3

Request for Alternative to the Requirements of the
ASME Boiler and Pressure Vessel Code, Section XI

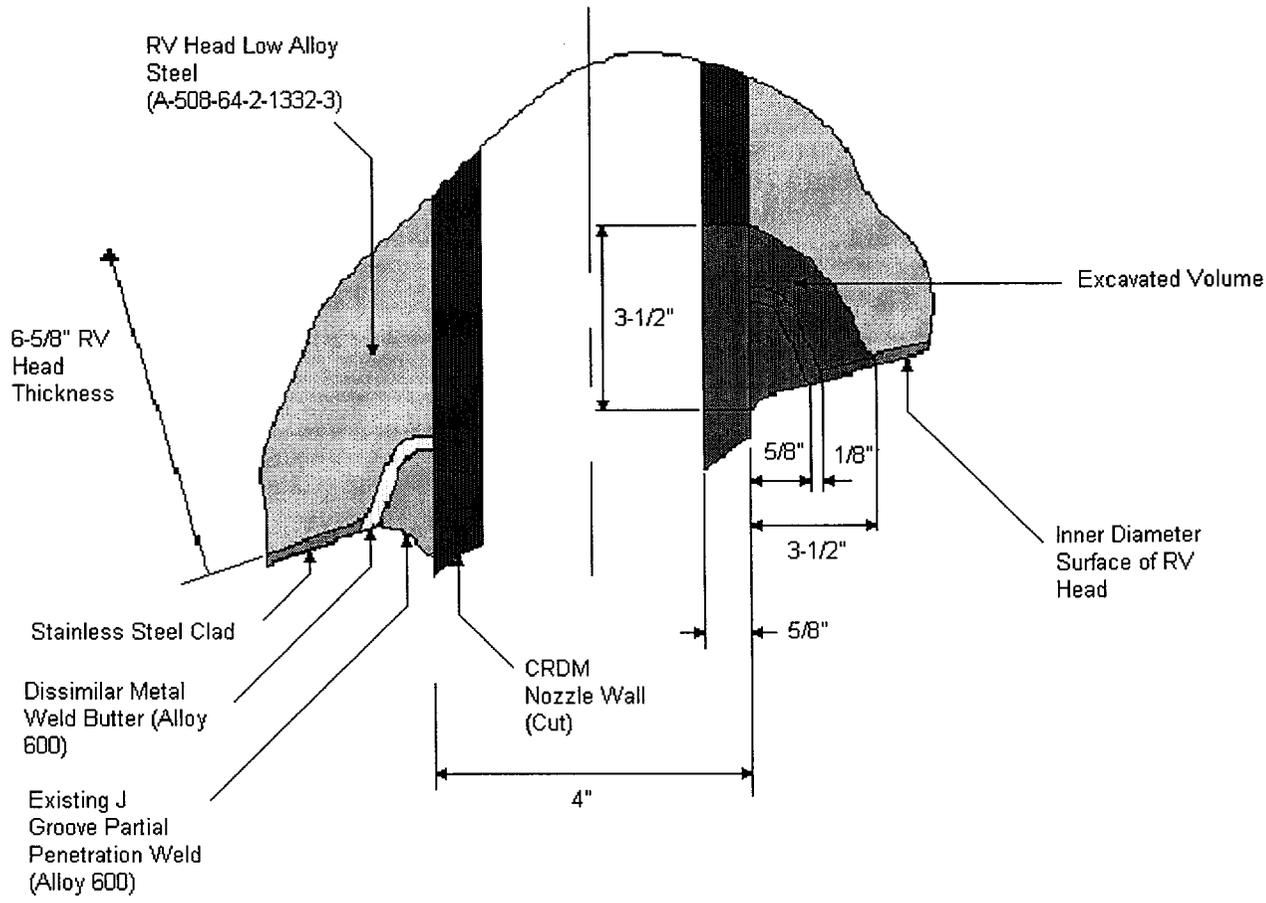
Figure 1
Oconee Nuclear Station
CRDM Nozzle Excavation Detail

To gain access for the repair of the Unit 3 Control Rod Drive Mechanism (CRDM) nozzle Nos. 50, 56, 34 and 63 (if needed¹) in the Reactor Vessel (RV) head and the associated J groove partial penetration welds, it was necessary to excavate up to three inches of the RV head base metal (See Figures 1 & 2)

In order to remove the indications in both the CRDM nozzles and J groove partial penetration welds, manual grinding and arc air thermal cutting were utilized. The depth of the excavation necessary to remove the indications and provide access for weld repair in the nozzle walls and welds resulted in the removal of portions of the RV head low alloy steel beyond the 3/8 inch depth limitation imposed by IWA-4530.

In lieu of the 3/8 inch base metal repair depth limit requirement of IWA-4530, it is proposed that the repair depth limitation be increased to three inches. This increase in the depth limit, while retaining the other restrictions of IWA-4530, would allow repair of the excavations into the RV head, repairs to the CRDM nozzles, and repairs to the J groove partial penetration welds by the temper bead technique per IWA-4532 in lieu of repairs requiring additional post weld heat treatment.

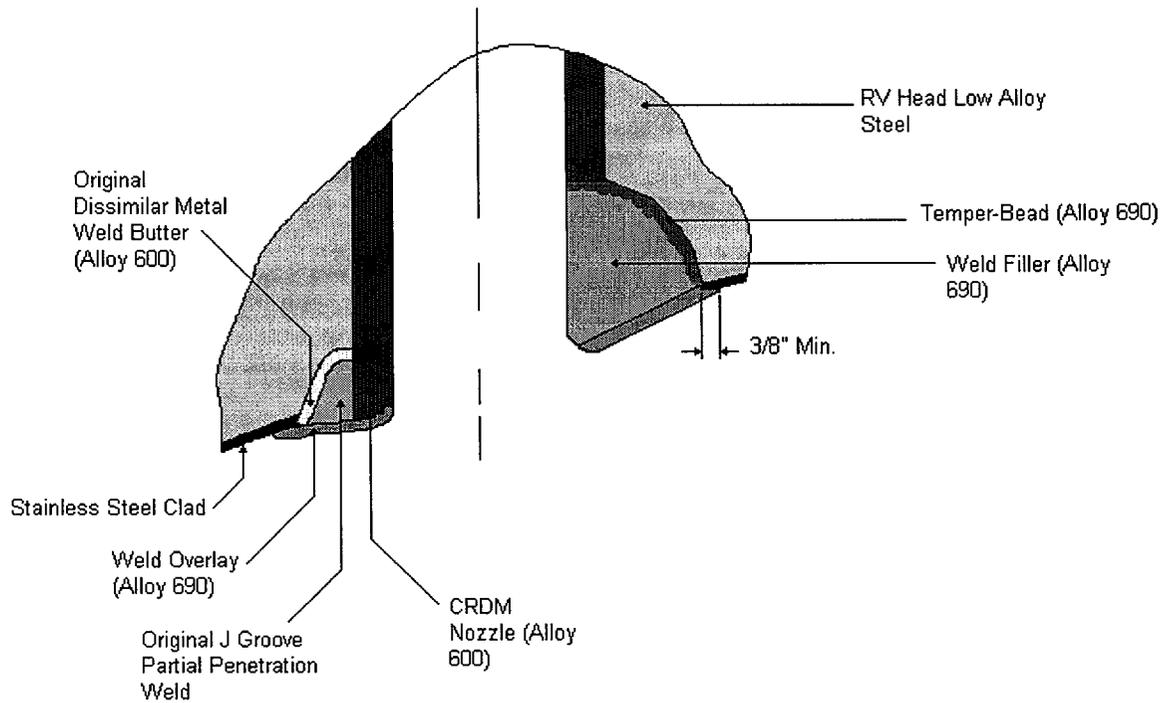
Figure 3
Oconee Nuclear Station

Detail of CRDM Nozzle Repaired Configuration

excavations, the similar metal procedure would be used to repair the base metal. For the repairs described herein, the as-repaired geometry (See Figure 3) and the choice of filler metal will satisfy the Section III design rules without fully restoring the base metal to its original geometry. In lieu of restoring the RV head base metal to its original geometry with a similar metal temper bead repair and then completing the attachment weld to the CRDM nozzle with a dissimilar filler material, it is proposed that the dissimilar metal temper bead weld procedure be used to repair the base metal as well as the dissimilar metal weld. The temper bead procedure has been fully qualified for the type repairs described herein. The dissimilar metal temper bead weld procedure will produce an acceptable tempering in the heat affected zone (HAZ) of the base metal. The extent of the HAZ is independent of the excavation limit. However, the HAZ could be a function of the overall depth of repair and therefore, the current IWA-4530 and Procedure Qualification Report (PQR) joint depth limits will be retained. The PQR qualified a similar P43 material (Alloy 600) to that being used in the repair (Alloy 690).
