SUBJECT: Oconee Nuclear Station - Unit 3  
Docket No. 50-287  
Request to use an Alternative to ASME Boiler and  
Pressure Vessel Code, Section XI in accordance with  
10 CFR 50.55a(a)(3)(ii)

DUKE ENERGY CORPORATION  
Oconee Nuclear Station, Unit 3

Request for Alternative to the Requirements of the  
ASME Boiler and Pressure Vessel Code, Section XI

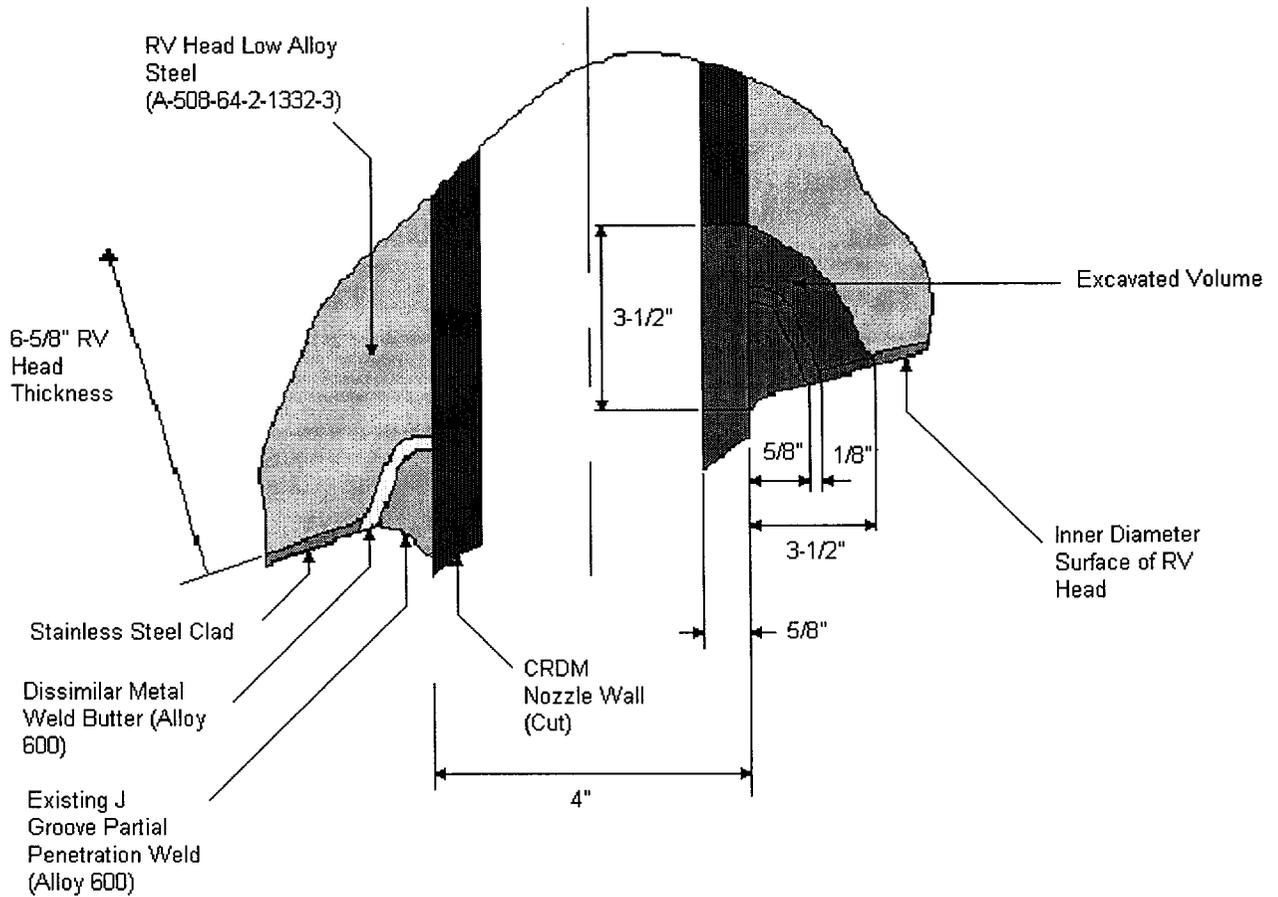
**Figure 1**  
**Oconee Nuclear Station**  
**CRDM Nozzle Excavation Detail**

To gain access for the repair of the Unit 3 Control Rod Drive Mechanism (CRDM) nozzle Nos. 50, 56, 34 and 63 (if needed<sup>1</sup>) in the Reactor Vessel (RV) head and the associated J groove partial penetration welds, it was necessary to excavate up to three inches of the RV head base metal (See Figures 1 & 2)

In order to remove the indications in both the CRDM nozzles and J groove partial penetration welds, manual grinding and arc air thermal cutting were utilized. The depth of the excavation necessary to remove the indications and provide access for weld repair in the nozzle walls and welds resulted in the removal of portions of the RV head low alloy steel beyond the 3/8 inch depth limitation imposed by IWA-4530.

In lieu of the 3/8 inch base metal repair depth limit requirement of IWA-4530, it is proposed that the repair depth limitation be increased to three inches. This increase in the depth limit, while retaining the other restrictions of IWA-4530, would allow repair of the excavations into the RV head, repairs to the CRDM nozzles, and repairs to the J groove partial penetration welds by the temper bead technique per IWA-4532 in lieu of repairs requiring additional post weld heat treatment.
