# Integrity Assessment for Reactor Vessel Head Penetration Nozzles at B&W-Design Plants

Presented by  
S. Fyfitch  
Framatome ANP

## Oconee Unit 1 & Unit 3 Reactor Vessel Head Leakage

Cracking of RV Head Penetrations  
Due to Primary Water Stress  
Corrosion Cracking (PWSCC)

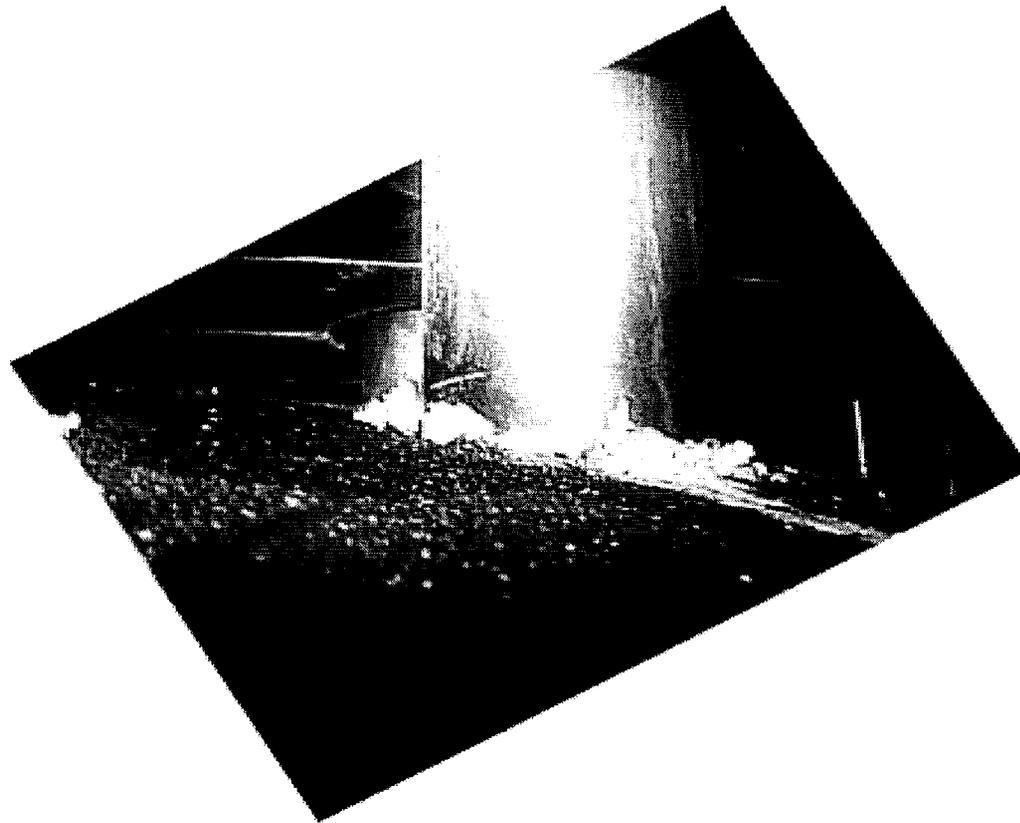
# ONS-1 RV Head Showing Boric Acid At CRDM Nozzle 21

- ◆ Visual inspection of Unit 1 RV head identified small amounts of boron accumulation at the base of CRDM nozzle 21 and several T/C nozzles.
- ◆ Visual inspection of Unit 3 reactor vessel head identified small amounts of boron accumulation at the base of several CRDM nozzles. The suspect nozzles were #'s 3, 7, 11, 23, 28, 34, 50, 56, 63.

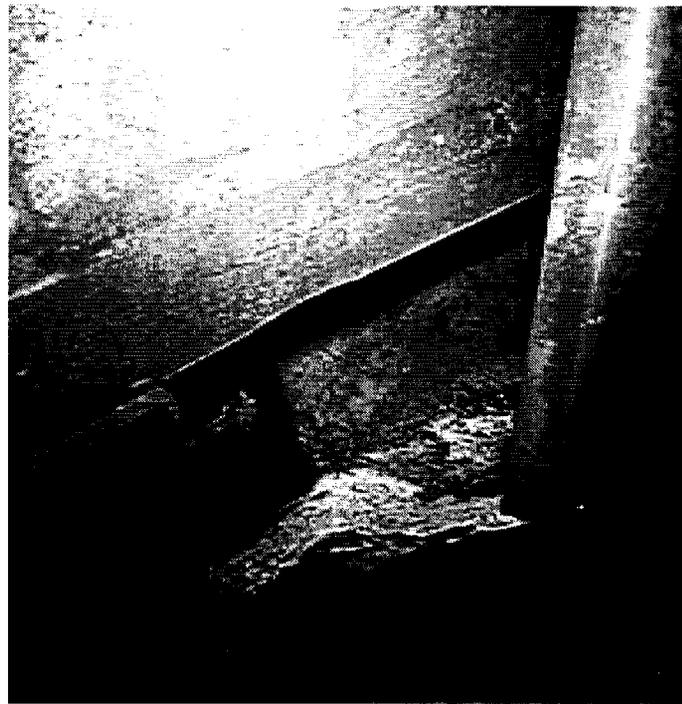
# ONS-1 RV Head Showing Boric Acid At Thermocouple Nozzle

- All eight thermocouple nozzles contained flaws predominantly axial in orientation
  - Five nozzles identified as leaking
  - ID cracking observed on all eight nozzles
  - Cracking penetrated into all eight nozzle welds
- CRDM nozzle 21 did not contain ID flaws
  - Flaws in weld material, predominantly axial/radial in orientation, identified as leak source
  - Flaw propagated through the weld area along the nozzle OD

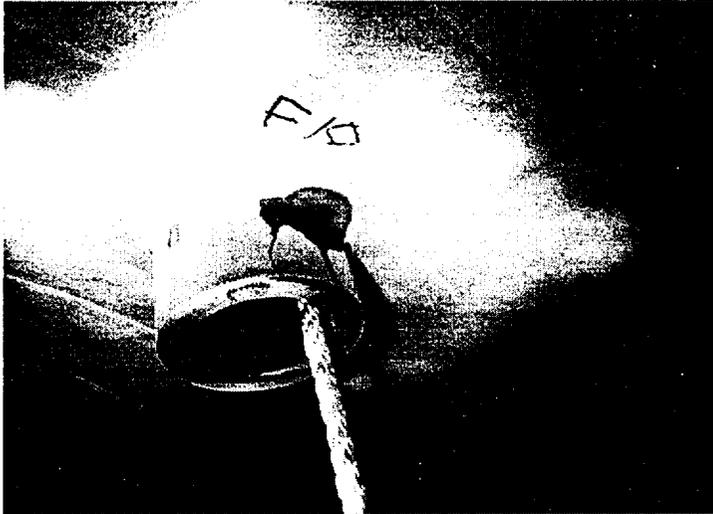
## CRDM Nozzle #11

Nozzle	
# 11	<ul style="list-style-type: none"> <li>▪ 7 Axial and 3 Circumferential Cracks</li> <li>▪ 3 Axial thru wall, 2 &gt; 75% thru wall, 2 about 50% thru wall</li> <li>▪ 3 thru wall are 3" long, 2 &gt; 75% are 3" long, 2 about 50% &lt; 1" long</li> <li>▪ All circ below weld, 1 is 10%, 1 is 57%, 1 is 70% thru wall</li> <li>▪ Deep circ crack is about 5.3" long, mid circ crack is 3.9" long</li> <li>▪ Areas of craze cracking above and below weld at high side</li> </ul>
#23	<ul style="list-style-type: none"> <li>▪ 6 Axial and 2 Circumferential Cracks</li> <li>▪ 2 Axial thru wall, 4 are 30% to 67% thru wall</li> <li>▪ 2 thru wall are .6" and 3.8" long, 4 are 0.5" to 1.1" long, both circ below weld, 1 is 77% thru wall, other is 67% thru wall</li> <li>▪ Circ cracks are about 2" long</li> <li>▪ Areas of crazed cracking above weld at high side</li> </ul>

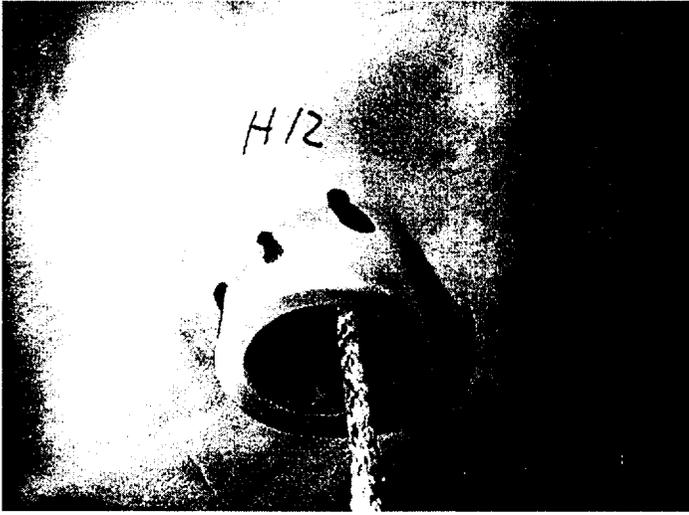
# CRDM Nozzle #23

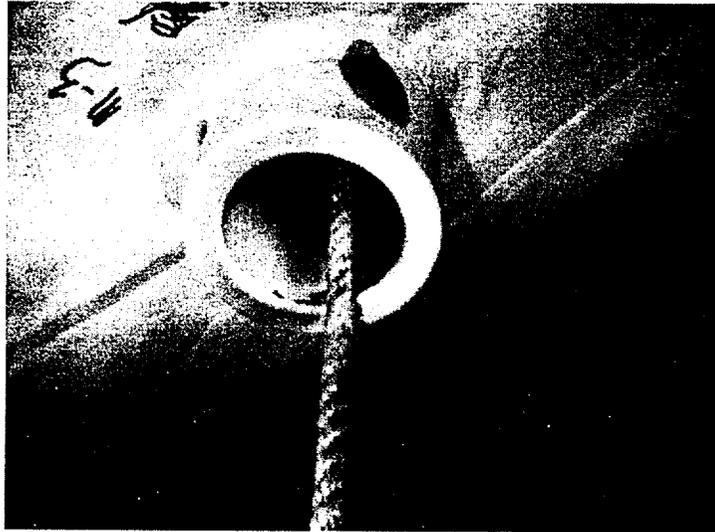
# CRDM Nozzle #56

Nozzle	
#56	<ul style="list-style-type: none"> <li>▪ 3 Axial and 1 Circumferential Cracks</li> <li>▪ 1 axial thru wall, One 38% thru wall, One 11% thru wall</li> <li>▪ Thru wall is 1.7" long, mid depth .75" long, shallow is 1.6" long</li> <li>▪ Circ crack above weld near high side and about 2.4" long</li> </ul>
#3	<ul style="list-style-type: none"> <li>▪ 7 Axial and no circumferential cracks</li> <li>▪ No Axial thru wall, all between 33% and 65% thru wall</li> <li>▪ All between .3" and 1" long</li> <li>▪ Areas of crazed cracking below weld at high side</li> </ul>
#7	<ul style="list-style-type: none"> <li>▪ 1 Axial and no Circumferential Cracks</li> <li>▪ Axial is 87% thru wall, 2.3" long</li> <li>▪ Areas of crazed cracking below weld at high side</li> </ul>

- ◆ Discovered during post weld repair NDE of Nozzles 50 & 56
- ◆ Circumferential cracks followed the weld profile contour and were O.D. initiated.
- ◆ Both ECT and UT inspections identified indications in these areas but were dispositioned as crazed cracks with unusual characteristics
- ◆ The original NDE characterization for nozzles 50 and 56 subsequently changed.
- ◆ This change in interpretation of the NDE signals is related to the flaw orientation with respect to the sound beam of the UT search units.
- ◆ Actions taken as a result of this discovery were:
  - All Unit 1 and 3 ECT and UT data has been re-reviewed applying the LLs
  - EPRI NDEC is leading an independent review of ONS 1 & 3 data to confirm results and findings

- ◆ Boat sample in the area of circ crack that was found above the weld after the weld repairs were completed
- ◆ Boat sample contained a face of the circ crack along with 3 small axial cracks that intersect the circ crack
- ◆ Section through the axial crack confirms crack is totally intergranular with small intergranular branches
- ◆ Scanning electron microscopy of the circ crack face revealed only intergranular morphology.
- ◆ There are no tears or other indications of the origin of the circ crack
- ◆ Circ crack is indicative of PWSCC

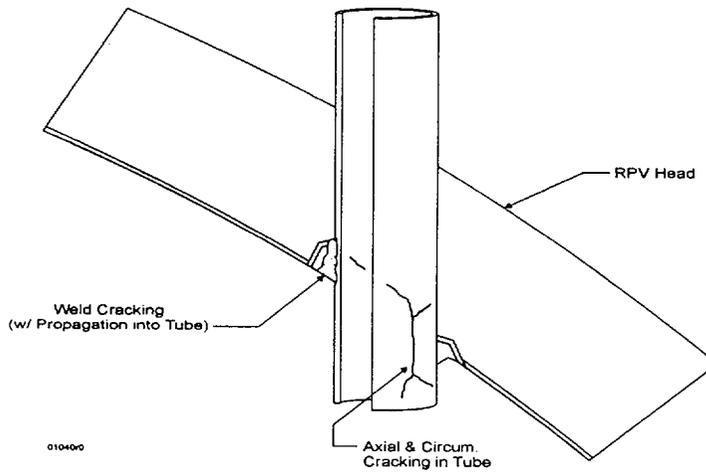
# CRDM Nozzle Cracks at ONS 1 & 3

- ◆ Total of 48 indications in the nine leaking CRDMs
  - 39 are axial and located beneath the weld at the uphill and downhill
  - 16 indications thru wall (39%), all are axial, and occur on 6 of 9 nozzles
- ◆ Confirmed two (2) above the weld circumferential cracks
  - Nozzle 56 crack was thru wall
  - Nozzle 50 except for pin hole indications on ID was not thru wall
  - Inspection and metallurgical results indicate the circumferential cracks were O.D. initiated.
- ◆ Unit 3 CRDMs extent of condition inspections (9 additional nozzles):
  - Cluster indications above and/or below the J groove weld.

- ◆ Repairs being performed in accordance with 1992 Section XI of ASME Code
- ◆ Removing all flaws entirely from both weld material and nozzle base material
- ◆ Use temper bead weld repair process to replace the weld
  - Code requirement since excavation entered the “buttering”.
  - Involves heating the RV head to 500 degrees F.
- ◆ Automated weld process to apply protective layer over J groove weld

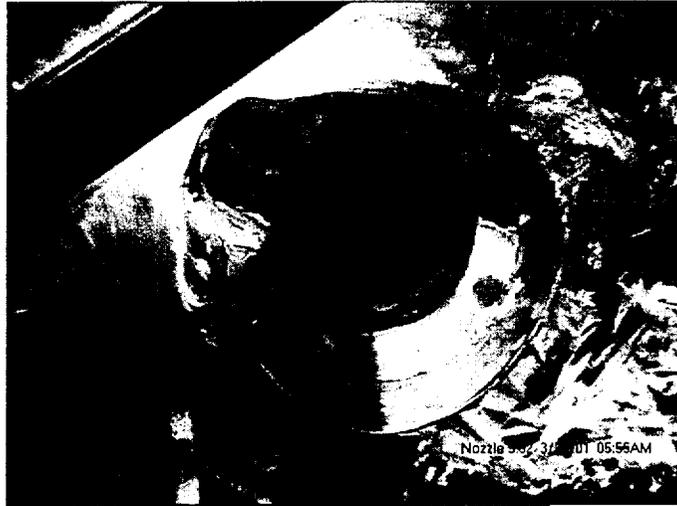
# CRDM Nozzle #3

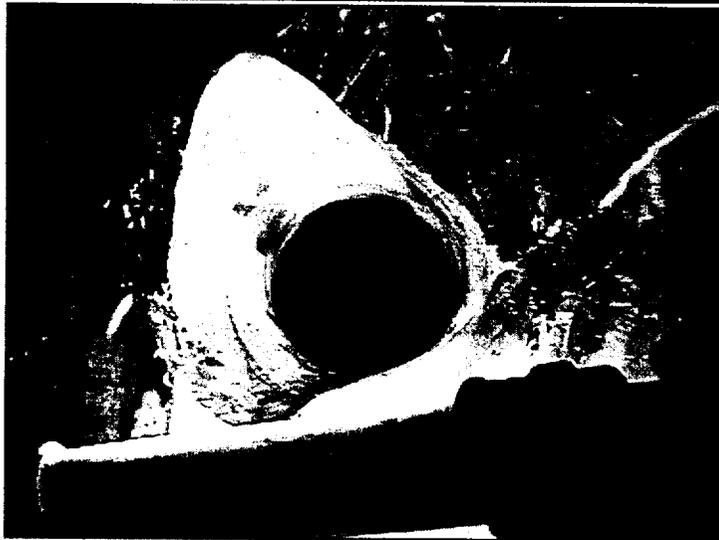
# CRDM Nozzle #50
