Duke Energy

Oconee Nuclear Station
7800 Rochester Highway
Seneca, SC 29672

Subject: Oconee Nuclear Station, Unit 3
Docket Nos. 50-287
Licensee Event Report 287/2001-001, Revision 0
Problem Investigation Process No.: O-01-00587

TITLE (4)
Reactor Pressure Vessel Head Leakage Due to Stress Corrosion Cracks Found in Nine Control Rod Drive Nozzle Penetrations

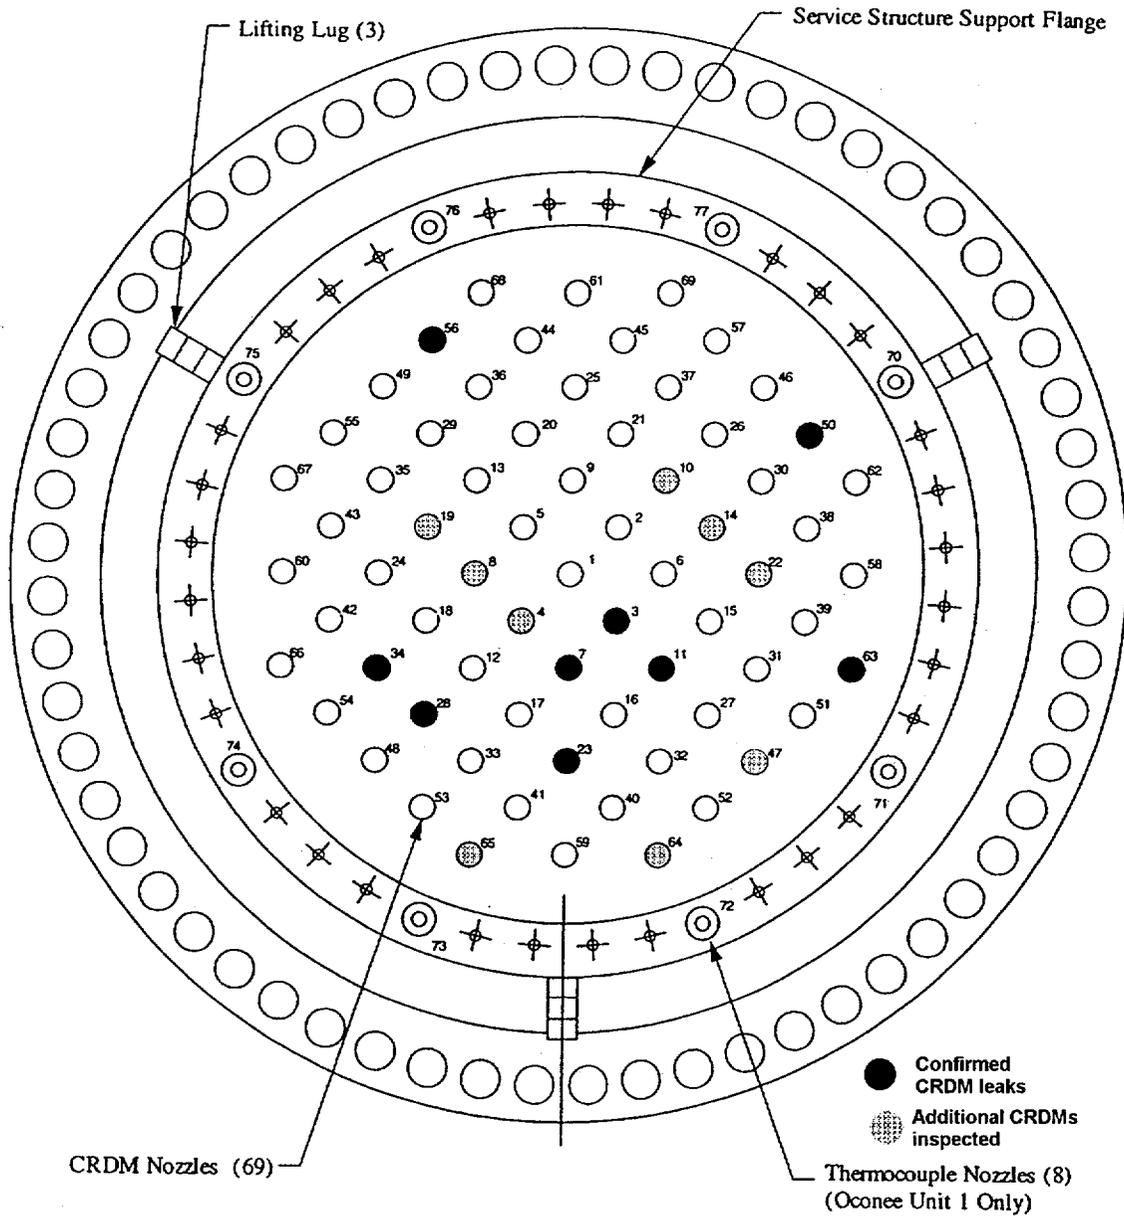
Figure 1

The boric acid deposits were identified around nine (Nos. 3, 7, 11, 23, 28, 34, 50, 56, and 63) of the sixty-nine total CRDM nozzles. The amount of boric acid around each of the CRDM nozzles was estimated to be no more than a few cubic inches but ultimately signified that reactor coolant system pressure boundary leakage had occurred. After confirming that the Reactor Coolant System (RCS) pressure boundary had been compromised, a February 18, 2001, 8-hour notification was made to the Staff in accordance with 10CFR50.72(b)(3)(ii)(B) reporting requirements. Subsequent non-destructive testing was performed on a total of eighteen CRDMs in order to effectively evaluate, characterize the leak mechanism, and determine extent of the condition.

In addition to the original nine leaking CRDMs, nine additional nozzles (Nos. 4, 8, 10, 14, 19, 22, 47, 64 and 65) from the same heat¹ of material as the initial nine CRDMs were EC and UT inspected for "extent of condition" purposes (see Figure 1). Results of this inspection are also given in Attachment 1.

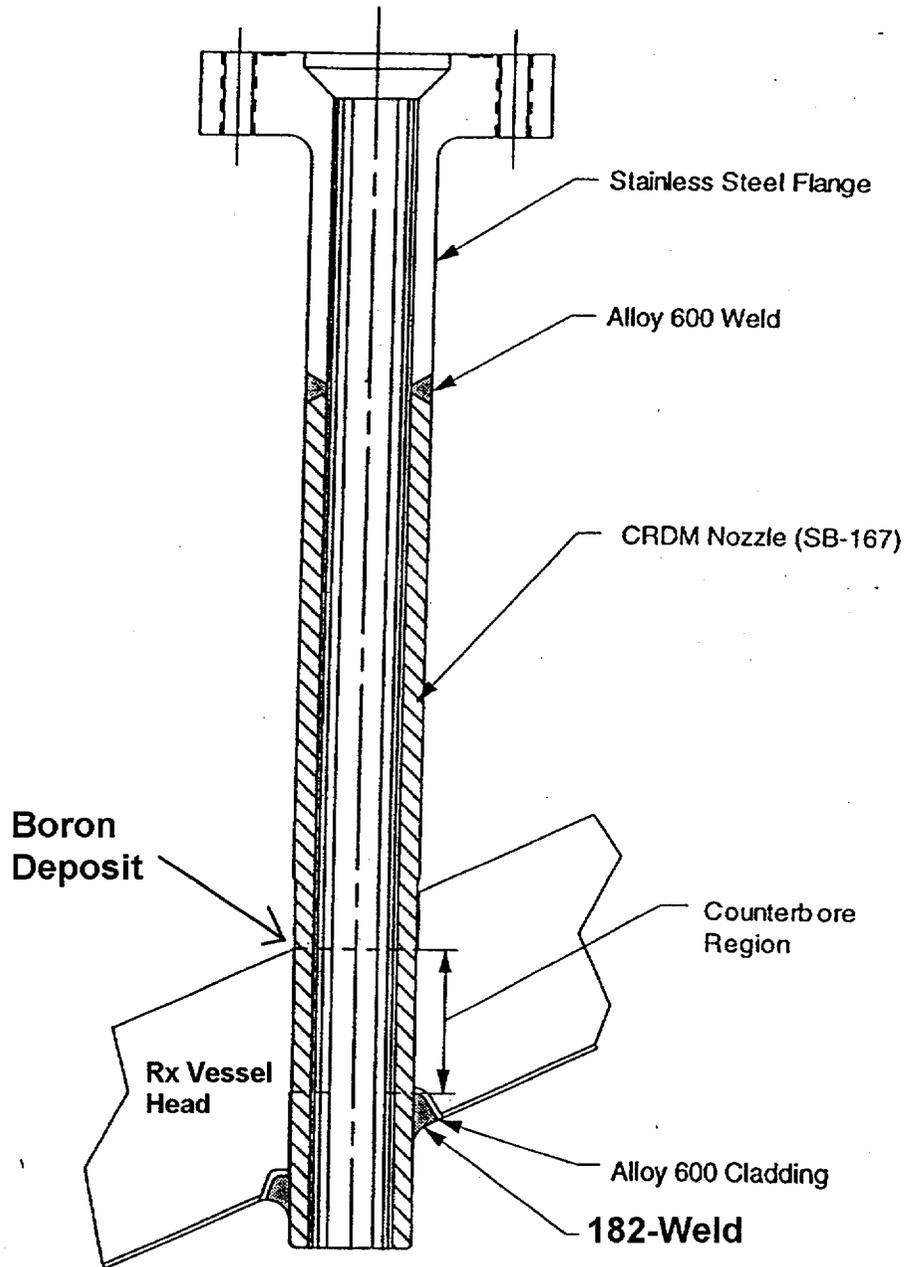
Figure 2

There are 69 Control Rod Drive Mechanism (CRDM) [EIS:AA] nozzles [EIS:NZL] that penetrate the reactor pressure vessel (RPV) [EIS:RCT] head (see Figure 1). The CRDM nozzles are approximately 5-feet long and are welded to the RPV head at various radial locations from the centerline of the RPV head. The nozzles are constructed from 4-inch outside diameter (OD) alloy 600 material. The lower end of the nozzle extends about 6-inches below the inside of the RPV head (see Figure 2).

Subsequent surface dye-penetrant test (PT) inspections of the nine nozzles' weld area and Outside Diameter (OD) identified several deep axial cracks that had initiated near the toe of the fillet weld had propagated radially into the nozzle material as well as axially along the OD surface. Some of these cracks had reached the bottom end of the CRDM nozzle housing. These potentially deep cracks were the most likely leakage pathway that lead to the visible accumulations of boric acid crystals found on the Unit 3 RPV head. Eddy Current (EC) examination of the nine leaking CRDM nozzles revealed cracks on several of the nozzles.

The general repair process was to remove all crack indications and weld repair the individual excavation(s) for each CRDM nozzle. The cracks were first ground out of the nozzle material (initially by manual grinding, later by air arc gouging followed by shallow surface grinding), sometimes exposing a small area of low alloy steel base metal for some nozzles. The final surface was PT examined prior to preheating for the weld repair process.

Following weld repair of the individual excavations, a protective weld overlay of alloy 52/152 material (alloy 690 type) was deposited over the CRDM repairs where original weld material (82/182 alloy 600) remained after the repair process. Five of the repaired nozzles (Nos. 3, 7, 11, 50, and 56) had this protective overlay. Nozzles 23, 28, 34, and 63 did not require a weld overlay since the entire weld was replaced with 52/152 material. This nonstructural weld material acts as a protective layer to the existing material, improving its resistance to PWSCC attack.
