June 1, 2001

On behalf of the Commission, I am writing in response to your letter of April 13, 2001, concerning the partial loss of offsite power at the Seabrook nuclear plant on March 5, 2001, during a winter storm. Responses to your questions are enclosed.

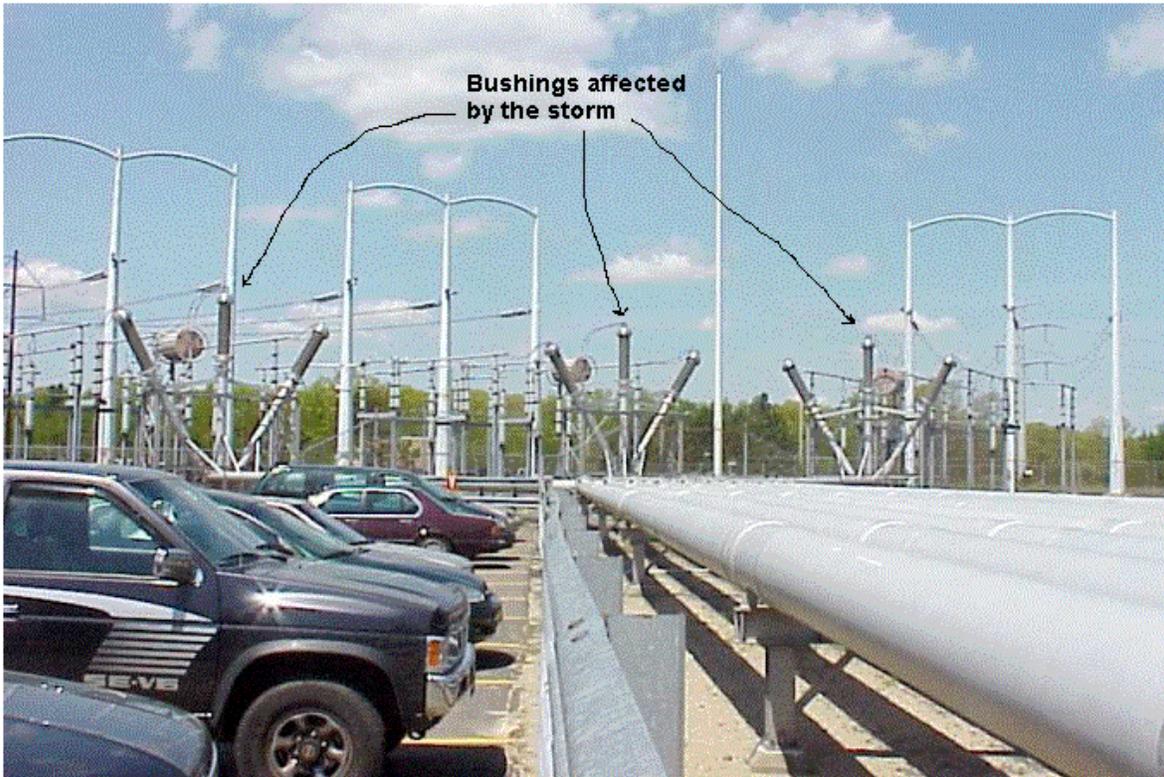
## Looking away from plant toward 345kv lines

physically independent circuits be operable from the offsite transmission network to the onsite vital buses; otherwise the plant must be shut down and cooled down to a cold shutdown condition. The problem at Seabrook during this storm was arcing at the bushings in the 345 kV termination yard. The bushings provide a transition point from the overhead 345 kV lines to the insulated bus sections of the 345 kV buses. For each of the offsite 345 kV lines, two of the three phase bushings are angled and the third bushing is mounted vertically. During the March 5, 2001, storm, wet, heavy snow was driven by high winds onto the bushings. Most of the snow and ice fell off the angled bushings but adhered to the vertical bushings, eventually causing a flashover (arcing) from the line to ground.

The NRC special inspection team reviewed this previous experience. The team found that the partial loss of offsite power during March 2001 had the same cause as the 1997 event. Snow buildup on the vertical bushings for the termination yard caused a short to ground, which opened circuit breakers in the offsite power switching station. After the EDGs energized the vital buses during the event in March 2001, the operators had the ability to restore power to the vital buses from offsite power. However, the operators decided to wait until the problem with the bushings was investigated.

Based on the March 2001 event, the licensee implemented procedure changes to improve the response to flashover at the bushings during severe weather. The operating crews now have specific instructions on performing timely restoration of the circuit connections to the transmission lines. The NRC special inspection team viewed this measure as an appropriate, interim corrective action. Seabrook also entered this condition into its corrective action program to determine what, if any, long-term solutions or enhancements should be implemented. The NRC will monitor the licensee's corrective actions through the normal baseline inspection program.
