Amersham International plc

Packaging Design Group

Test Report No. 1901

1.1 Package Design No 3750A.

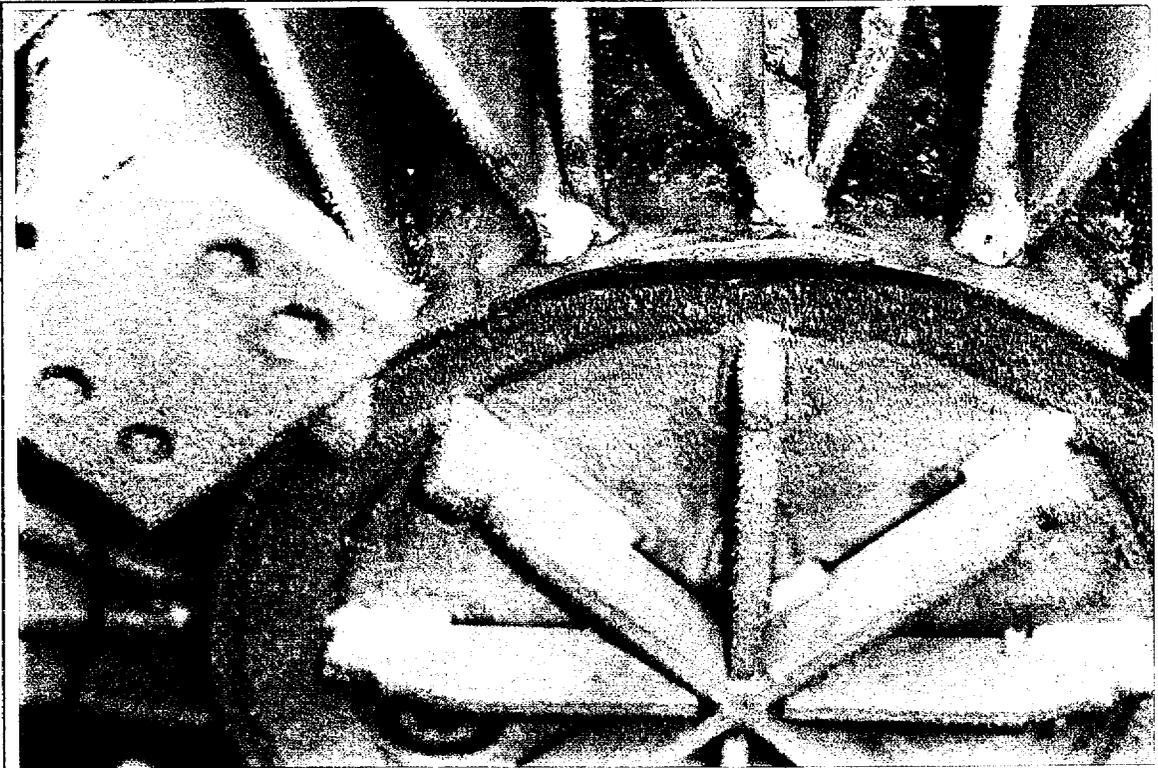
4.4.3 Cask body: The cask and jacket were undamaged except for a bruise on the lower edge of the cask shell 35 mm long x 5 mm maximum width (fig 4). The test caused no damage to the base fins, the base plate, its weldment or the leak test point. The edges of the cooling fins nearest the shell bruise were indented to a maximum depth of 3 mm over a 15 mm length (fig 5). All eight closure studs and nuts were undamaged, secure and unscrewed freely. All twelve jacket screws were undamaged, secure and unscrewed freely.

Figure 4: Cask base showing bruise to shell

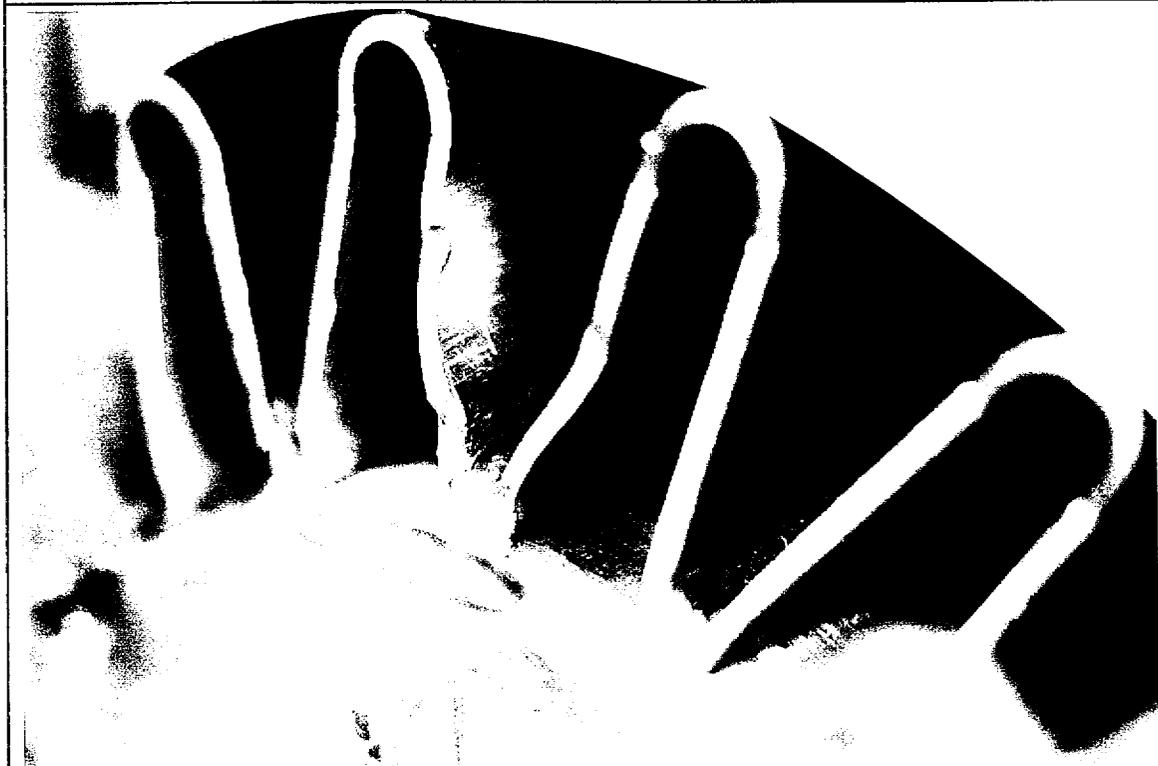
Figure 5: Cask base showing secondary indentations to cooling fins

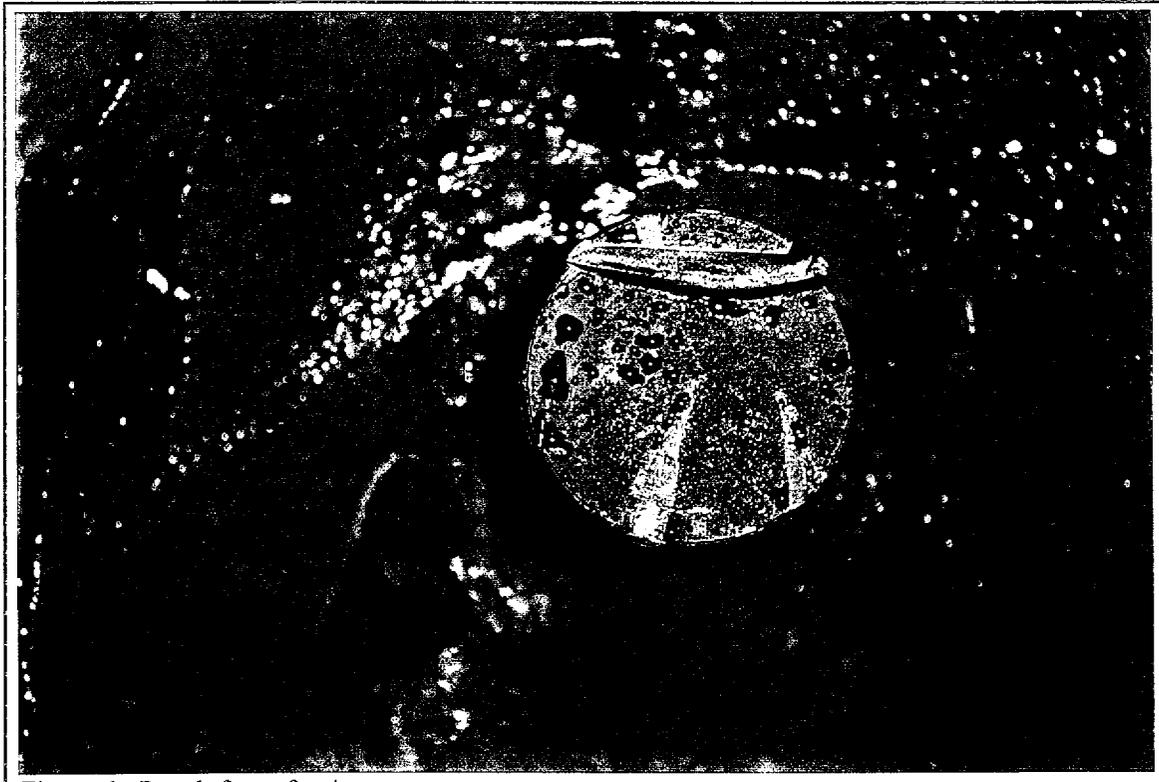
Figure 6: Punch face after impact

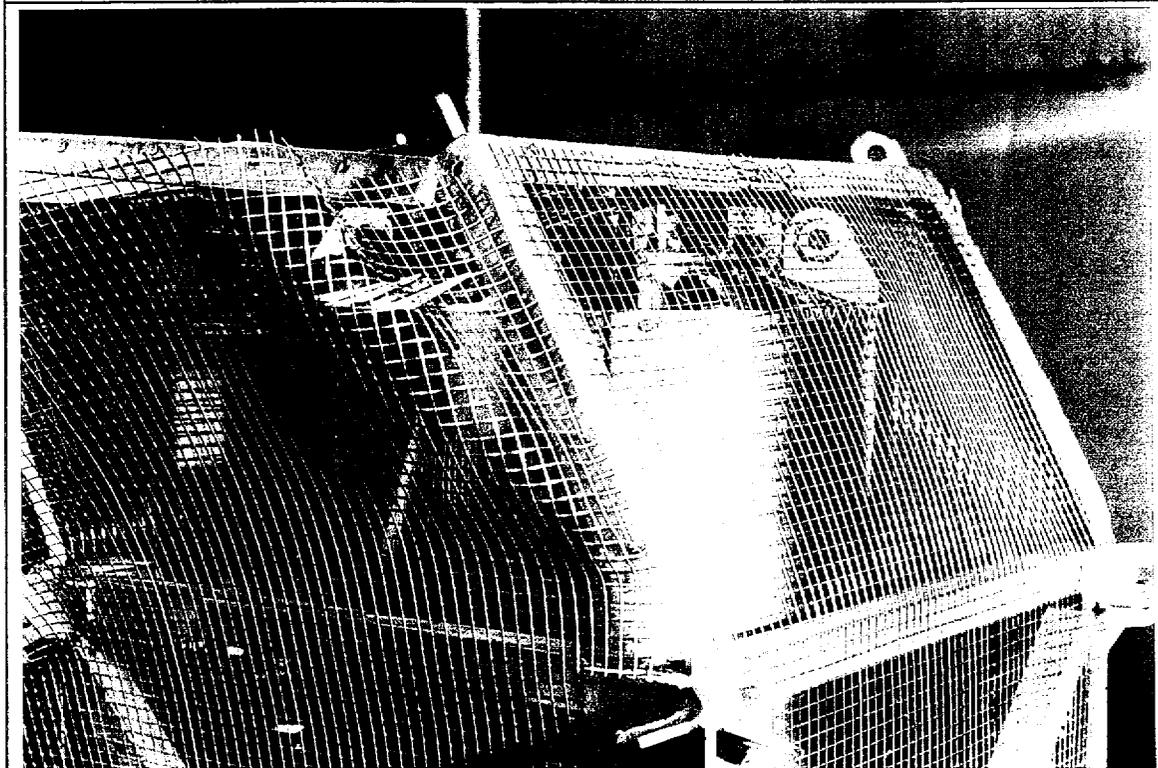
Figure 5: Distortion in upper section of cage

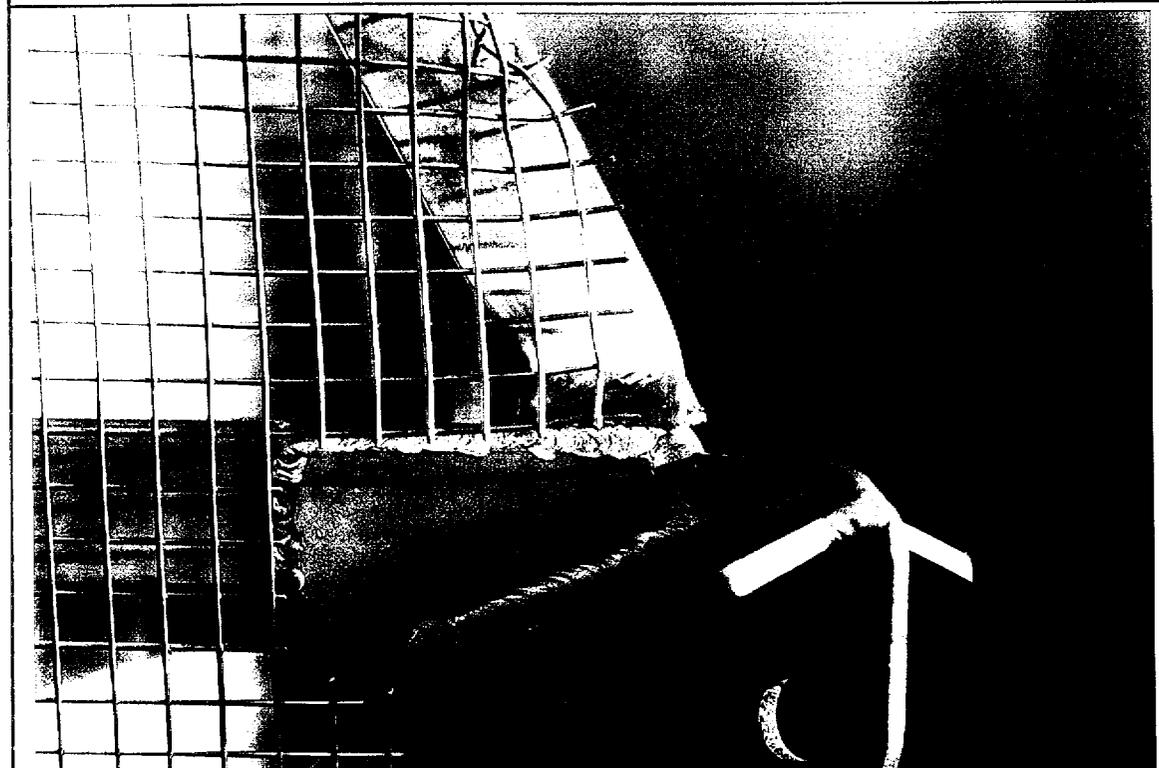
Figure 7: Buckled joint in cage

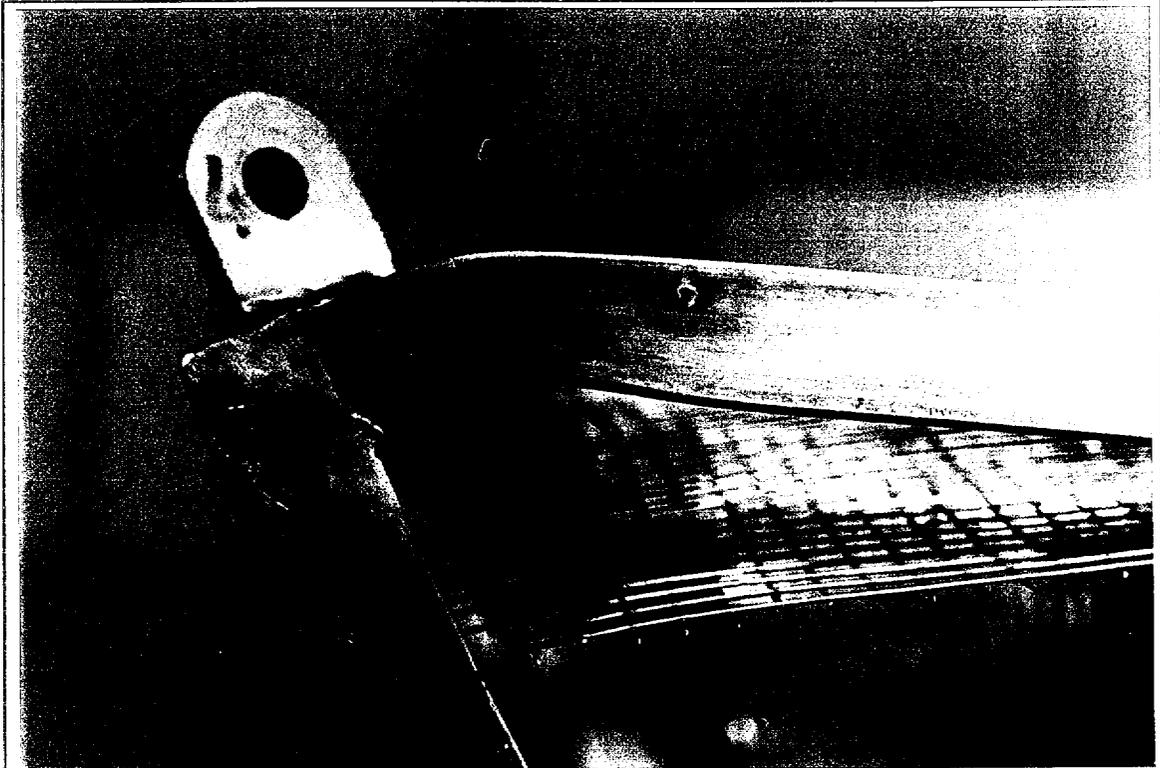
Figure 8: Buckled joint in cage

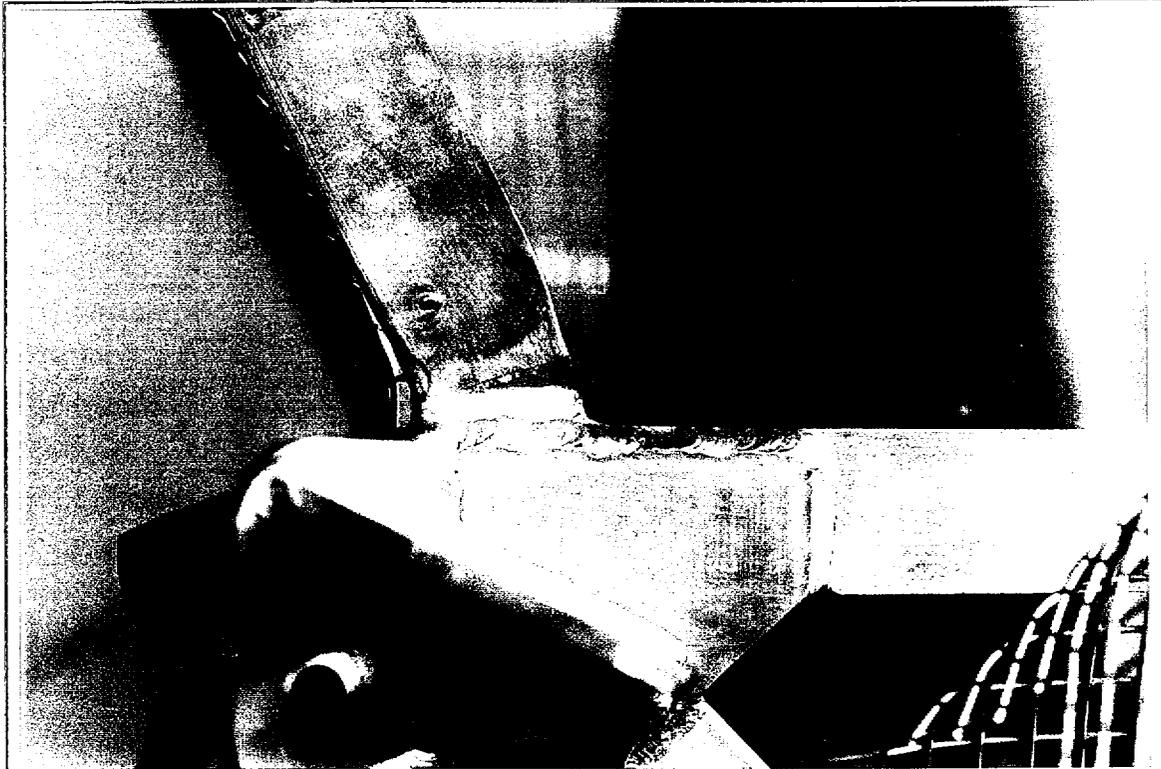
Figure 10: Split near cage weld

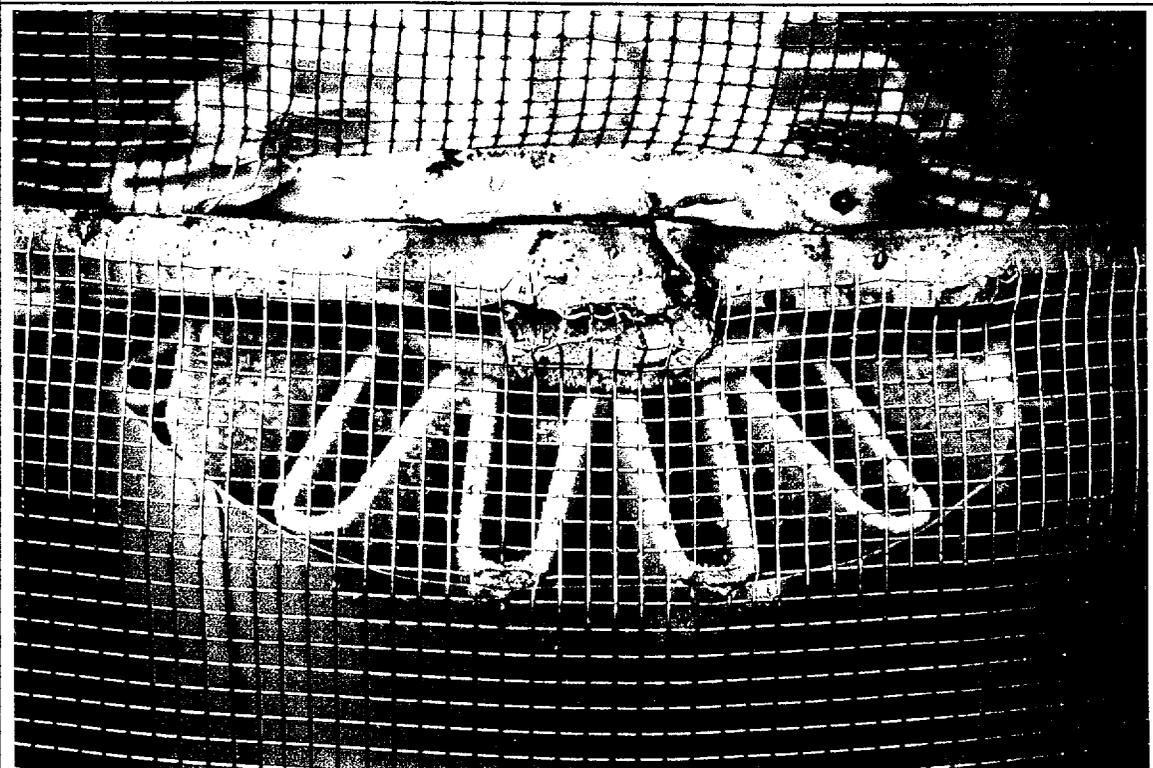
- 4.4.2 Cage: The cage showed relatively little additional damage. The upper half of the cage was twisted sideways at an angle of approximately 32° from the vertical (fig 4). The top mesh panel was largely detached. The upper cross member underneath the impact was flattened over a length of 150 mm and almost severed by two of the closure shock absorbers (figs 5 & 6). Otherwise the cage was undamaged. All twelve pallet screws were undamaged.

Figure 5: Upper cage showing cross member damage and minor bruising to tips of cooling fins

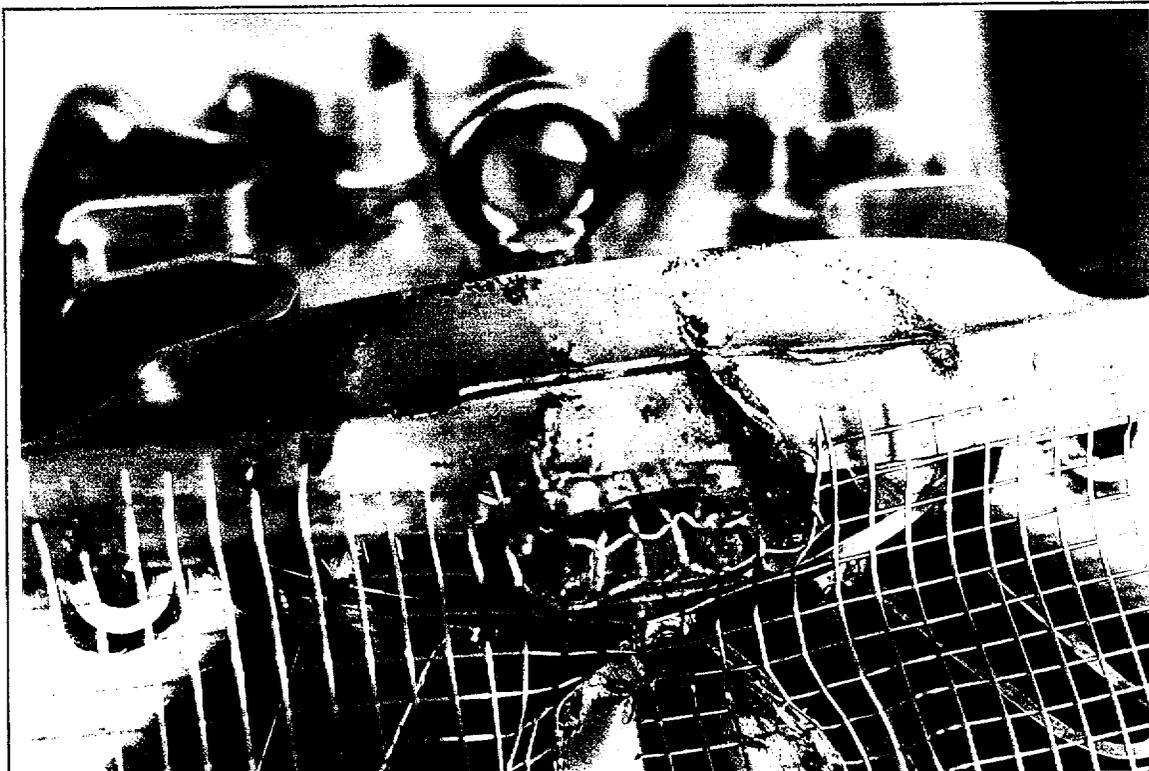
Figure 6: Upper cage showing cross member damage

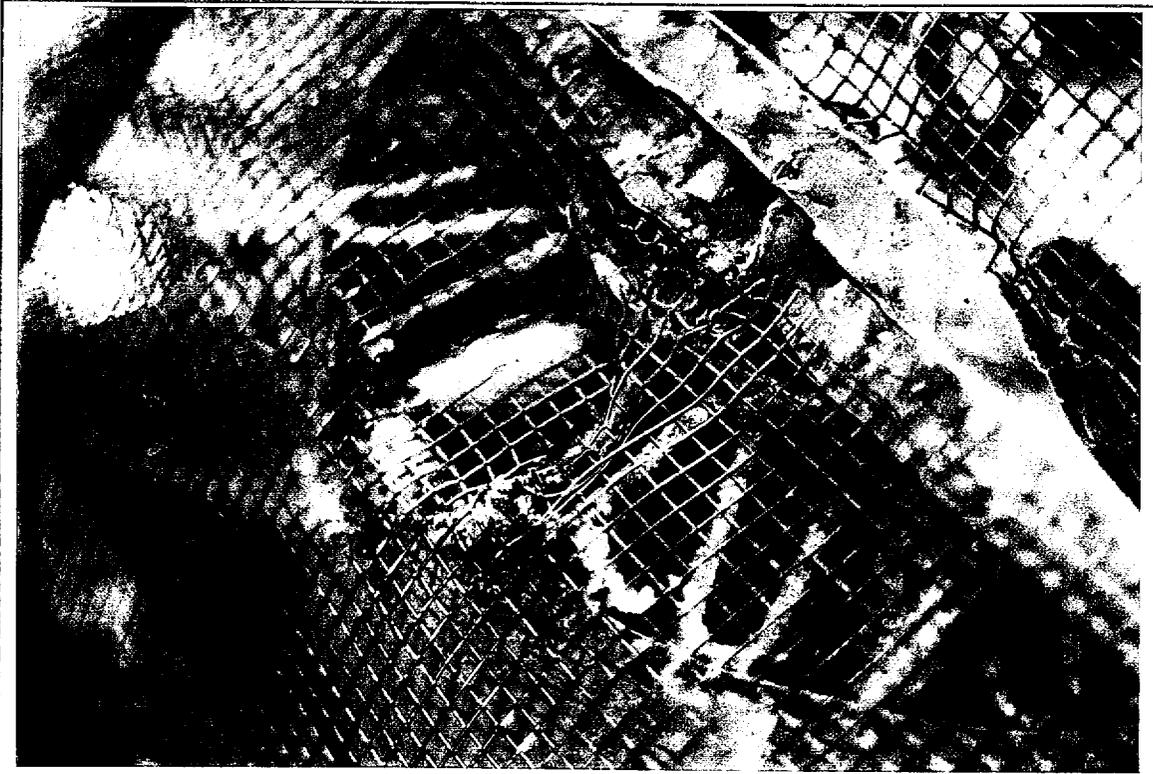
Figure 4: Cage showing punch indentation

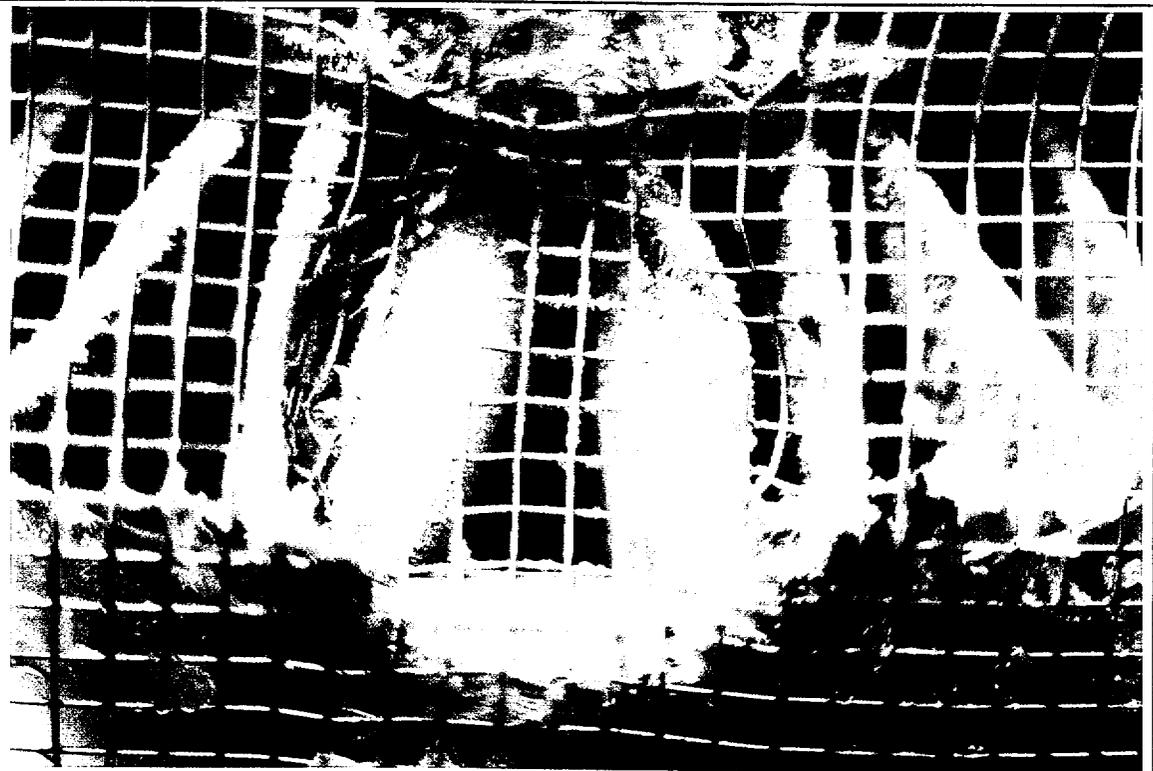
4.4.4 **Cask body:** The inner edges of the two fins hit by the punch were bent over away from each other (figs 5 & 6). The jacket was bent inwards between the two fins. The remainder of the damage was from the 9.0m drop. The lifting points to each side were bent over at 30° and 40° respectively from the vertical (figs 7-9) and were bruised on their top edge. On one of the lifting points a crack had opened on the tensile side of the bend adjacent to the jacket fixing screw (fig 10). The screw and jacket remained quite secure. The body flange had two, smooth-edged, semi-elliptical bruises at its outer edge under the crushed closure shock absorbers (fig 11). The bruises were less than 0.5 mm deep, 10 mm maximum width and extended inwards not more than 5 mm. There was no distortion below, towards the flange-to-shell weld, or inwards, towards the closure studs. There was no other damage to the cask body. All eight closure studs and nuts were undamaged, secure and unscrewed freely. All twelve jacket screws, including the one next to the crack, were undamaged, secure and unscrewed freely.

Figure 5: Cooling fin and jacket damage from punch

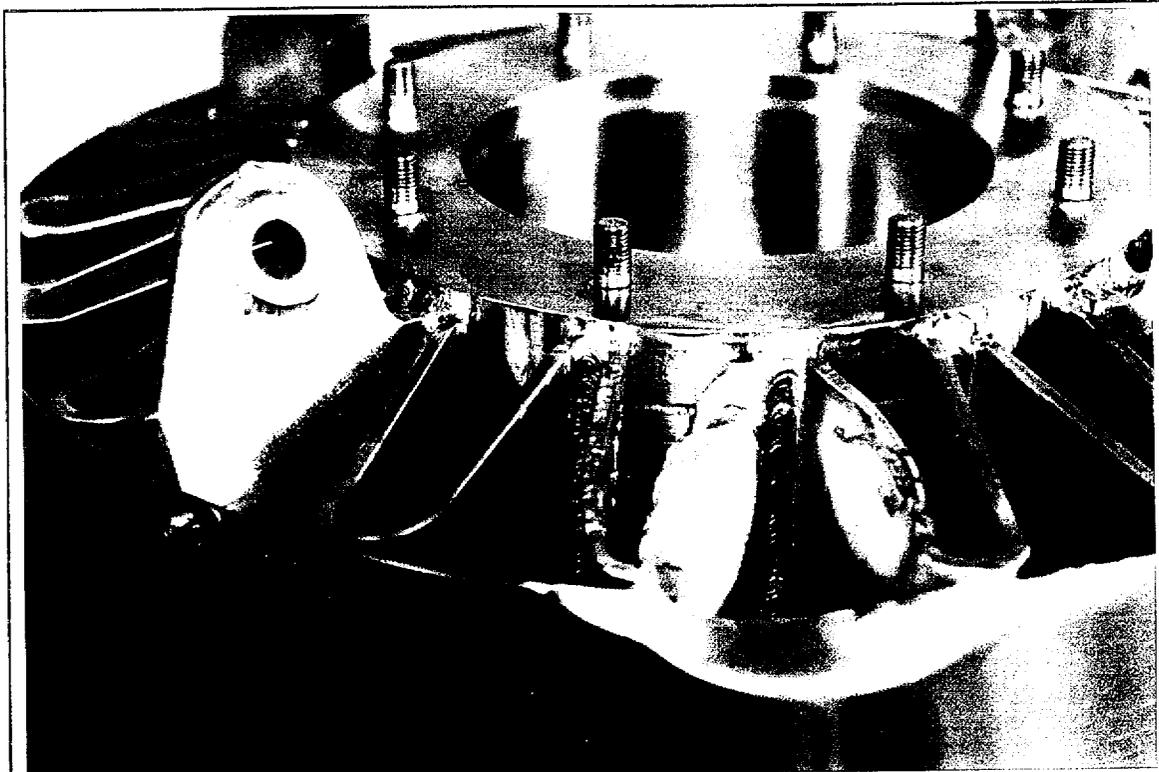
Figure 6: Cooling fin and jacket damage from punch

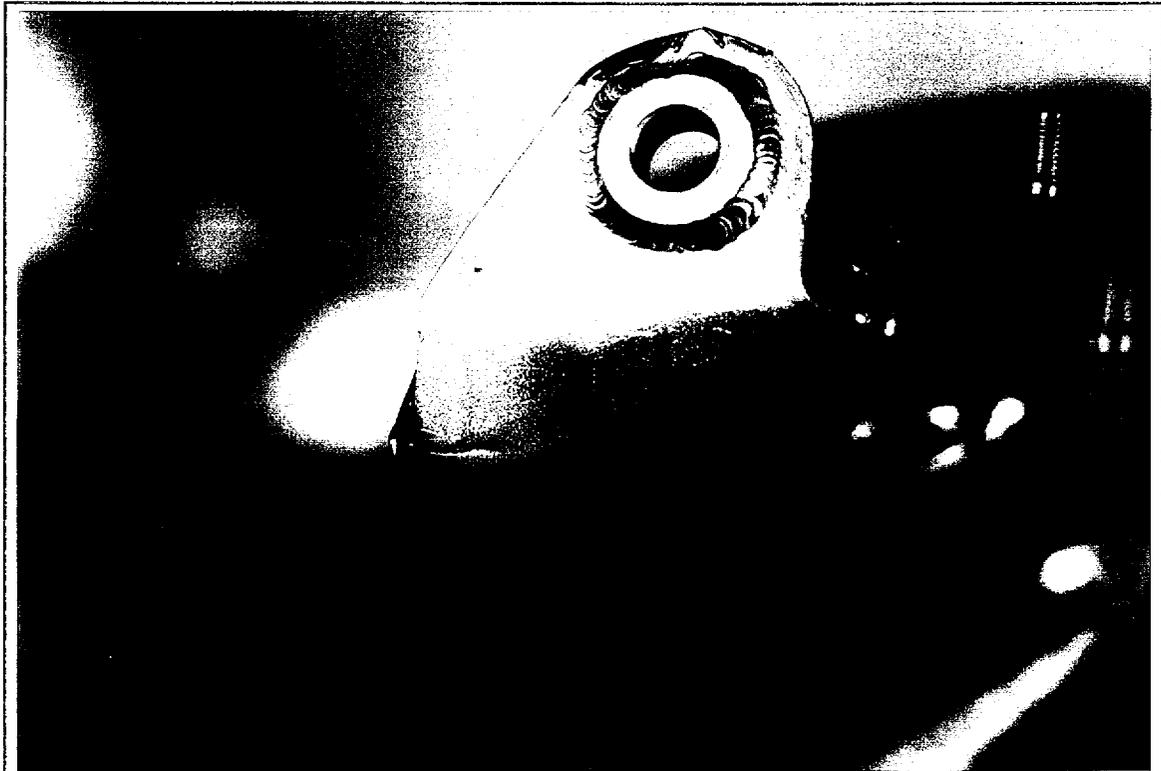
Figure 10: Crack in fin near jacket screw

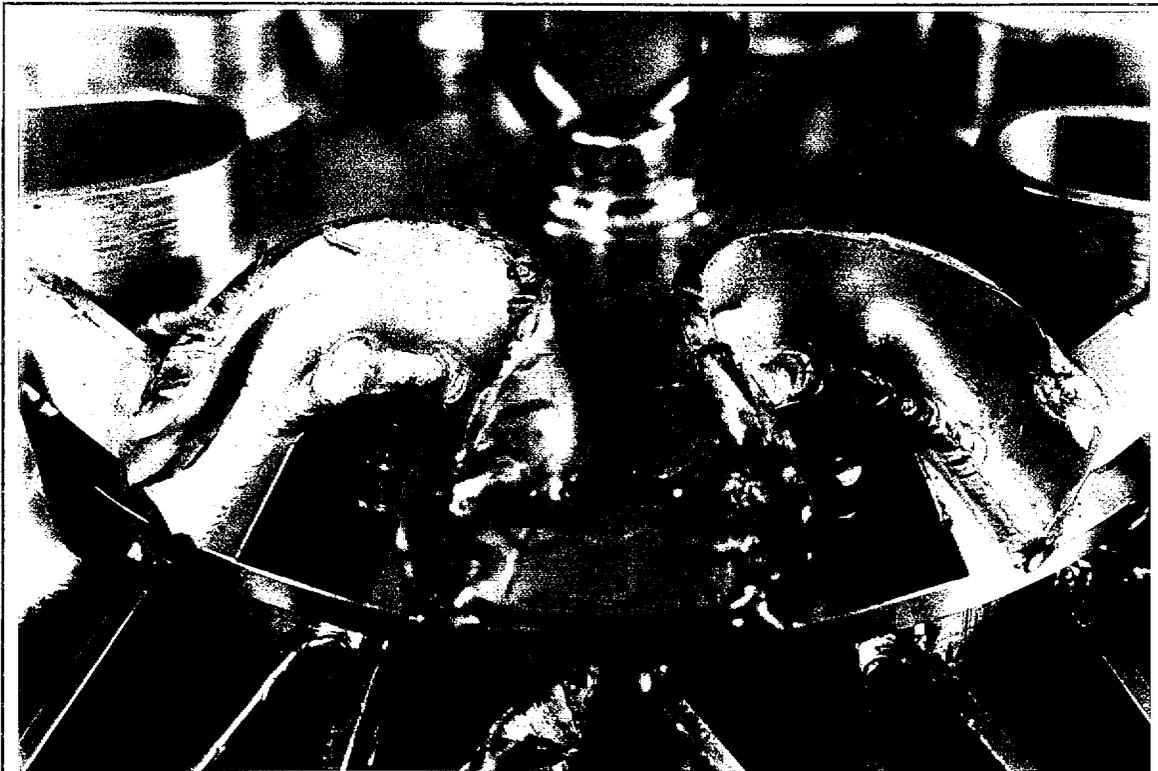
4.4.5 **Cask closure:** The closure disengaged freely from the body. The two fins under the 9.0m impact were crushed flat (fig 12). The two to each side were slightly distorted (figs 13 & 14). Under the inner edges of the two crushed fins the closure flange had taken a gently rippled profile outside the edge of the body flange (figs 15 & 16) creating a lip some 5 mm wide, 60 mm long and 1 mm maximum depth. Other than this the closure was free from damage. There was no evidence of bruising, scratching or distortion to the leak test plug, the closure flange or the underside.

Figure 12: Crushed closure shock absorbers

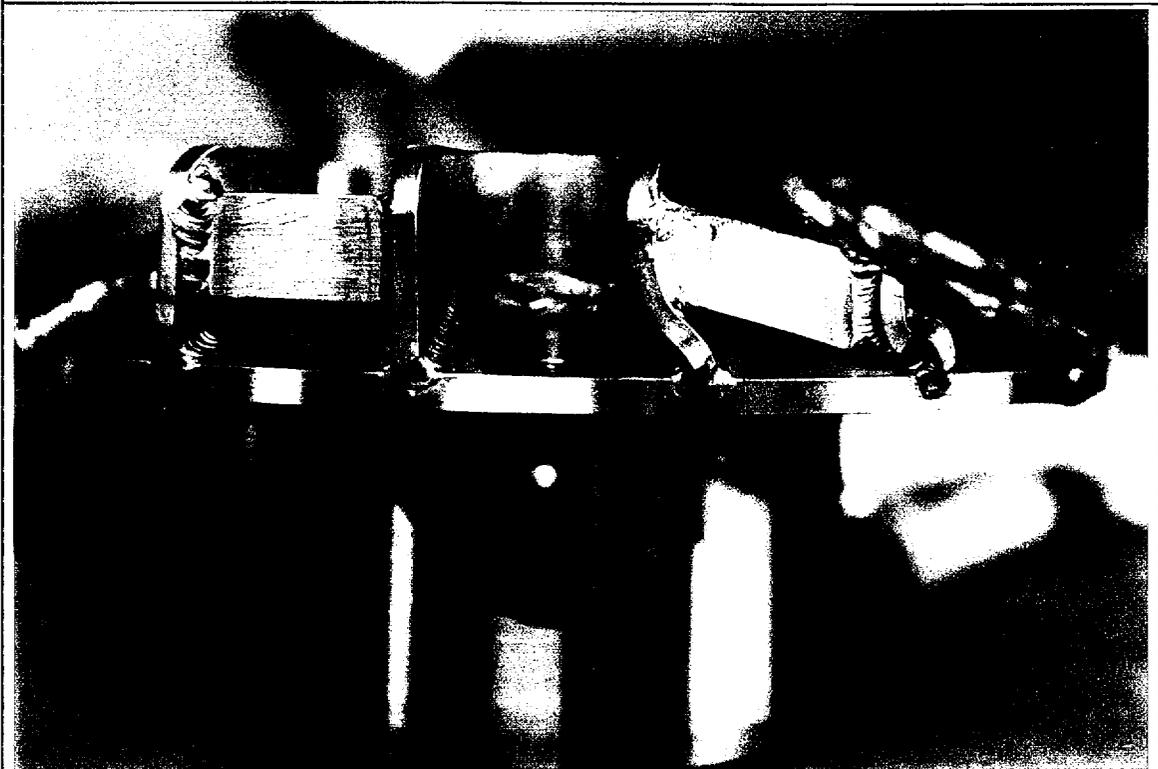
Figure 13: Distortion to adjacent shock absorber

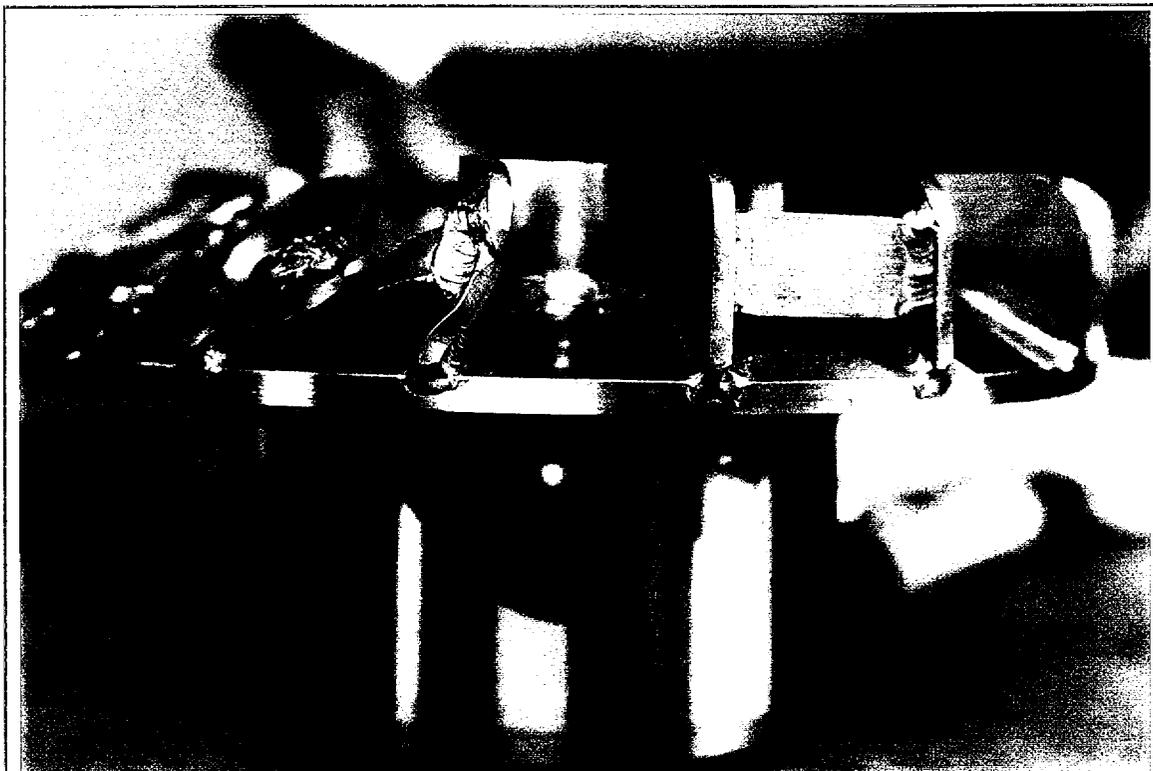
Figure 14: Distortion to adjacent shock absorber

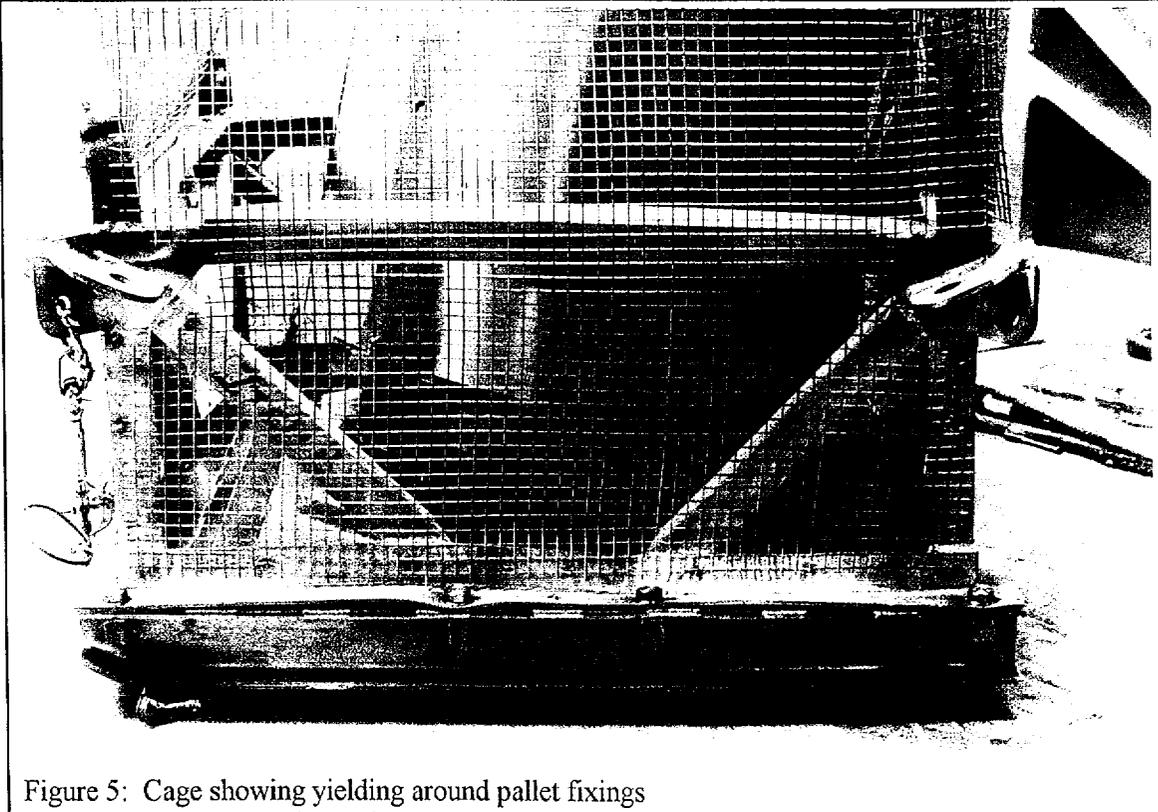
Figure 5: Cage showing yielding around pallet fixings

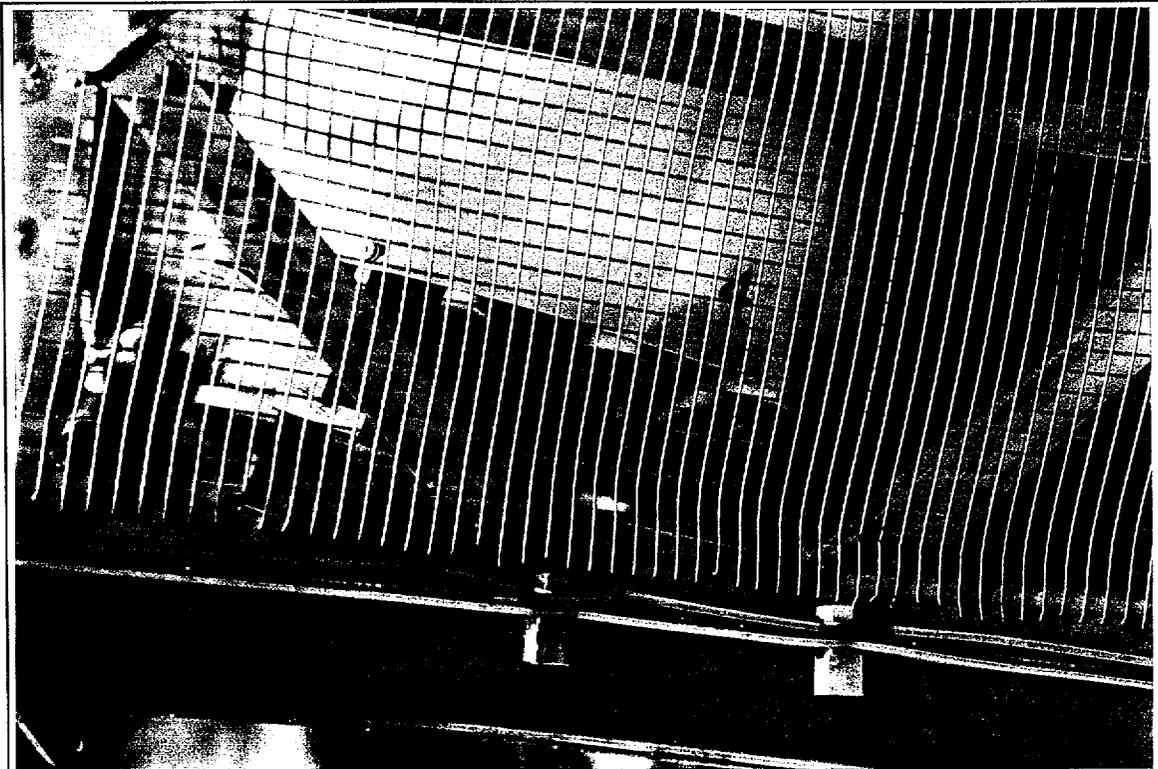
Figure 6: Cage showing yielding around pallet fixings

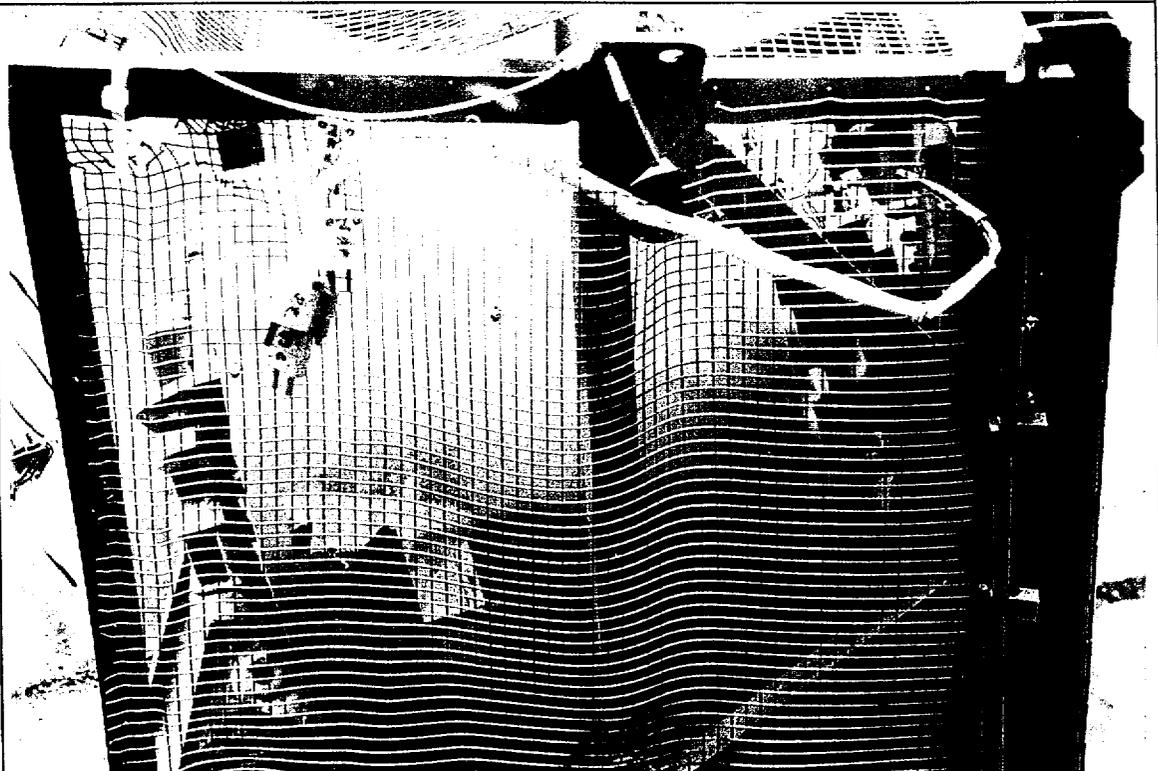
Figure 7: Cage showing yielding around pallet fixings

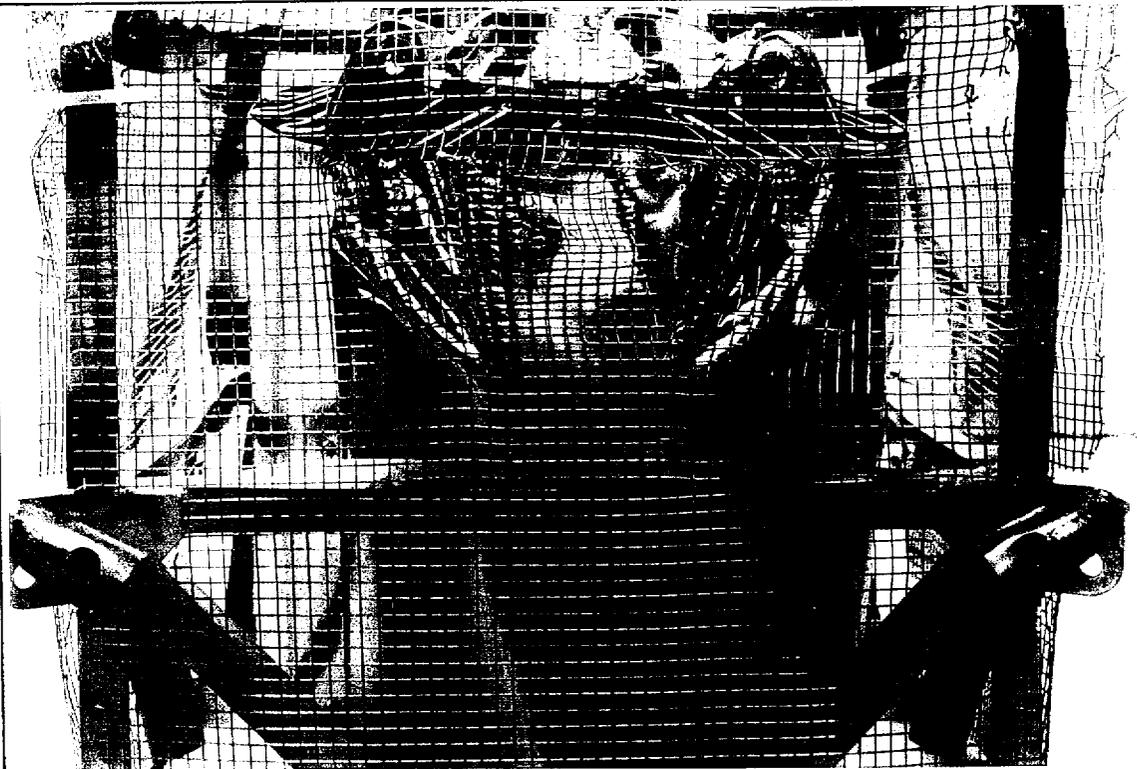
- 4.4.4 Cask body: The cask body showed crushing of the jacket and cooling fins over an area best described as an inverted triangle extending at its broadest along the top of the jacket almost the full quadrant between two lifting points and downwards to a point midway between and half way down the jacket (fig 9). The lifting points were undamaged. The cooling fins were distorted away from the centreline of the impact. The jacket had a triangular split (fig 10) 20 mm wide at the top extending 85 mm down from the top edge which appeared to have been initiated by the indentation caused by the jacket being compressed between the tips of the cooling fins and the cage mesh. There were several such indentations and the split clearly followed one of them. The jacket was corrugated and folded to each side. All twelve jacket screws were in place and appeared undamaged. All eight closure studs and nuts were in place and appeared undamaged.

Figure 9: Crush damage to upper cask

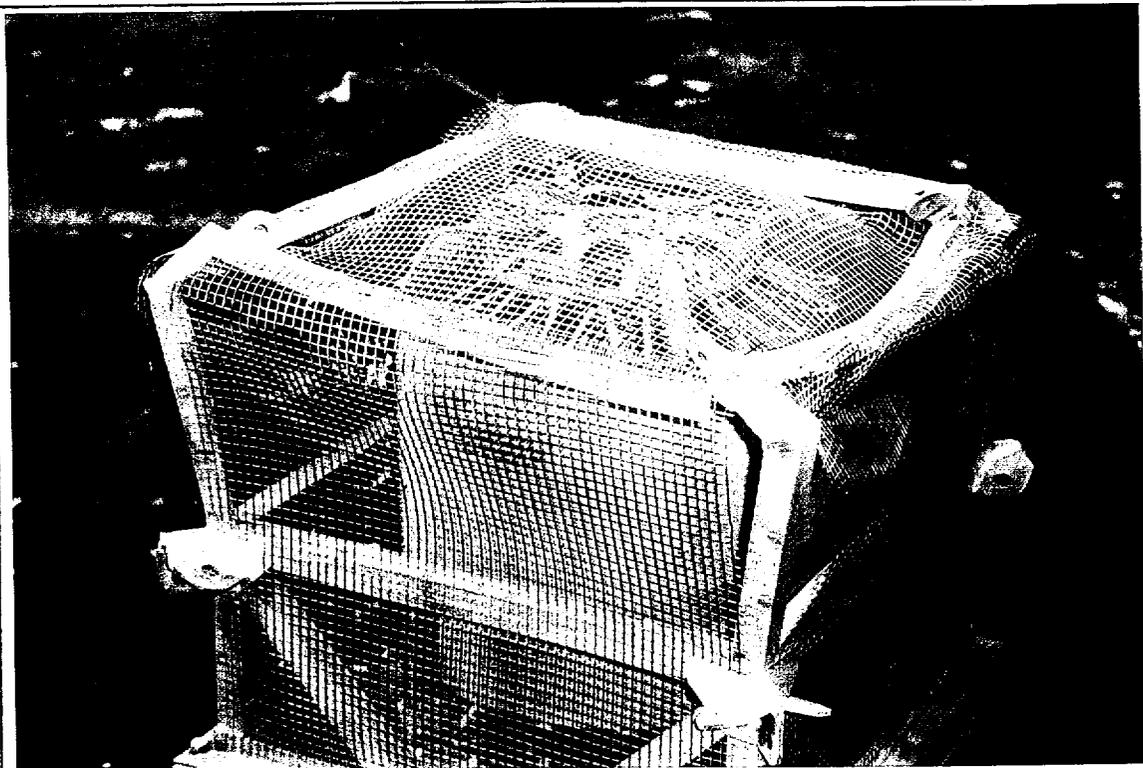
Figure 5: Cage showing compression damage

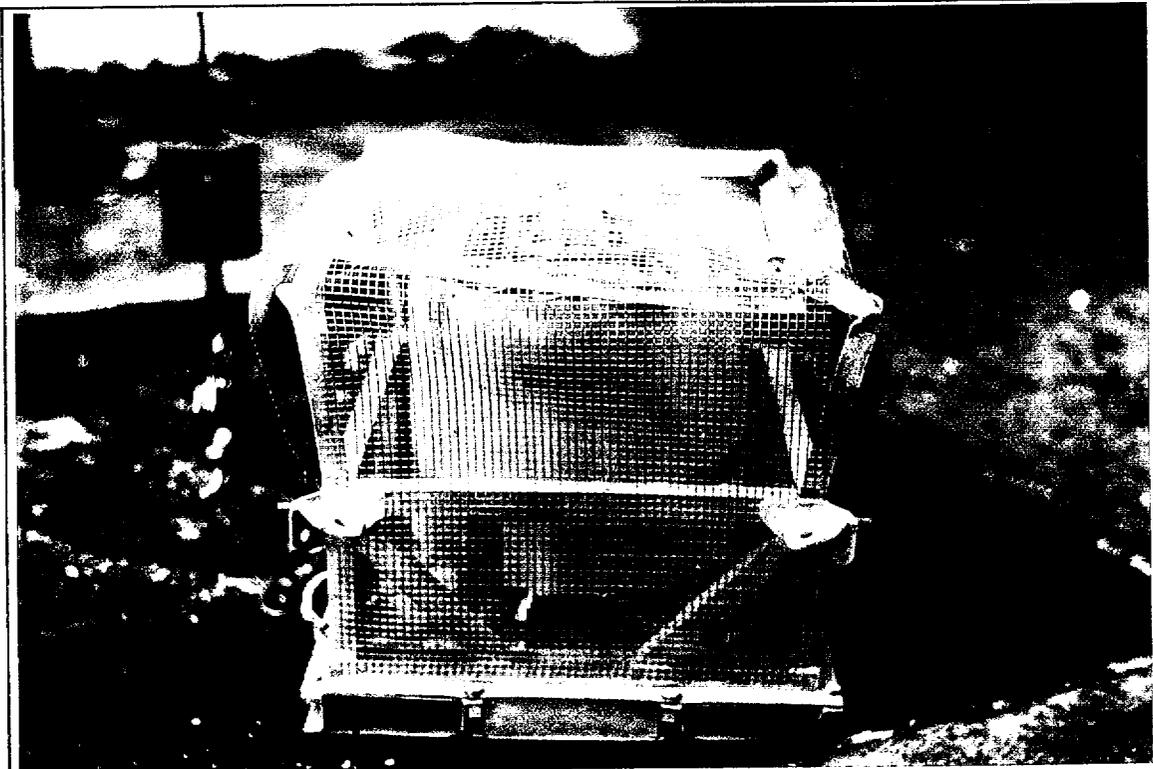
Figure 6: Cage damage and pallet distortion

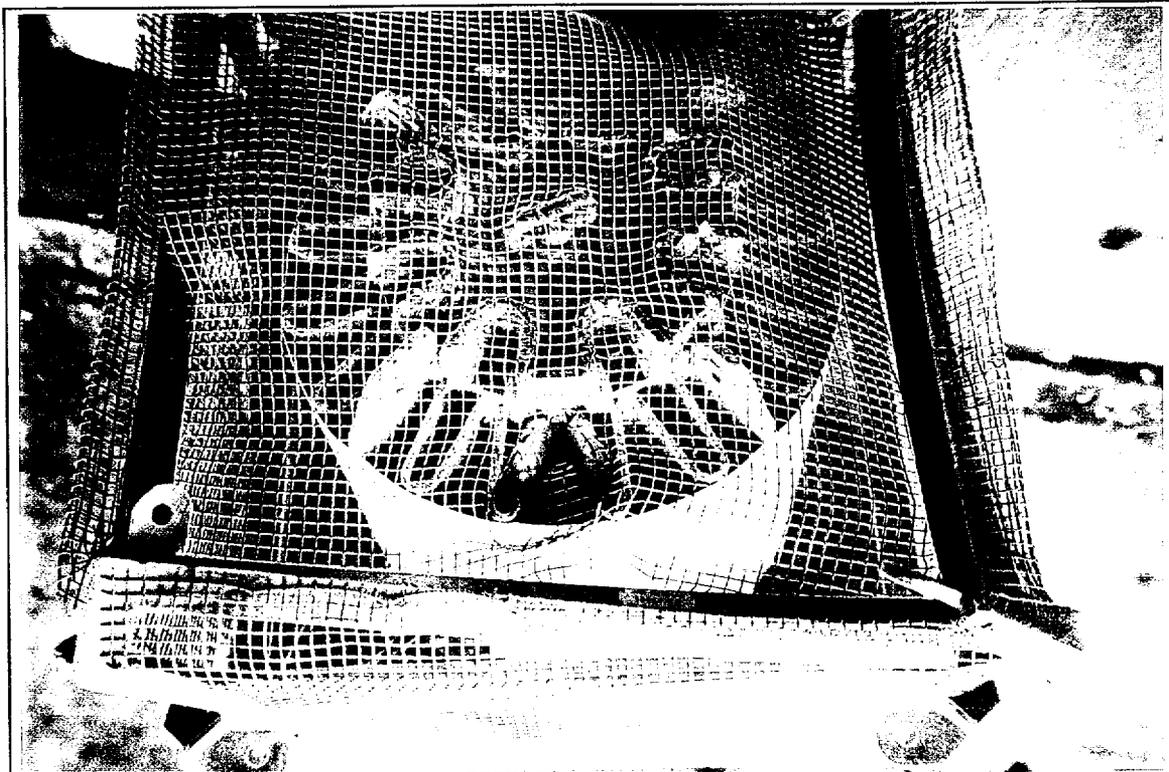
Figure 6: Package showing punch indentation
