SHEARON HARRIS NUCLEAR POWER PLANT DOCKET NO. 50-400/LICENSE NO. NPF-63 SPECIAL REPORT – STEAM GENERATOR TUBE INSERVICE INSPECTION RESULTS

Shearon Harris Nuclear Power Plant

Steam Generator

Inspection Summary

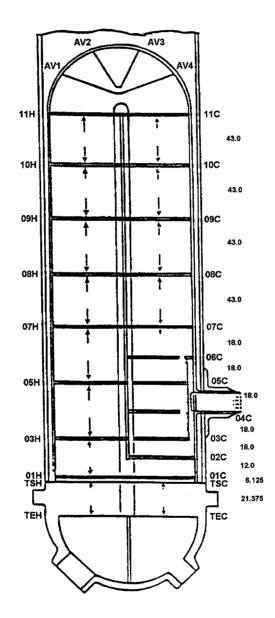
Appendix D Tube Support Diagram

The model D4 SG's were built by Westinghouse and the plant started operations in 1987. There are 3 SG's each having 4578 tubes. The tubes are mill annealed Inconel 600 with dimensions of 0.75" OD x 0.043" wall thickness. Supports include carbon steel drilled supports; eight on the hot leg side and eleven on the cold leg side and anti-vibration bars in the u-bend section.

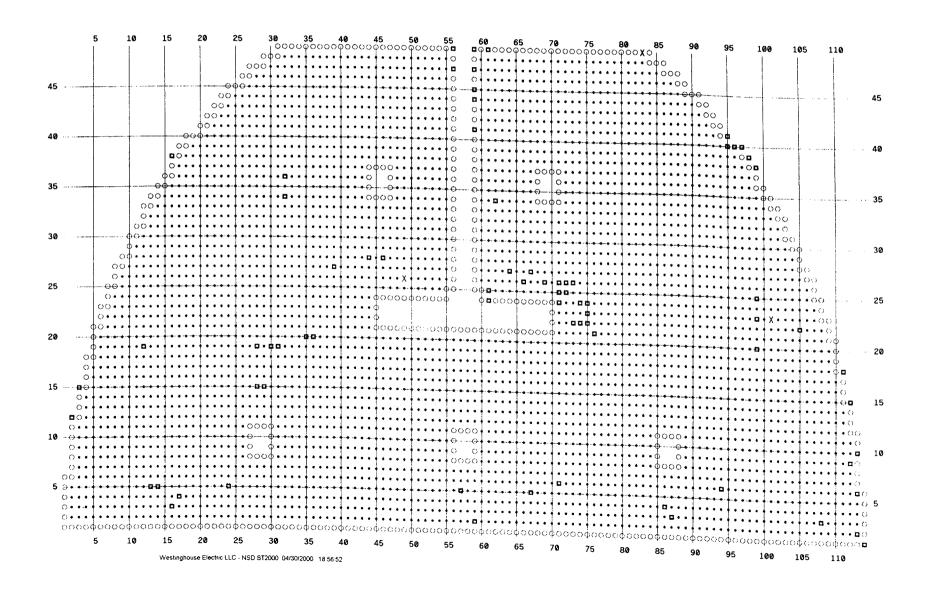
SG - A UPDATED PLUG TUBE HISTORY

X 3 TUBE PLUGGED THIS OUTAGE BASED ON EC RESULTS

74 EXISTING PLUGGED TUBE

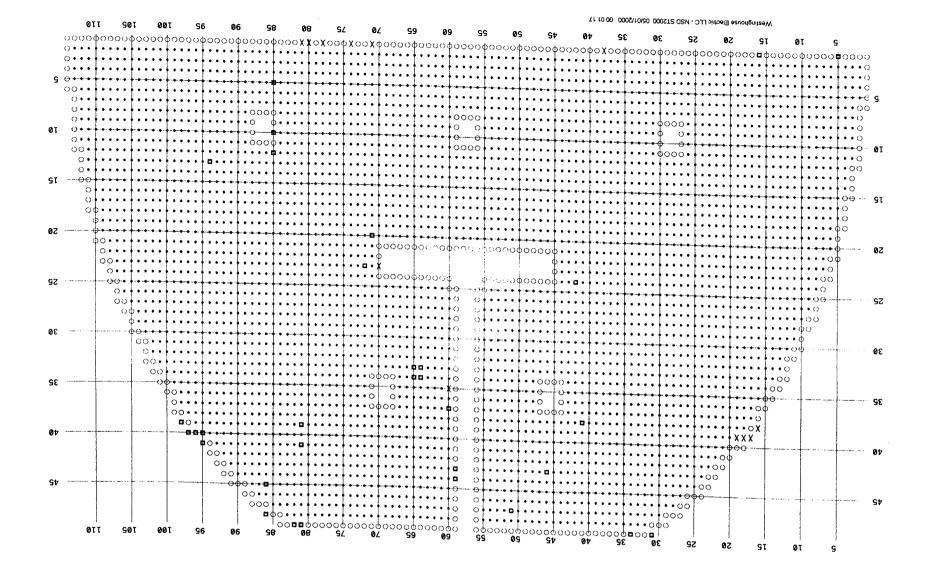
YAOTSIH 38UT DUJA DATED PLUG TUBE HISTORY

REASED ON EC RESULTS X IS TUBE PLUGGED THIS OUTAGE

■ 35 EXISTING PLUGGED TUBE

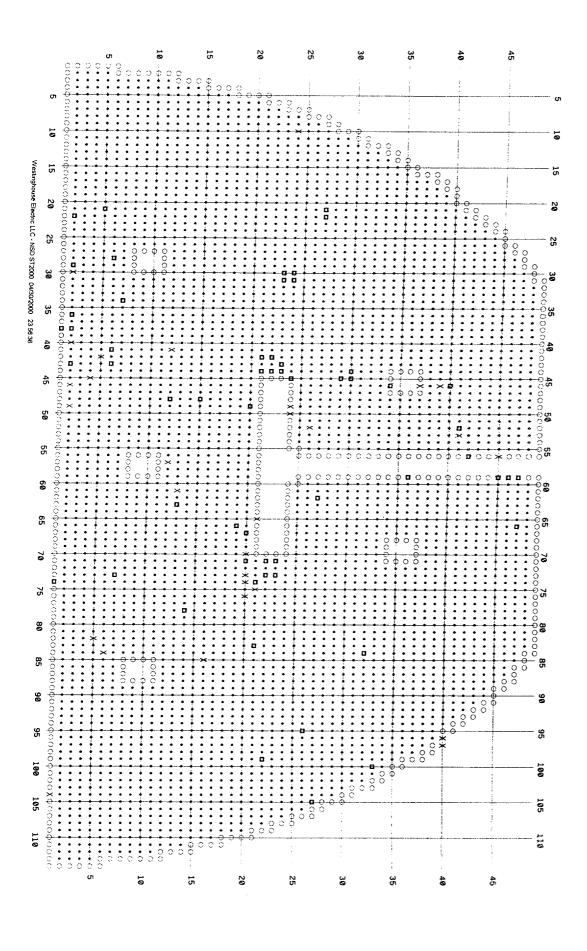
SG - C UPDATED PLUG TUBE HISTORY

X 29 TUBE PLUGGED THIS OUTAGE BASED ON EC RESULTS

58 EXISTING PLUGGED TUBE
