South Texas Project
Unit 2
Docket No. STN 50-499
Licensee Event Report 2-01-003
Steam Generator 2C Classified as Category C-3

TITLE (4)
Steam Generator 2C Classified as Category C-3 in 2RE08

On March 19, 2001, during refueling outage 2RE08, the results of steam generator tube inspections in steam generator 2C were classified as category C-3 in accordance with Technical Specification 4.4.5.2.d. in that 48 tubes out of 4,615 (i.e., >1%) had been found defective. All defective steam generator tubes were plugged before the steam generators were returned to service. There were not any adverse safety consequences or implications as a result of this event. This event did not adversely affect the safe operation of the plant or the health and safety of the public. The cause of the imperfections was outside diameter stress corrosion cracking.

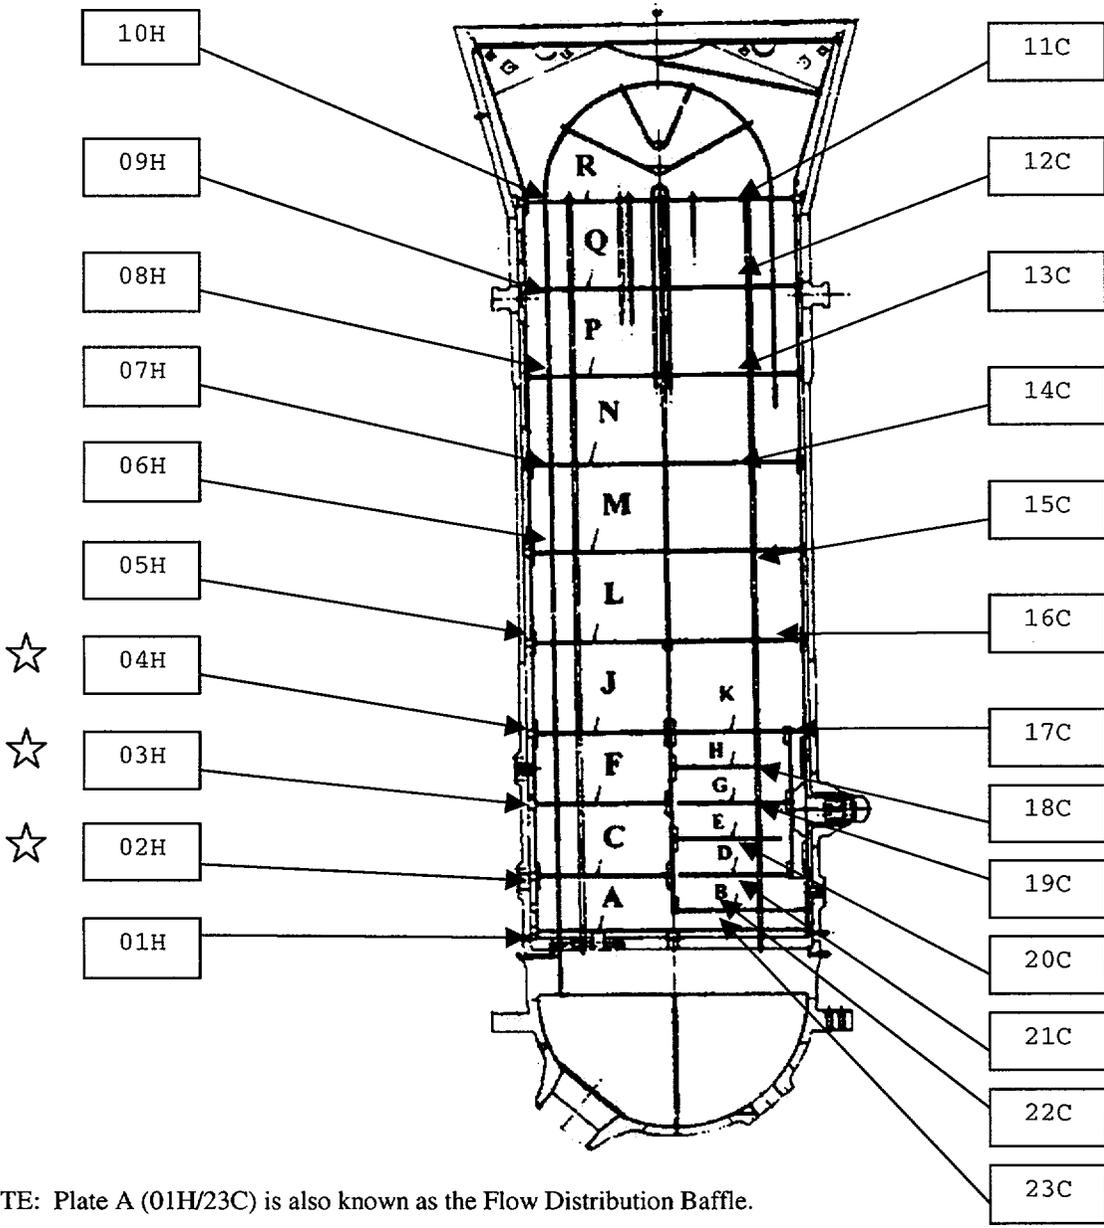
**FIGURE 1
TUBE SUPPORT PLATE IDENTIFICATION IN MODEL E SGs**

The inspection results are discussed below by degradation mechanism. A summary of how many defective tubes were attributed to each of these damage mechanisms is provided in Table 1. As discussed below, many tubes were also preventively plugged. A summary of all tube plugging is given in Table 2. Figure 1 provides identification of the tube support plates in the Model E steam generators.

☆ Three Volt ARC applies at these plates only.
