Monticello Nuclear Generating Plant
2807 West County Road 75
Monticello, MN 55362-9637

LER 2001-009

**Construction Error Results in Failure to Perform Periodic
Testing of One Instrument Line Excess Flow Check Valve**

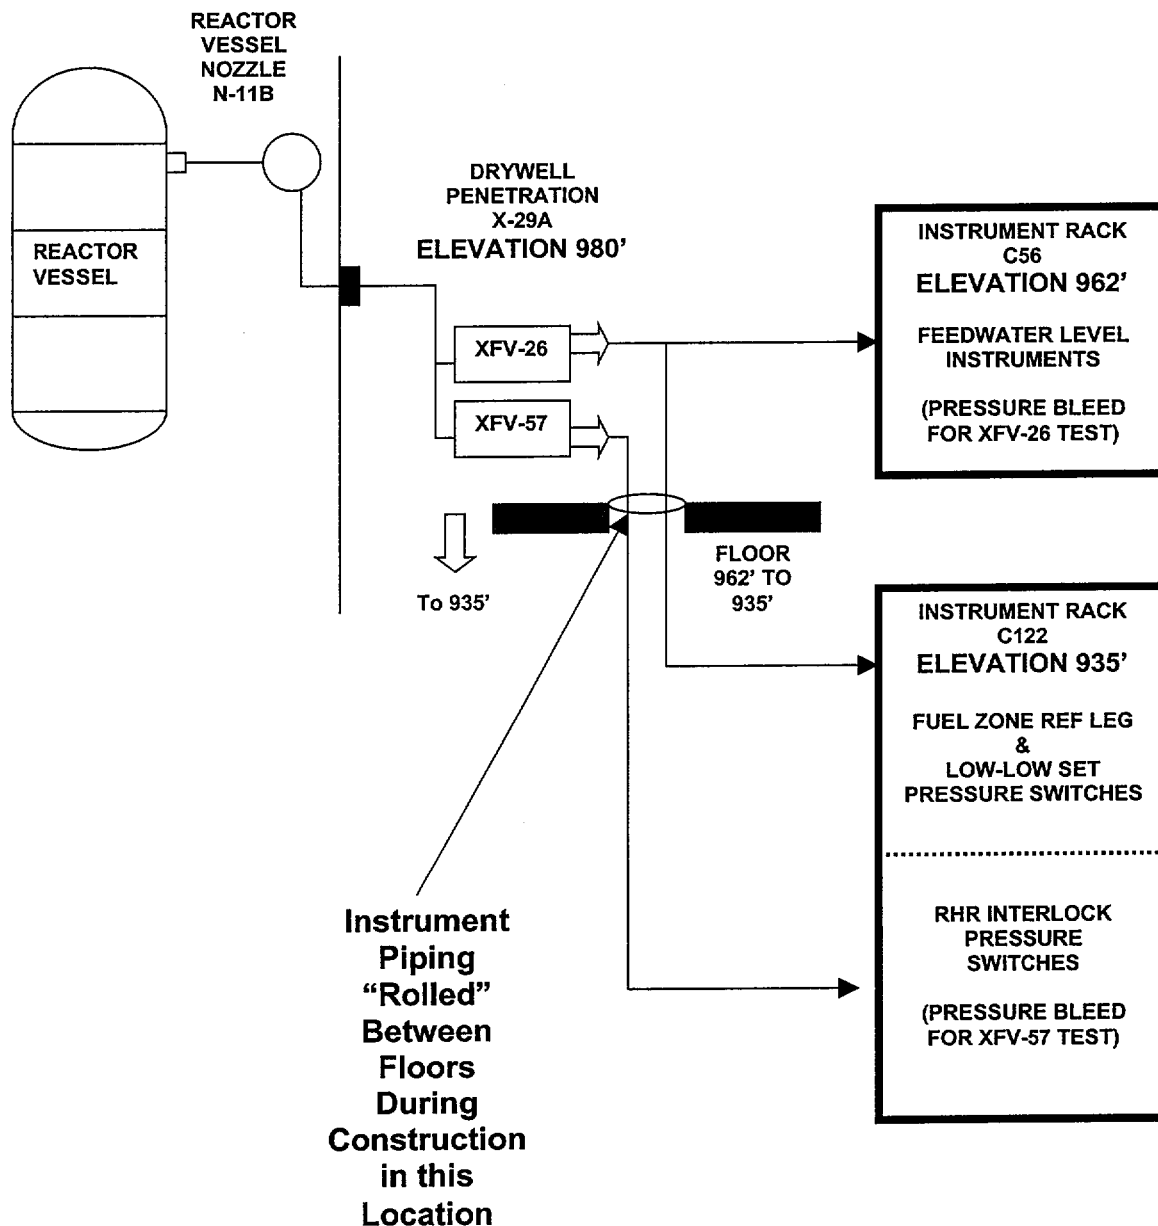
Figure 1
Simplified Drawing of As-Designed
B Reactor Vessel Instrument Piping

The P&ID shows instrument piping downstream of containment penetration X-29A splitting into two branches. The first branch connects to feedwater level instrumentation on panel C56 and fuel zone level and safety/relief valve (SRV) low-low set pressure switches³ on panel C122 via excess flow check valve⁴ XFV-26. The second branch connects to residual heat removal (RHR) permissive interlock pressure switches⁵ on panel C122 via excess flow check valve XFV-57. Panel C56 is on elevation 962' and panel C122 is on elevation 935' in the Reactor Building. Refer to Figure 1.

Investigation found that the piping between C56 and C122 were rolled in the vertical pipe run between floors. This resulted in the RHR pressure switches actually being connected to XFV-26 and the fuel zone and SRV low low set pressure switches connected to XFV-57. The operability of instrumentation connected to XFV-26 and XFV-57 was not affected by the piping error since it made no difference which excess flow check valve supplied each instrument.

Field investigation confirmed that the true cause of the occurrence was a construction error resulting from "rolling" of the B leg piping in passing through the concrete structure of the Reactor Building between elevations 935' and 962'.

The scope of Modification 01Q075 was expanded to include routing of the B reactor vessel instrumentation piping to eliminate the error caused by "rolling" of the piping between elevations 935' and 962'. Modification 01Q075 was satisfactorily completed on the B leg piping.
