Monticello Nuclear Generating Plant
2807 West County Road 75
Monticello, MN 55362-9637

LER 2001-009

**Construction Error Results in Failure to Perform Periodic
Testing of One Instrument Line Excess Flow Check Valve**

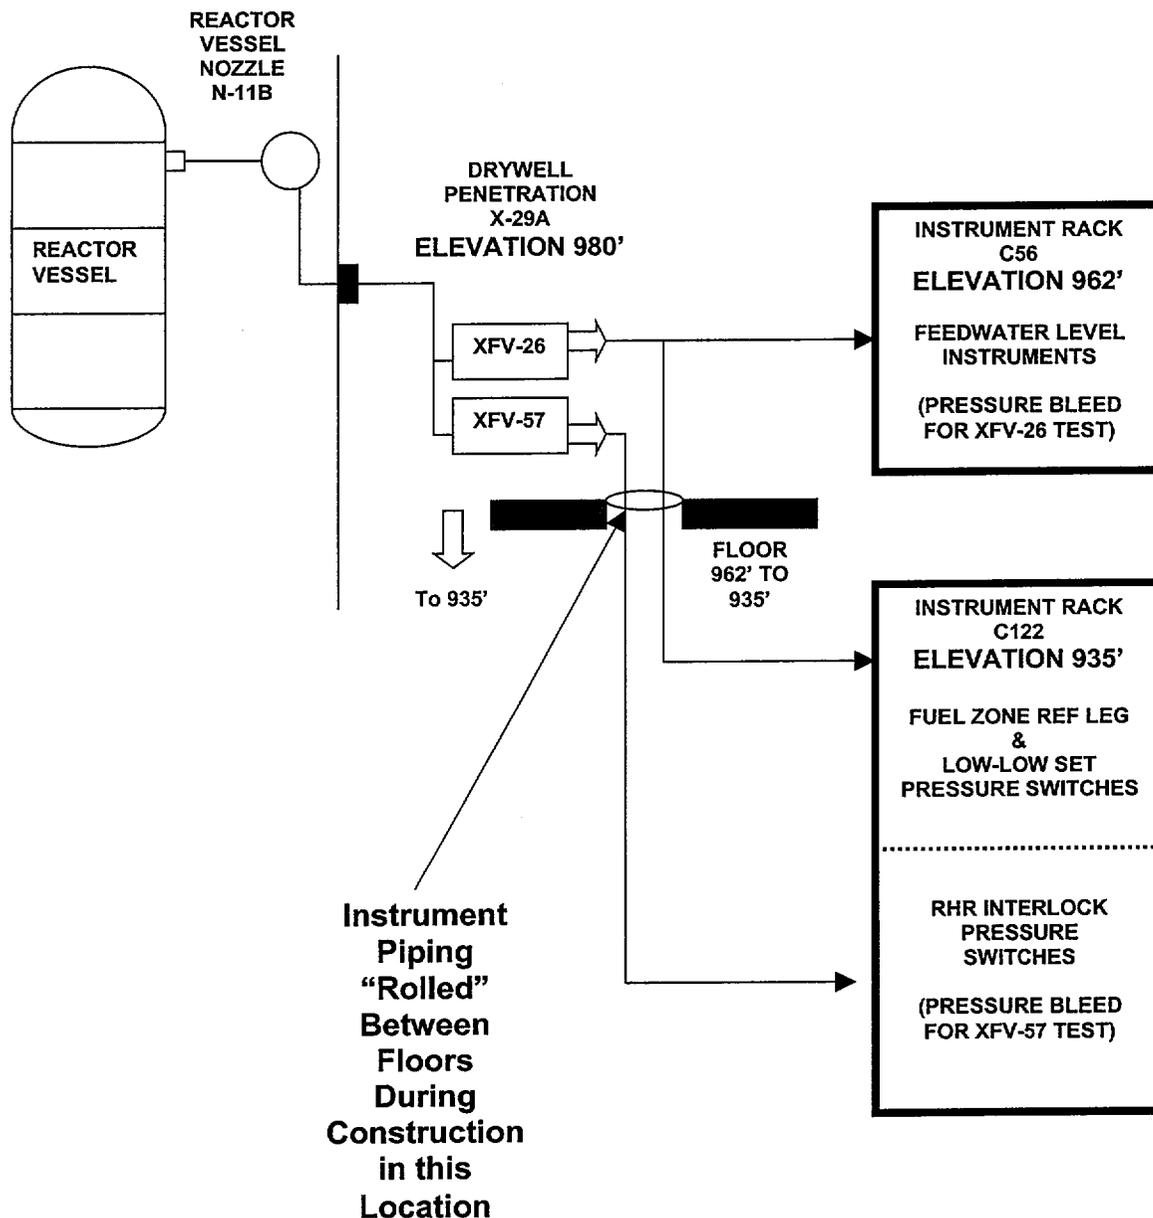
Figure 1
Simplified Drawing of As-Designed B Reactor Vessel Instrument Piping

The P&ID shows instrument piping downstream of containment penetration X-29A splitting into two branches. The first branch connects to feedwater level instrumentation on panel C56 and fuel zone level and safety/relief valve (SRV) low-low set pressure switches³ on panel C122 via excess flow check valve⁴ XFV-26. The second branch connects to residual heat removal (RHR) permissive interlock pressure switches⁵ on panel C122 via excess flow check valve XFV-57. Panel C56 is on elevation 962' and panel C122 is on elevation 935' in the Reactor Building. Refer to Figure 1.

Investigation found that the piping between C56 and C122 were rolled in the vertical pipe run between floors. This resulted in the RHR pressure switches actually being connected to XFV-26 and the fuel zone and SRV low low set pressure switches connected to XFV-57. The operability of instrumentation connected to XFV-26 and XFV-57 was not affected by the piping error since it made no difference which excess flow check valve supplied each instrument.

Review of the excess flow check valve surveillance test procedure showed that the low side instrument tap of feedwater level transmitter LT-6-52B was being used to bleed off pressure when testing XFV-26. The piping routing error did not prevent a valid test of XFV-26. The instrument tap for RHR permissive Interlock pressure switch PS-2-3-49B was used in the procedure to bleed off pressure when testing XFV-57. Because the RHR permissive interlock pressure switch was actually connected to XFV-26 due to the piping error, a valid test of XFV-57 was not performed and XFV-26 was actually being tested twice.

Field investigation confirmed that the true cause of the occurrence was a construction error resulting from "rolling" of the B leg piping in passing through the concrete structure of the Reactor Building between elevations 935' and 962'.

The scope of Modification 01Q075 was expanded to include routing of the B reactor vessel instrumentation piping to eliminate the error caused by "rolling" of the piping between elevations 935' and 962'. Modification 01Q075 was satisfactorily completed on the B leg piping.

Demin water was injected at various instrument taps with the instruments and associated trips bypassed to confirm that the revisions to the B leg piping were correctly installed.
