May 30, 2001

**DOCKET 50-255 - LICENSE DPR-20 - PALISADES PLANT**  
**LICENSEE EVENT REPORT 01-002, CONTROL ROD DRIVE SEAL HOUSING LEAK**  
**AND CRACK INDICATIONS**

**TITLE (4)**  
**CONTROL ROD DRIVE SEAL HOUSING LEAK AND CRACK INDICATIONS**

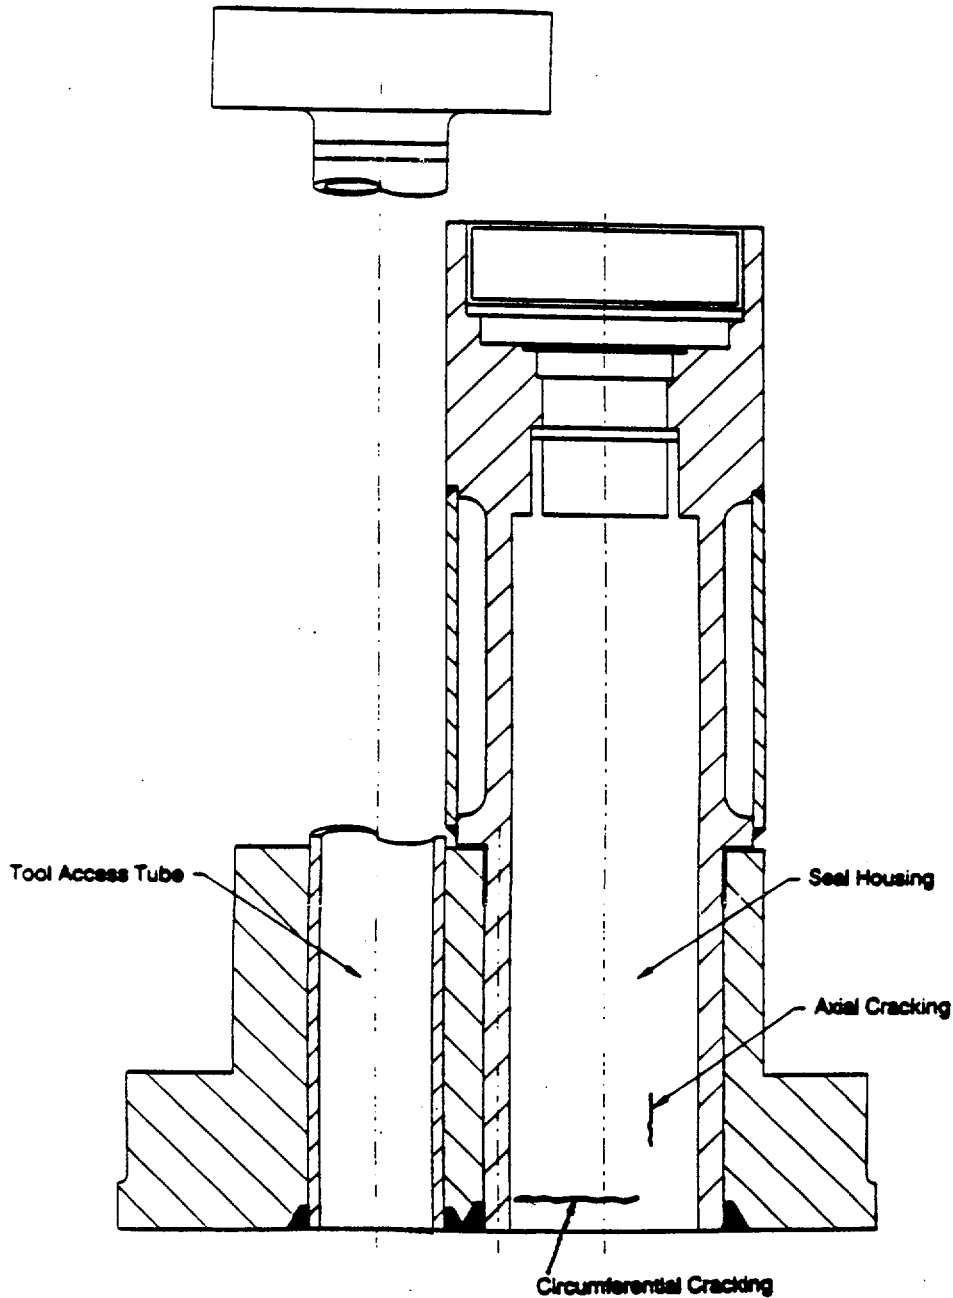
**FIGURE 1**

Each control rod at Palisades is driven by an electric motor through a drive shaft and bevel gears which engage a rack assembly coupled to the control rod. The drive shaft is offset from, and parallel to, the axis of its associated control rod. Figure 1 provides a sketch of the CRD seal housing assembly configuration. The primary coolant pressure boundary is provided by a rotating mechanical seal located at the top of the seal housing tube. The lower flange of the seal housing (autoclave flange) is fastened to the support tube with the autoclave nut. The lower region of the seal housing below the mechanical seal provides the primary coolant pressure boundary. The drive motor and clutch assembly mount on the atmospheric side of the mechanical seal at the top of the seal housing. The tool access tube penetrates the autoclave flange directly above the rack assembly. The tool access tube provides access for coupling and uncoupling rods, and is closed with a blank flange when the primary coolant system is filled.

**Control Rod Drive Seal Housing**
