**DOCKET 50-255 - LICENSE DPR-20 - PALISADES PLANT**  
**LICENSEE EVENT REPORT 01-002, CONTROL ROD DRIVE SEAL HOUSING LEAK**  
**AND CRACK INDICATIONS**

<b>FACILITY NAME (1)</b> PALISADES NUCLEAR PLANT	<b>DOCKET NUMBER (2)</b> 05000255	<b>PAGE (3)</b> 1 OF 5
---	--------------------------------------	---------------------------

**TITLE (4)**  
**CONTROL ROD DRIVE SEAL HOUSING LEAK AND CRACK INDICATIONS**

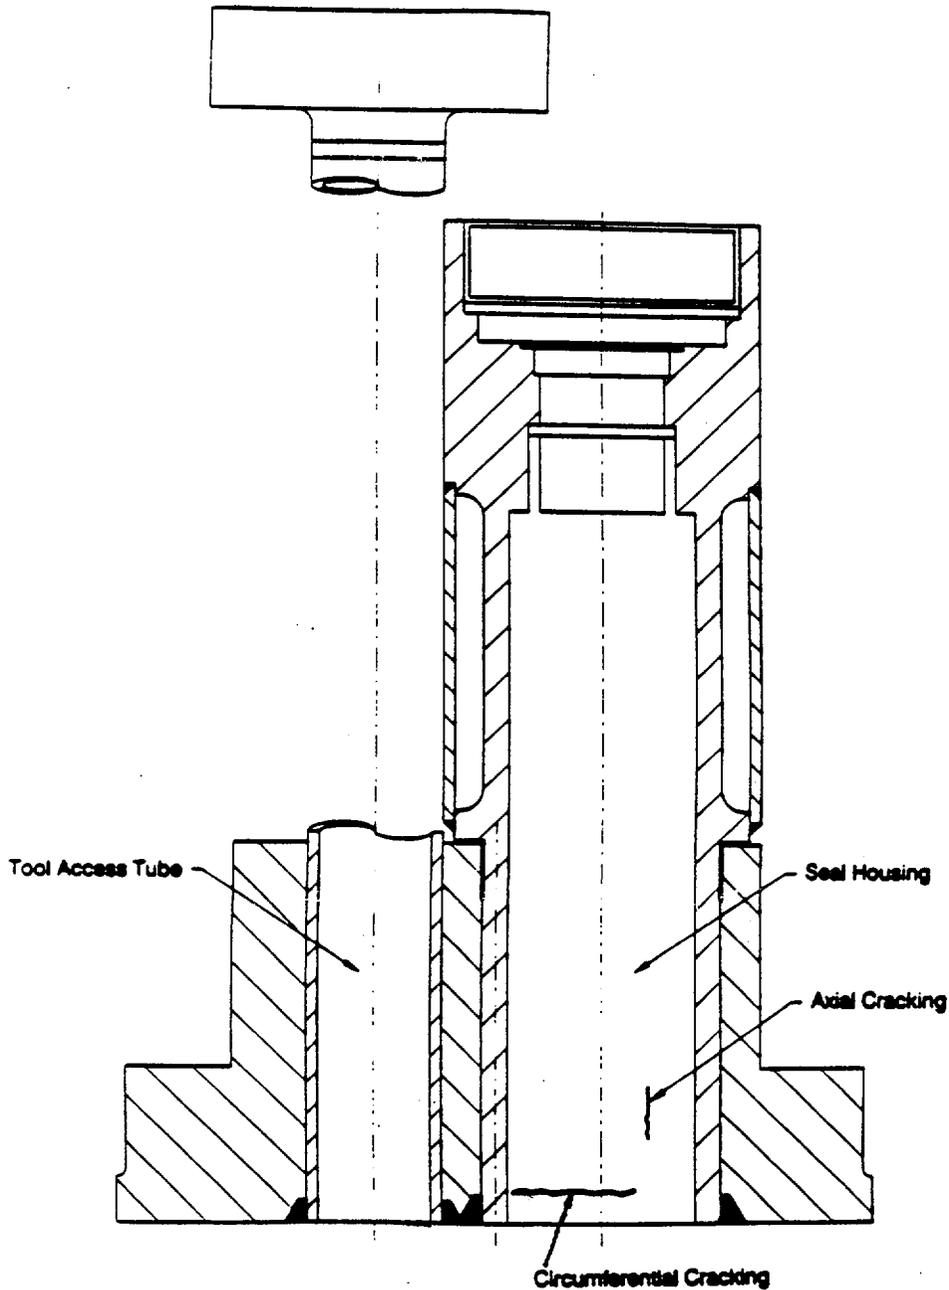
**FIGURE 1**

Each control rod at Palisades is driven by an electric motor through a drive shaft and bevel gears which engage a rack assembly coupled to the control rod. The drive shaft is offset from, and parallel to, the axis of its associated control rod. Figure 1 provides a sketch of the CRD seal housing assembly configuration. The primary coolant pressure boundary is provided by a rotating mechanical seal located at the top of the seal housing tube. The lower flange of the seal housing (autoclave flange) is fastened to the support tube with the autoclave nut. The lower region of the seal housing below the mechanical seal provides the primary coolant pressure boundary. The drive motor and clutch assembly mount on the atmospheric side of the mechanical seal at the top of the seal housing. The tool access tube penetrates the autoclave flange directly above the rack assembly. The tool access tube provides access for coupling and uncoupling rods, and is closed with a blank flange when the primary coolant system is filled.

**Control Rod Drive Seal Housing**
