SUBJECT: MEETING WITH EXELON REGARDING DRESDEN UNIT 2/3  
REACTOR BUILDING CRANE ISSUES

### May 23, 2001 Meeting Between NRC RIII and Exelon Generating Company Dresden Unit 2/3 Reactor Building Crane

Meeting with NRC  
Unit 2/3 Reactor Building Crane

Exelon Generation Company, LLC  
Dresden Nuclear Power Station  
May 23, 2001

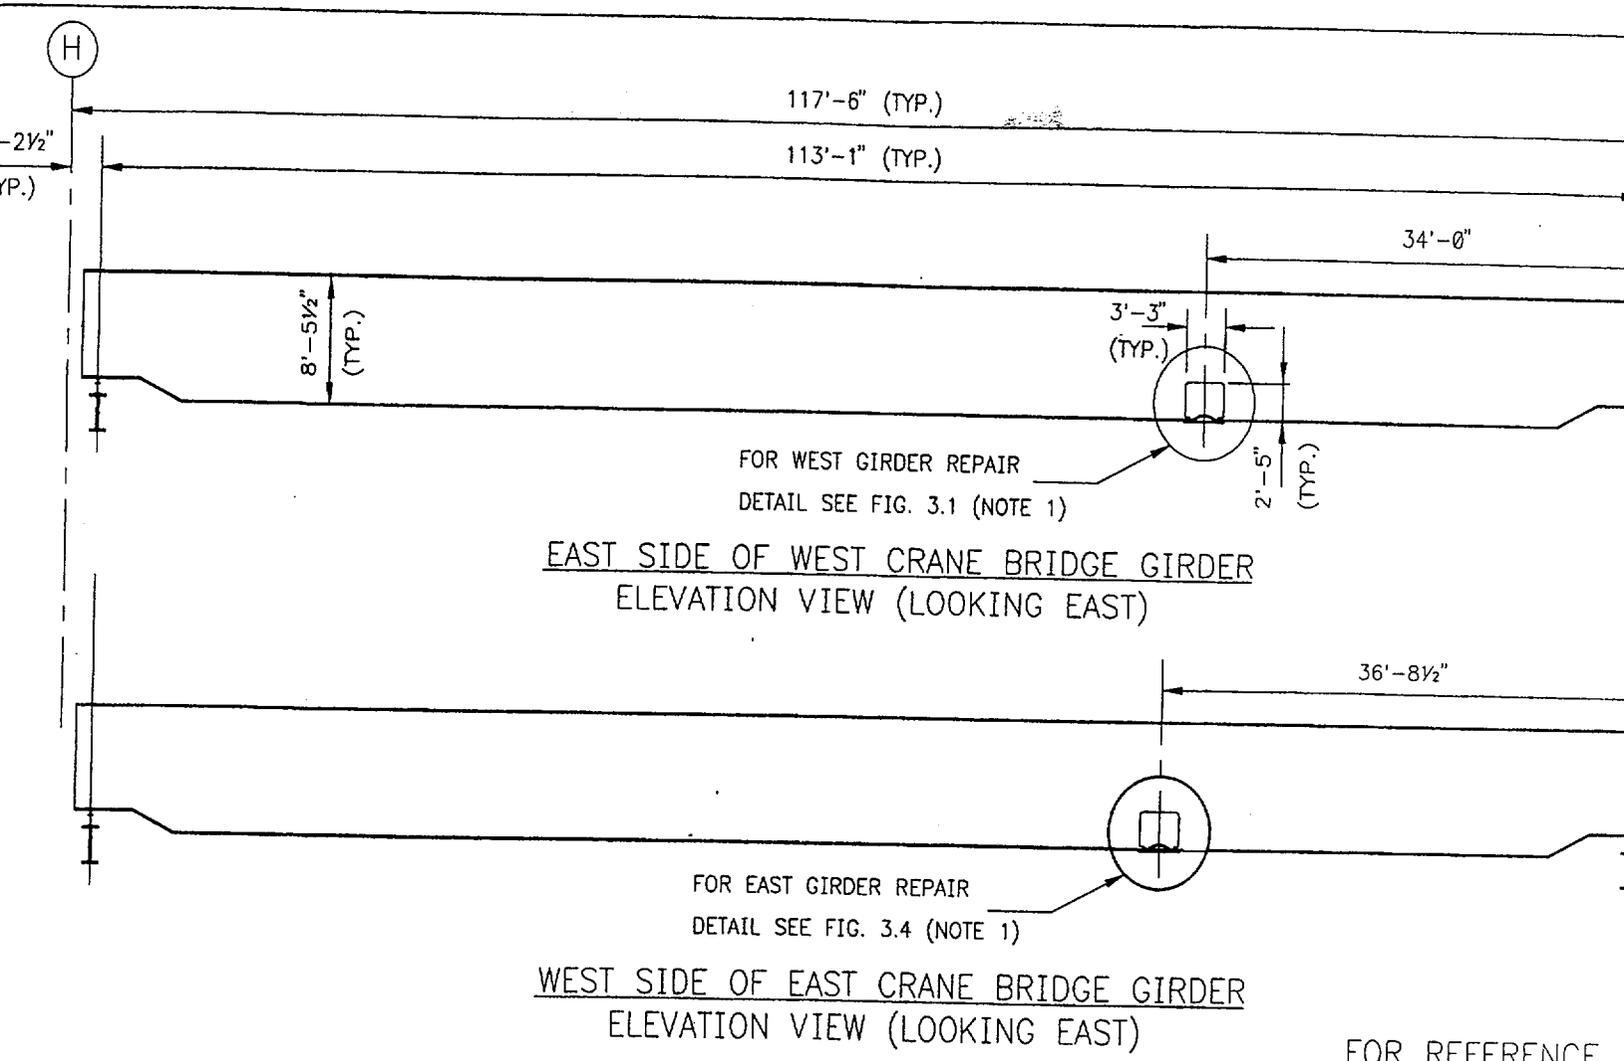
CRANE BRIDGE GIRDERS  
(LOCATION OF GIRDER REPAIR)

The implications of a 1981 incident were discussed. The Unit 2/3 reactor building crane was damaged in 1981, during a lift involving the reactor vessel head lift "strongback" (approximately a 10-ton load), when the strongback struck the under side of the crane bridge girders. The inside web and the bottom flange of each girder were deformed. The licensee presented information to support their view that the damage incurred and the repairs to restore the crane girders to "design" were not "extensive." This was an issue because ANSI/ASME B30.2.0 - 1967, to which the licensee was committed, specified a 125% rated load test be performed on "new, extensively repaired or altered" cranes.

Calculations were presented to define the "overstress" experienced by the girders. In that the licensing basis for the crane was Safety Class II, the licensee maintained that restoration of the crane was not mandatory by regulation. Rather, the restoration was to regain margin of safety which was established in beyond-design-basis calculations. Specifically, one girder was found to have experienced 22% overstress for OBE with full load. Thus, the margin represented in meeting a 0.6 Fy criterion was reduced, but all stresses were less than yield.

- Bottom of girders damaged by a 10 ton lifted load
- Damage affected 2' x 2'2" lower section of inside web and bent bottom flange on each girder (0.3% of total bridge girder surface area)

- Conservative analysis of damage without repair
  - Assumes damaged material removed and not replaced
  - All stresses less than yield; no permanent deformation
    - 22% overstress for OBE with full load ( $.6 F_y$ )
    - Within allowable for SSE with full load ( $.9 F_y$ )

The repair consisted of cutting out the deformed section of each girder web and welding a new plate over the area, and welding a plate over the deformed section of each flange. An expert consultant's assessment of the damage and the repair were presented in support of the licensee's position that the repairs were not "extensive."

- Repair was to cut out web plates and replace with cover plates along web and bottom flange in two girders
- Repaired girders are stronger than original
  - Welds visually inspected by QC inspector
- Function of crane unchanged
