Ref: University of California, Davis McClellan Nuclear Radiation Center (UCD/MNRC),  
Docket No. 50-607, Facility Operation License No. R-130

Subject: UCD/MNRC Annual Report for CY 2000

# 2000 ANNUAL REPORT

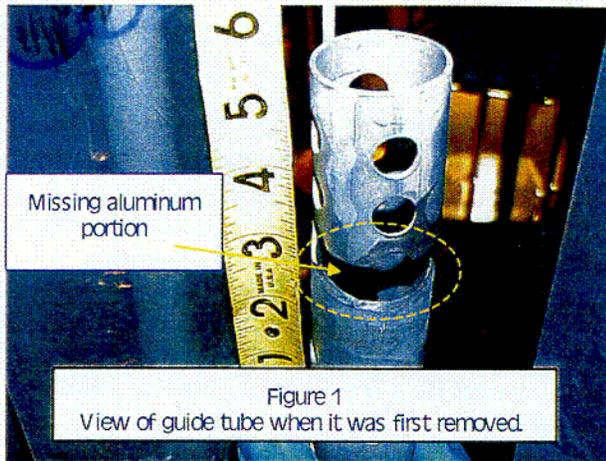
Figure 1  
 View of guide tube when it was first removed.

inspection and to remove the transient rod from the guide tube. Operations personnel noticed that a segment of the guide tube was missing (Figure 1). The missing segment is approximately two inches from the top; ½ inches wide and extended approximately half way around the circumference of the guide tube.

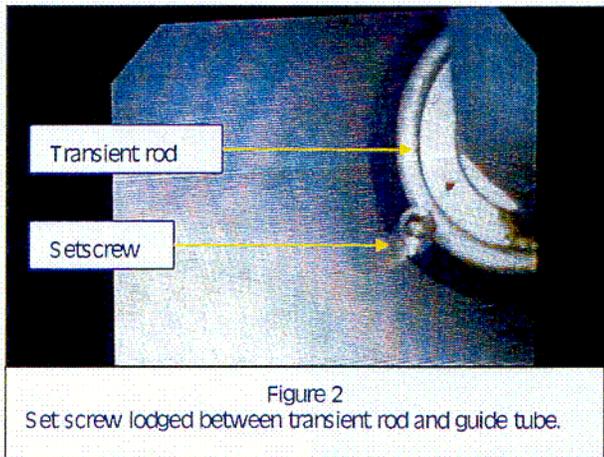
Operations personnel attached a ¼ inch threaded rod through the Teflon piston and into the lower connecting rod. As they attempted to remove the transient rod from the guide tube, it became apparent the transient rod was stuck in the guide tube. The Reactor Manager instructed operations personnel to cut the guide tube approximately two inches below the Teflon piston and insert a fiber optics camera down the guide tube to see if anything was jamming the transient rod in the guide tube.

Figure 2  
 Set screw lodged between transient rod and guide tube.

When operations personnel cut and removed the upper portion of the guide tube they discovered that two setscrews were missing.

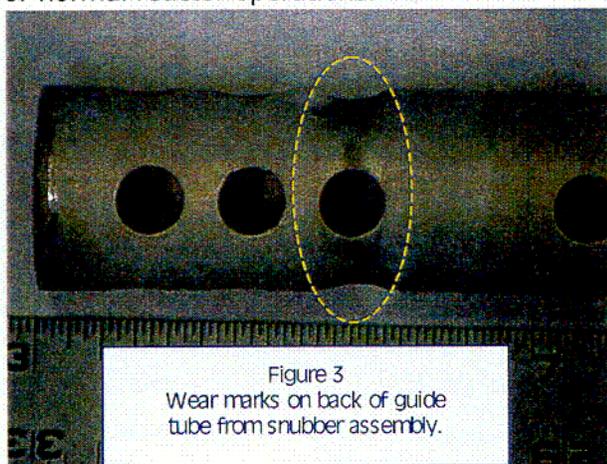
Figure 3  
 Wear marks on back of guide tube from snubber assembly.

On a closer inspection of the guide tube, the back (Figure 3) shows wear marks that closely match the inlet bevel of the snubber. On the left side, view (Figure 4) one can observe a beveled line on the cut through the guide tube. This appears to be caused by vibration between the guide tube and the snubber assembly. The vibrations are either from the natural harmonics of the reactor structure or water from the <sup>16</sup>N

diffuser causing lateral movement between the guide tube and snubber. The latter seems more likely as the guide tube bent towards one of the <sup>16</sup>N diffuser discharge nozzles and the missing section of guide tube is on the opposite side as one of the <sup>16</sup>N diffuser discharge nozzles.

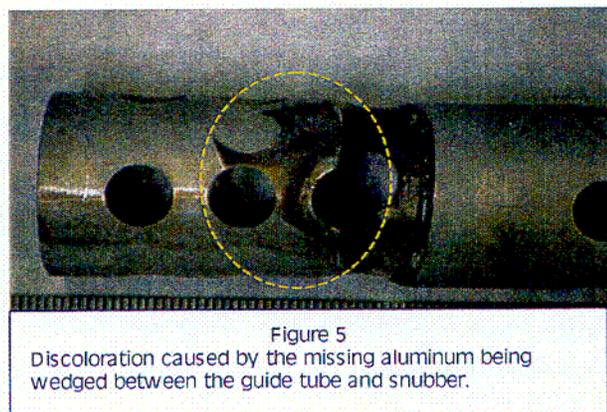
Figure 5  
 Discoloration caused by the missing aluminum being wedged between the guide tube and snubber.

Figures 5 and 6 (front and right sides of guide tube) clearly show the missing piece of aluminum. This piece of aluminum could not be located in the reactor tank. Discoloration on the guide tube shows where the missing aluminum had, at some point in time, peeled in an upward direction and lodged between the guide tube and the snubber. This could be a result of the August 1999 fuel
