| CENTRAL LABORATORIES SERVICES TECHNICAL REPORT | | Report No. | 95-1021 |
| Plant/Project: | Watts Bar Nuclear Plant | | |
| Subject: | ICE CONDENSER BASKET SCREWS | | |

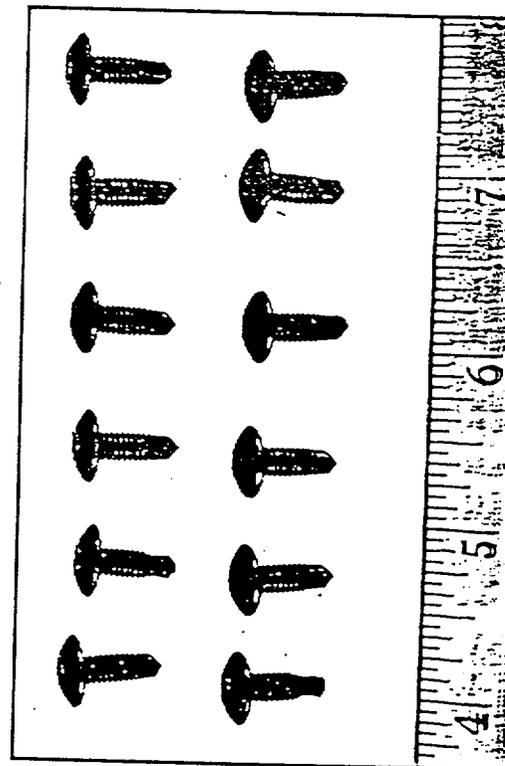
Figure 1:

- Set "A": Ten fractured screw heads, seen in the upper left view of Figure 1, and one new screw (not shown).
- Set "B": Twelve new screws, seen in the upper right view of Figure 1.
- Set "C": Two screws removed from service, labeled "Bay '24' Top Ring D-6".
- Set "D": Two screws removed from service, labeled "Bay '24' Bottom Ring D-6".
- Set "E": Two screws removed from service, labeled "Bay '12' Top Ring A-6".
- Set "F": Two screws removed from service, labeled "Bay '12' Bottom Ring A-6".
- Set "G": Two screws removed from service, labeled "Bay '1' Top Ring A-6".
- Set "H": Two screws removed from service, labeled "Bay '1' Bottom Ring A-6".

Left: As-received photograph of the fractured screws (set "A"). Note that the unfractured screw from this set is not shown. Right: As-received photograph of the new screws (set "B").

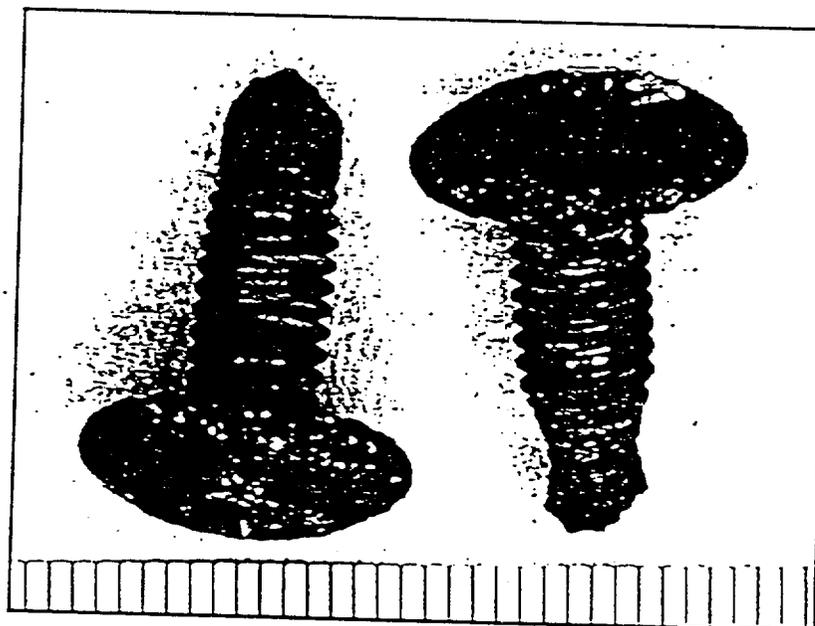
All screws removed from service had varying amounts of corrosion products on them, mostly in the threaded region. The lower view of Figure 1 shows a typical set of screws that were removed from service. The customer indicated that the screws were cyclically cooled and warmed between 15°F and room temperature. The customer also indicated that the screws were probably over-torqued when installed.

As-received photograph of a typical pair of used screws. Note that each set of used screws (set "C" through set "H") varied in degree of corrosion.

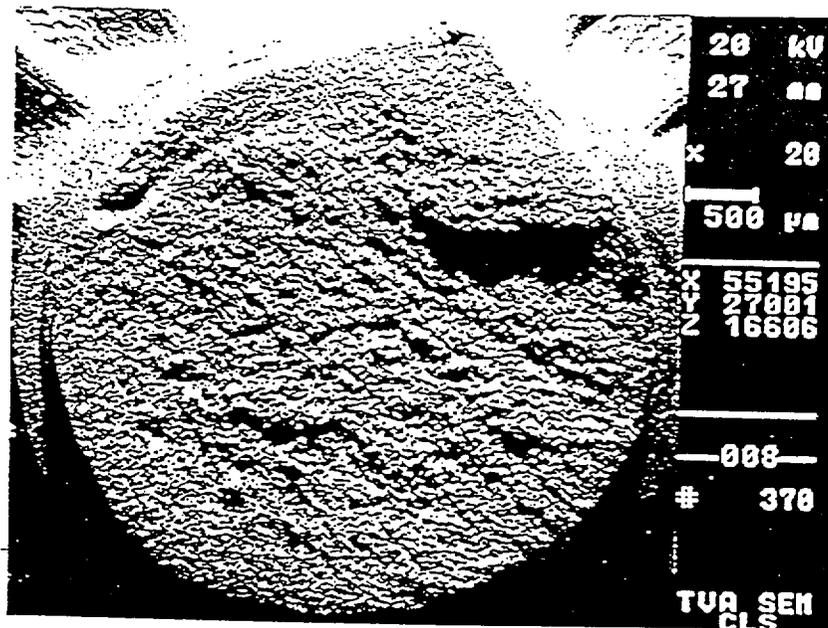
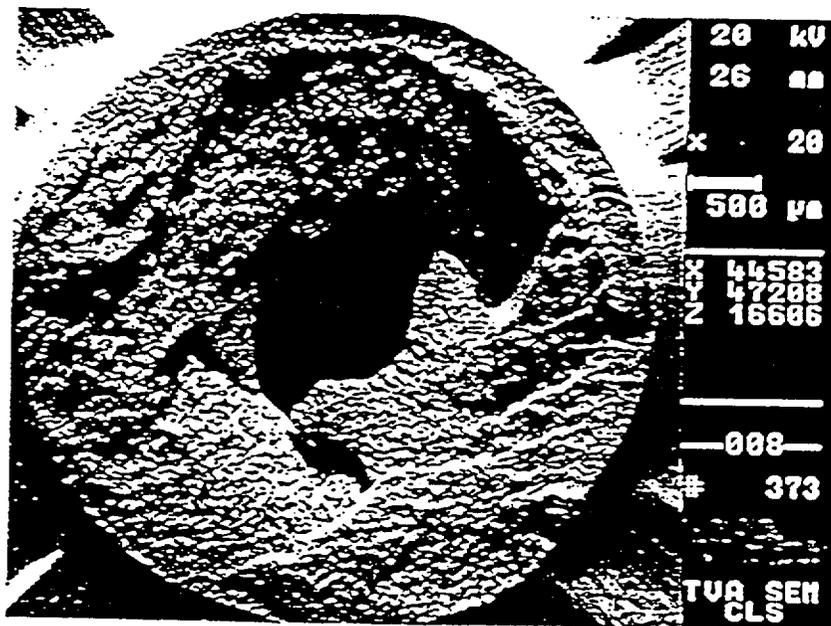
Figure 2:

All of the fractured screws received in set "A" were examined in a Scanning Electron Microscope (SEM) in order to determine the mode of failure. Figures 2 and 3 show that the screws fractured in a brittle manner as indicated by the intergranular failure mode seen on all screws examined. There was usually a small final-fracture area on the fracture surface near the center of the shank that failed in a ductile manner.

SEM photographs of typical fracture surfaces taken from fractures screws (set "A"). Note that all fractured screws received in set "A" failed in a brittle manner (except for the small final fracture area near the center which failed in a ductile manner). 20X.

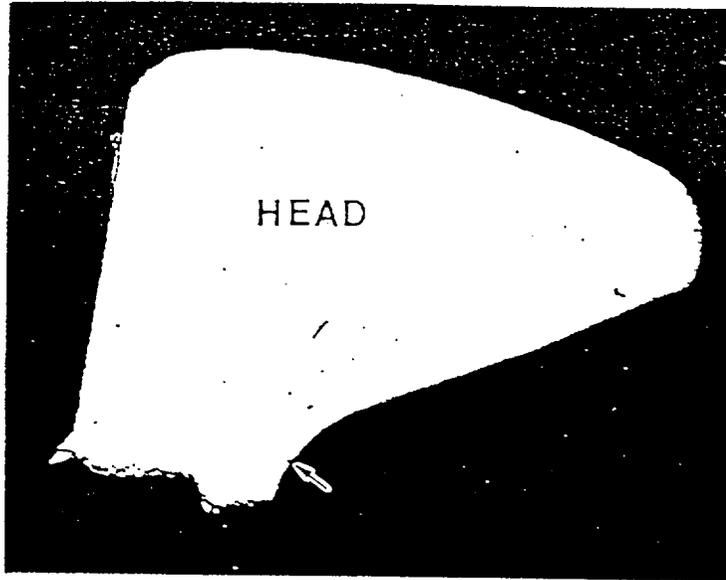
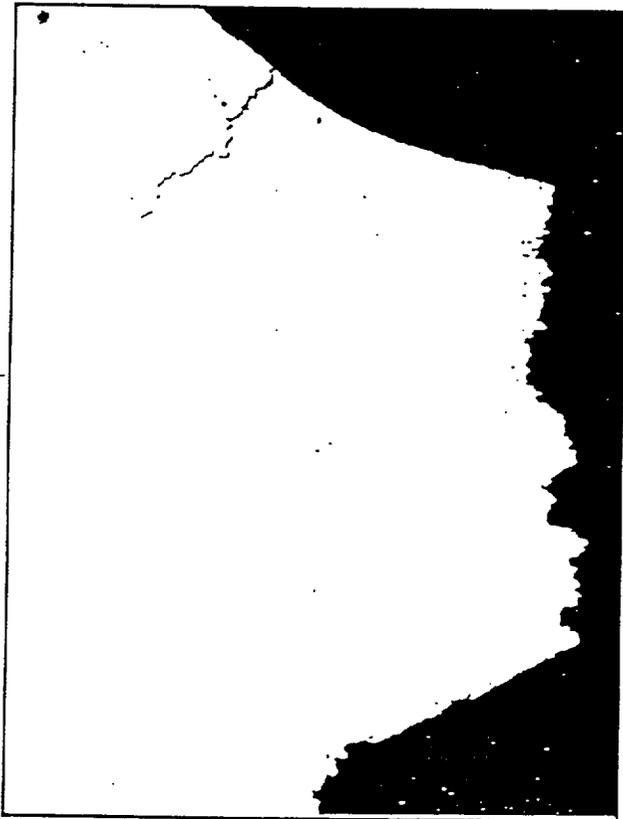
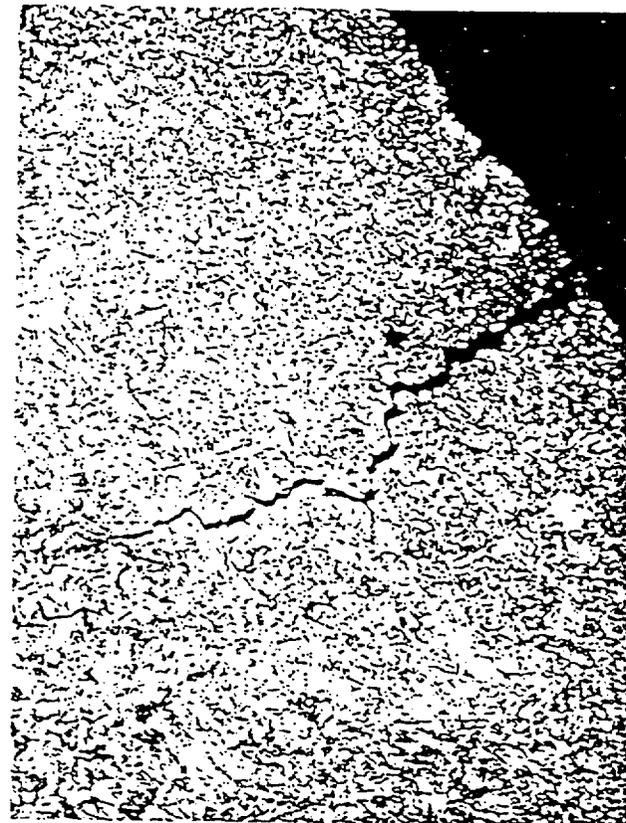
Figure 4:

An arbitrarily selected fractured screw from set "A" was cut so that a longitudinal cross-section through the fracture surface could be examined (as seen in Figure 4). Note that a secondary crack was noticed above the fracture surface. Closer examination of this crack revealed that it traveled in an intergranular manner. A screw that was removed from service (set "G") was similarly sectioned as seen in Figure 5. Note that two cracks were found in adjacent tooth roots. Similar cracks were discovered in the new screw received in set "A" and in the transverse section of a new screw sample examined from set "B" (see Figure 7). EDX analysis

of the crack revealed the presence of zinc (see Table I) indicating that the crack may have been present prior to plating (possibly formed when quenched during the manufacturer's heat treatment).

Longitudinal cross section through a fractured screw. The arrow points to a secondary crack above the fracture surface. 20X. As-polished.

Close-up views of secondary crack seen in the upper view of this Figure. Left: As-polished, 125X; Right: Vilella's etch, 400X.

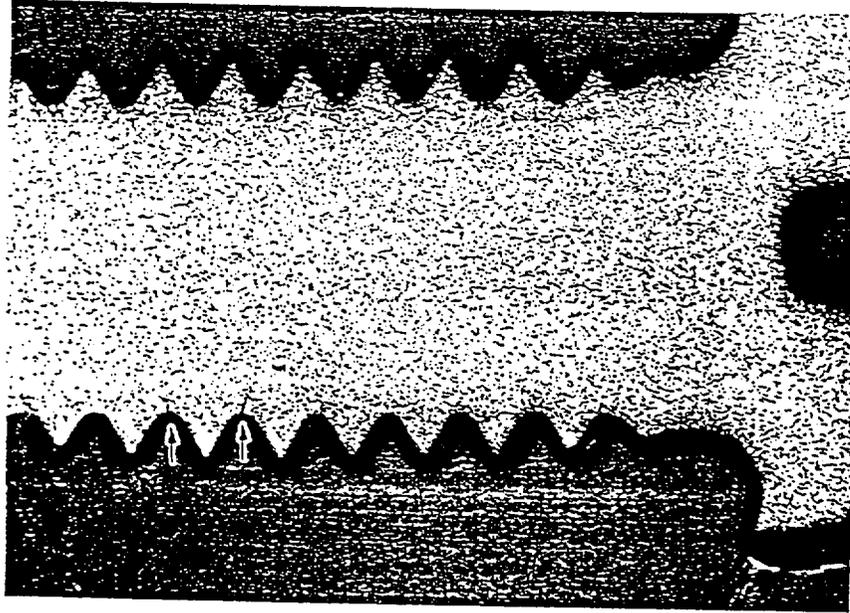
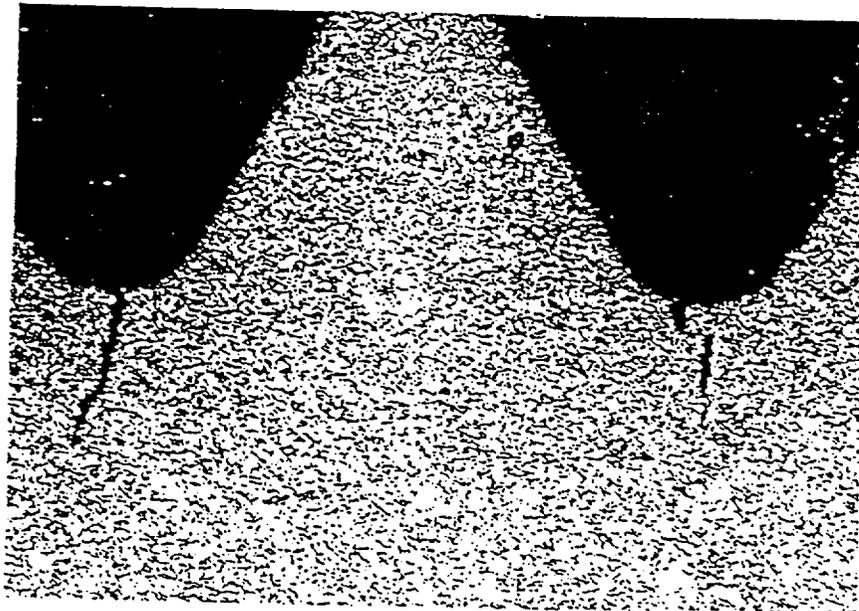
Figure 5: Ice Condenser Basket Screws, Watts Bar Nuclear Plant, Unit No. 1. Customer Identification No. 95-07, Laboratory Report No. 95-1021.

Longitudinal view of cracks present in one of the screws that were removed from service in set "G". Top: 12X; Bottom: 100X.

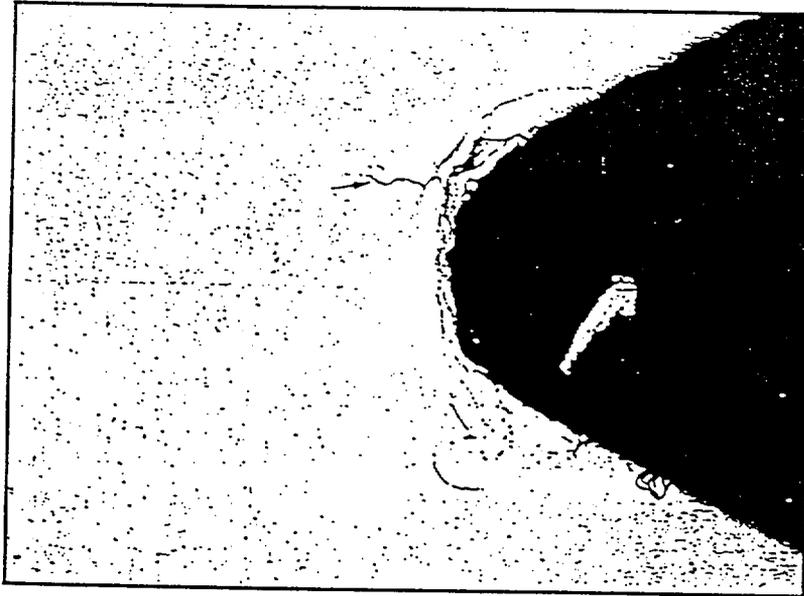
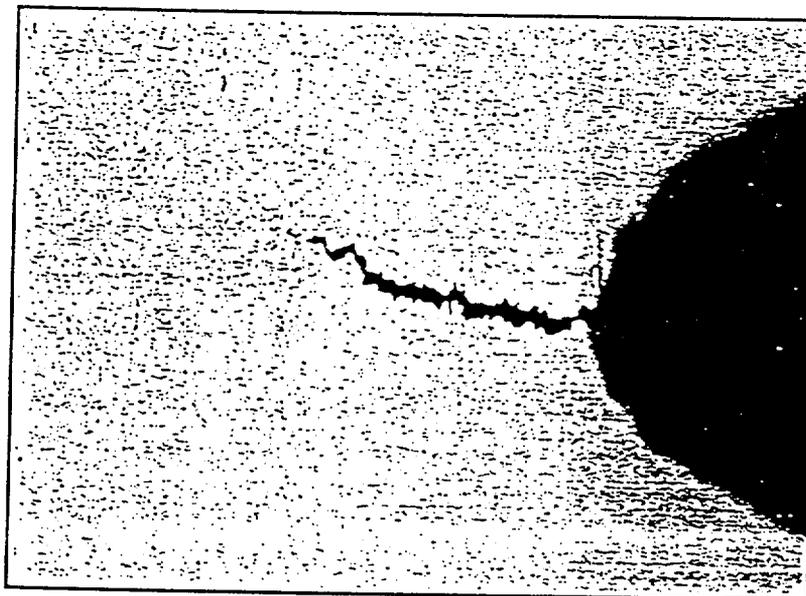
All screws examined had lapping from the thread-rolling process in the pitch, face, and root vicinities (see upper view of Figure 6). Lapping at the roots of the threads would be undesirable due to the fact that this is usually an area of high stress, and the lapping may initiate a fatigue crack. The lower view of Figure 6 shows a crack at a tooth root of one screw that was removed from service (set "G") that may have propagated by intergranular fatigue. Note that similar cracks were found both in the new and used screws (see Figure 7).

As-polished, longitudinal view of lapping present at tooth root of a screw that was removed from service in set "G". 200X.

As-polished, longitudinal view of crack present at tooth root of a screw that was removed from service in set "G". 200X.

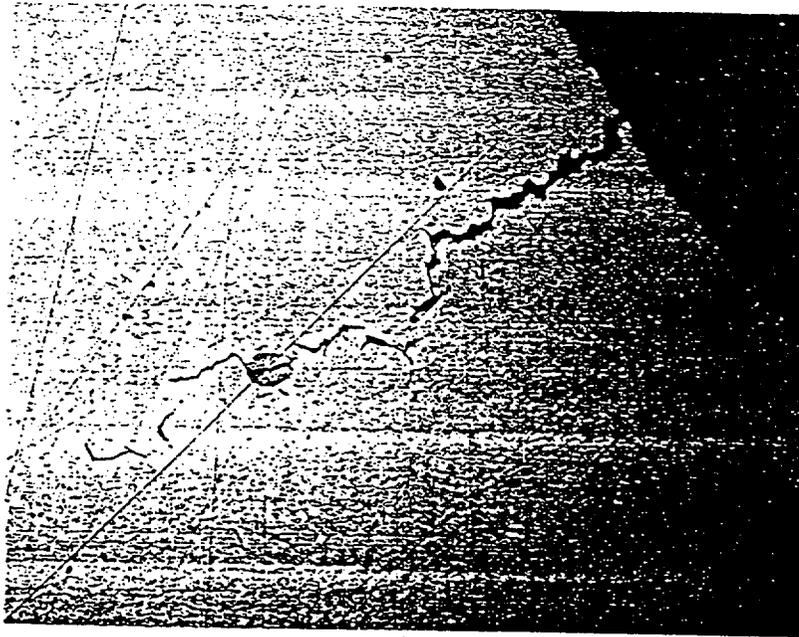
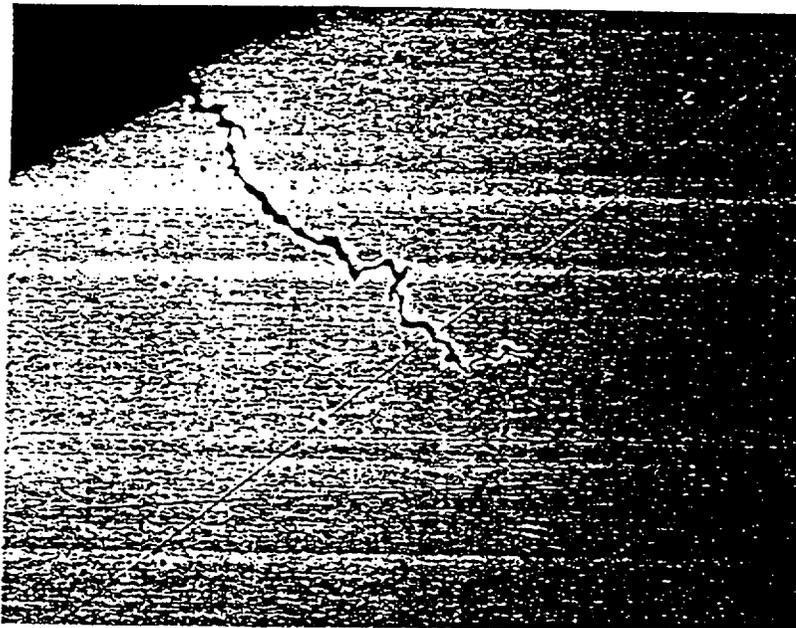
Figure 7:

As-polished, longitudinal view of crack present in shank, near head of a screw that was fractured in set "A" (see Figure 4). 400X.

As-polished, transverse view of crack present in a new screw that was received in set "B". 400X.

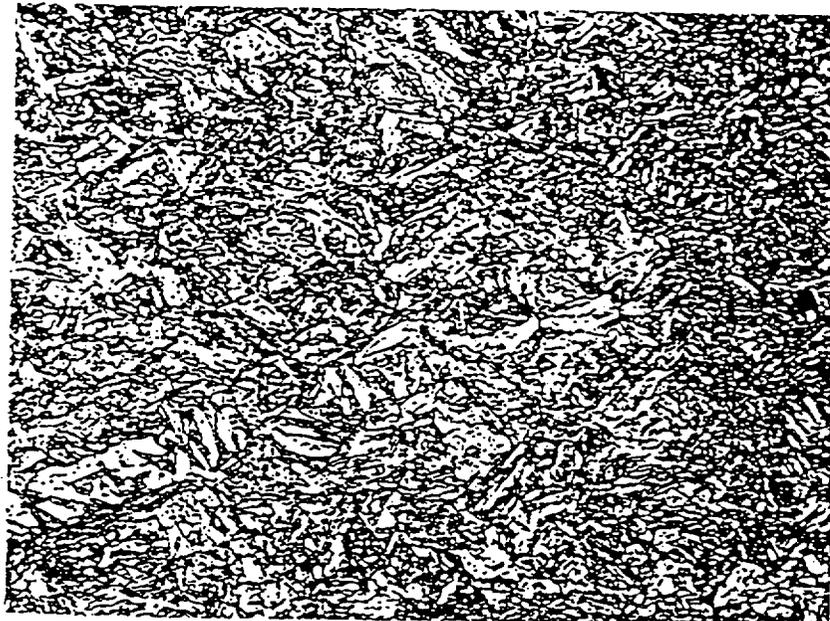
Figure 10: Ice Condenser Basket Screws, Watts Bar Nuclear Plant, Unit No. 1. Customer Identification No. 95-07. Laboratory Report No. 95-1021.

The general microstructure of all screws was determined to be tempered martensite (see Figures 10 and 11). Note that the hardness of martensite is determined by carbon content, thus the used screws with higher carbon contents (except set "H") were harder than the new screws with lower carbon contents (the hardness values of screws in set "H" were not obtained due to lack of time).

General microstructure of a typical new screw: tempered martensite. Top: 100X; Bottom: 500X.

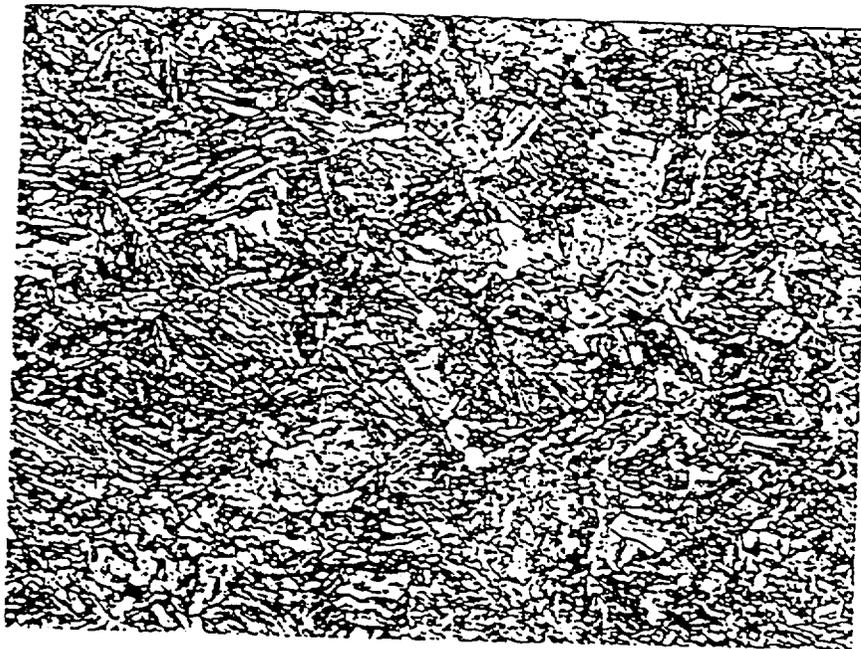
Figure 11: Ice Condenser Basket Screws, Watts Bar Nuclear Plant, Unit No. 1. Customer Identification No. 95-07, Laboratory Report No. 95-1021.

General microstructure of a typical screw that was removed from service in set "G": tempered martensite. Note microstructure was similar for screws in each set that was removed from service. Top: 100X; Bottom: 500X.
