CENTRAL LABORATORIES SERVICES TECHNICAL REPORT	Report No.	95-1021
	Sheet No.:	1 of 2
	Date of Report:	JUN 19 1995
Plant/Project:	Watts Bar Nuclear Plant	
Subject:	ICE CONDENSER BASKET SCREWS	
Standards Used:	904694, 901387, 516825	
Copies Sent to:	Vonda Sisson, IOB 1M-WBN (4); RIMS; Lab Files	
Prepared by:	Daryl A. Smith / LAB	Approved by: <i>Deisa L. Frazier</i>

Ice Condenser Basket Screws, Watts Bar Nuclear Plant, Unit No. 1. Customer Identification No. 95-07, Laboratory Report No. 95-1021.

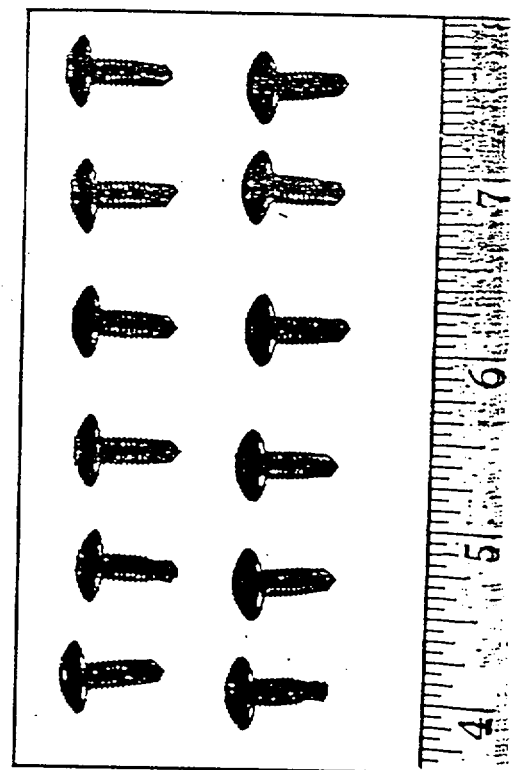
Figure 1:

- Set "A" : Ten fractured screw heads that were in service (seen in the upper left view of Figure 1) , and one whole screw that was not in service (not shown).
- Set "B" : Twelve new screws, seen in the upper right view of Figure 1.
- Set "C" : Two screws removed from service, labeled "Bay '24' Top Ring D-6".
- Set "D" : Two screws removed from service, labeled "Bay '24' Bottom Ring D-6".
- Set "E" : Two screws removed from service, labeled "Bay '12' Top Ring A-6".
- Set "F" : Two screws removed from service, labeled "Bay '12' Bottom Ring A-6".
- Set "G" : Two screws removed from service, labeled "Bay '1' Top Ring A-6".
- Set "H" : Two screws removed from service, labeled "Bay '1' Bottom Ring A-6".

Left: As-received photograph of the fractured screws (set "A"). Note that the unfractured screw from this set is not shown. Right: As-received photograph of the new screws (set "B").

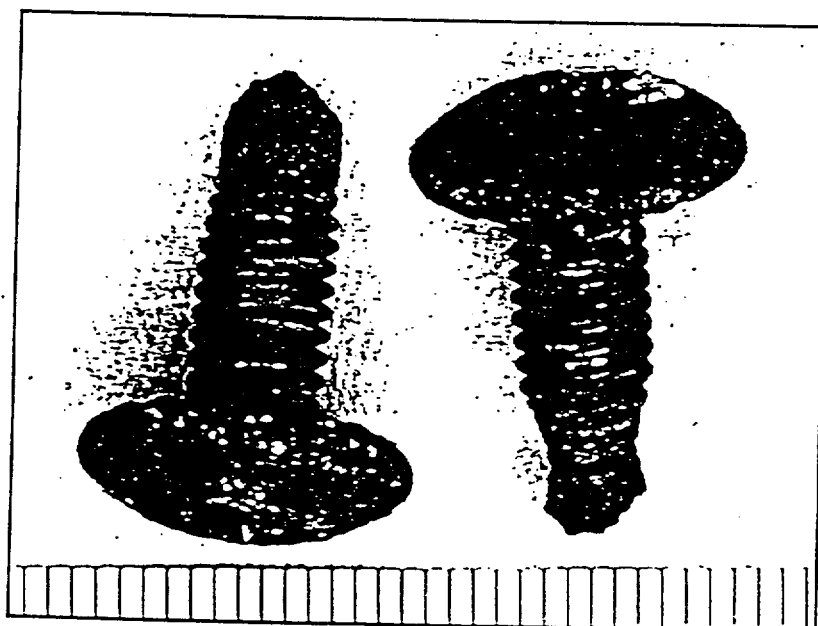
All screws removed from service had varying amounts of corrosion products on them, mostly in the threaded region. The lower view of Figure 1 shows a typical set of screws that were removed from service.

As-received photograph of a typical pair of used screws. Note that each set of used screws (set "C" through set "H") varied in degree of corrosion.

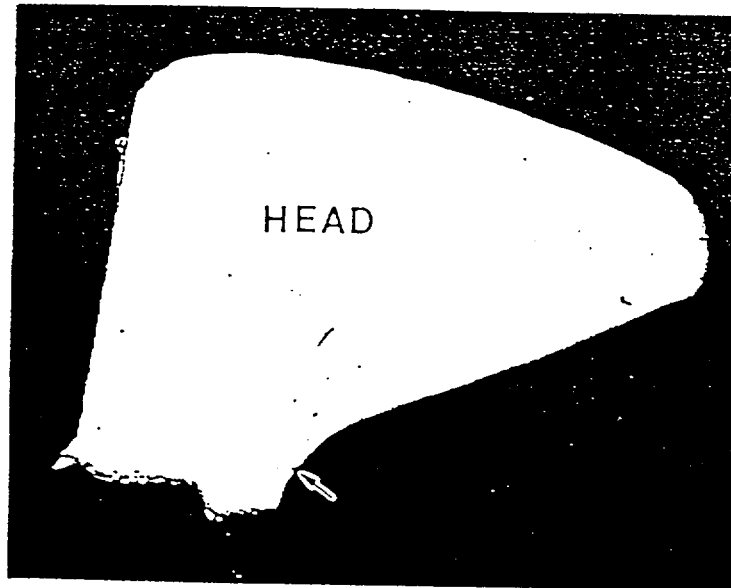
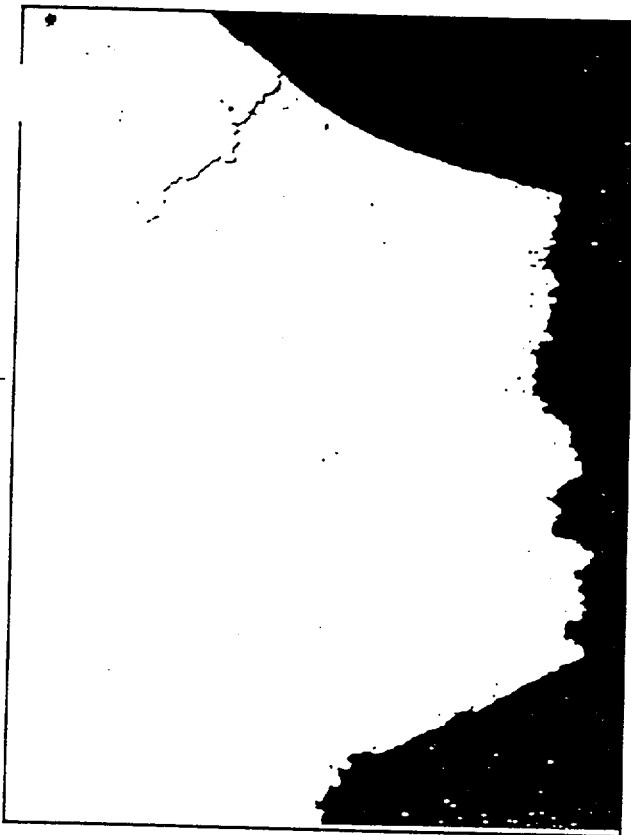
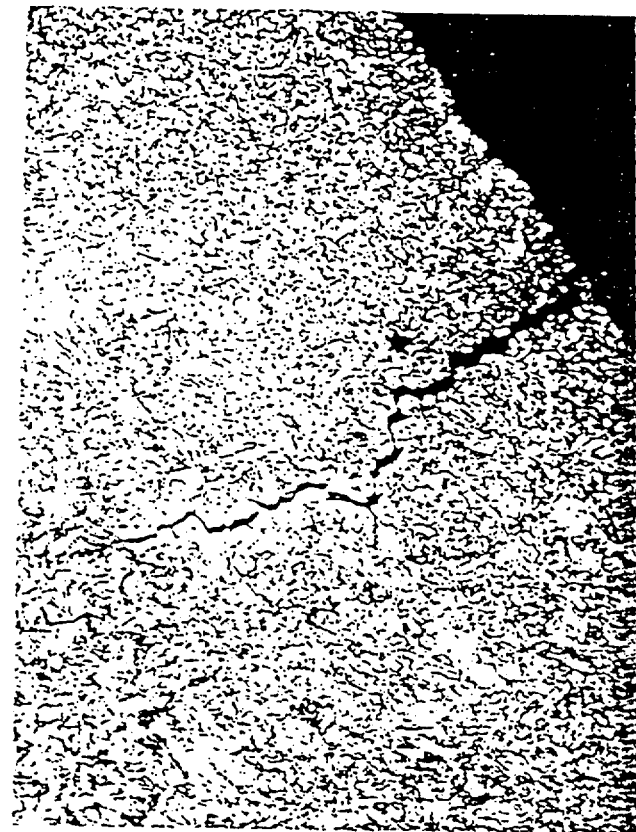
Figure 4:

An arbitrarily selected fractured screw (that was in service) from set "A" was cut so that a longitudinal cross-section through the fracture surface could be examined. Note that a secondary crack of intergranular nature was noticed above the fracture surface as seen in Figure 4. A screw from set "G" was similarly sectioned, and two cracks were found in adjacent thread roots as seen in Figures 5 and 6. Similar intergranular cracks were discovered in a transverse section of the whole screw from set "A" and at the thread roots of a screw from set "H" (Figure 7).

Screws from sets "C", "G", and "H" contained intergranular cracks similar to those seen in Figures 5, 6, and 7. Note that the intergranular crack found in a representative sample taken from a fractured screw in set "A" seen in Figure 4 differed from the intergranular cracks seen in Figures 5 through 7 because it was probably a secondary crack (since it is above the primary fracture and perpendicular to the curved neck of the screw rather than at the thread roots).

Longitudinal cross section through a fractured screw. The arrow points to a secondary crack above the fracture surface. 20X. As-polished.

Close-up views of secondary crack seen in the upper view of this Figure. Left: As-polished, 125X; Right: Vilella's etch, 400X.

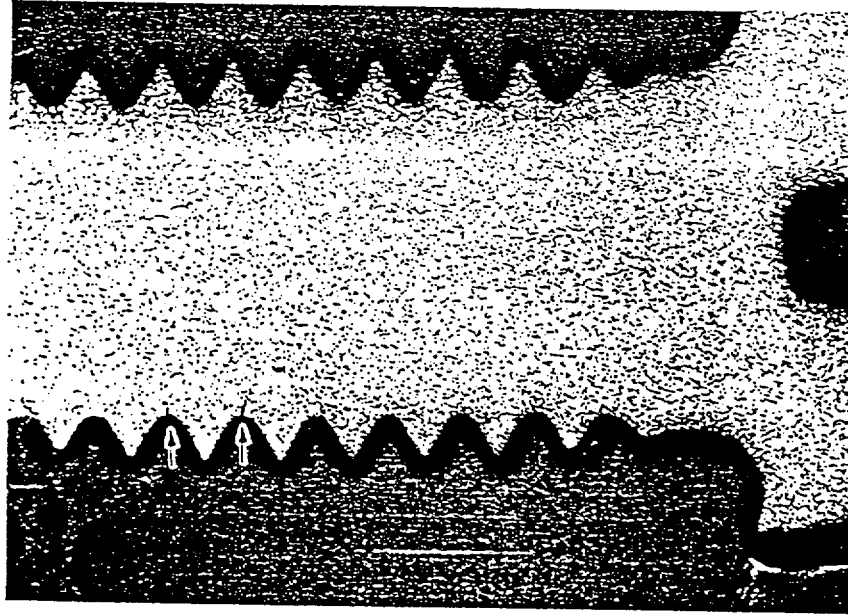
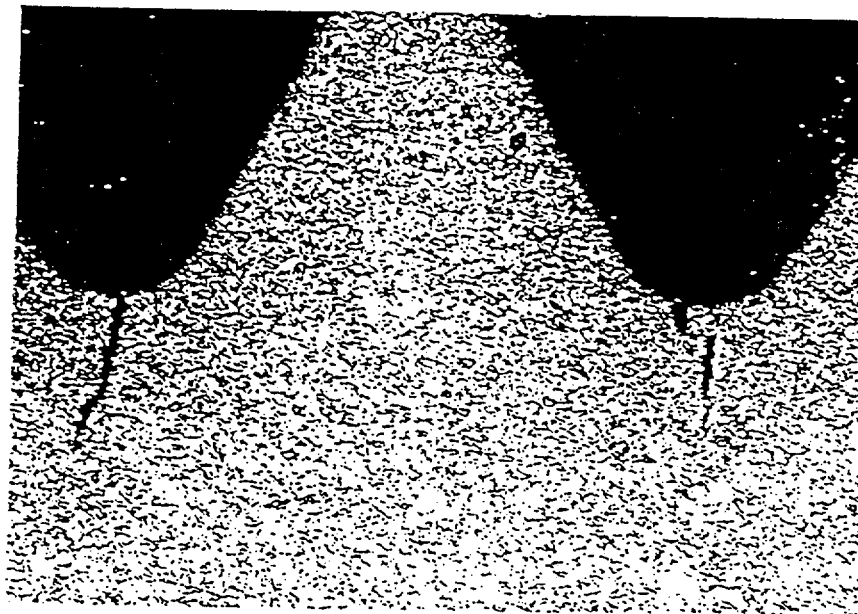
Figure 5:

Longitudinal view of cracks present in one of the screws that were removed from service in set "G". Top: 12X; Bottom: 100X.

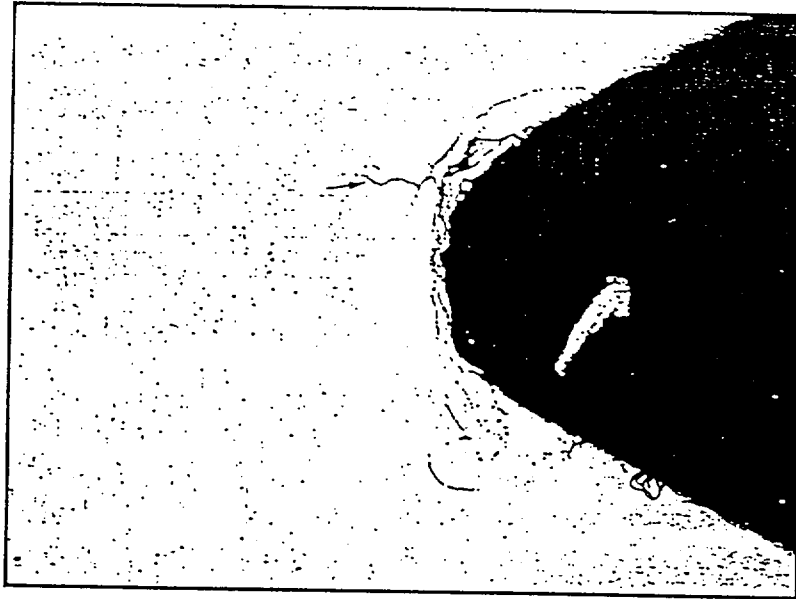
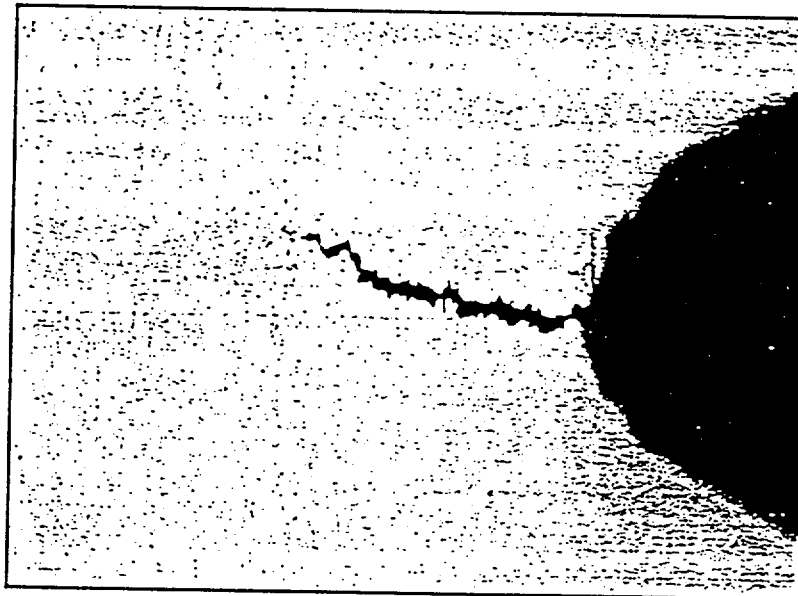
Figure 6:

EDX* analysis of the material in one of the cracks seen in the longitudinal cross section of a screw from set "G" revealed the presence of zinc as seen in Table I. Note in the upper view of Figure 6 that a lapped area was present at the thread roots of a screw from set "G". Similar lapped regions were discovered at the tip, face, and roots of every screw that was examined and is typical of the thread rolling process.

As-polished, longitudinal view of lapping present at tooth root of a screw that was removed from service in set "G". 200X.

As-polished, longitudinal view of crack present at tooth root of a screw that was removed from service in set "G". 200X.

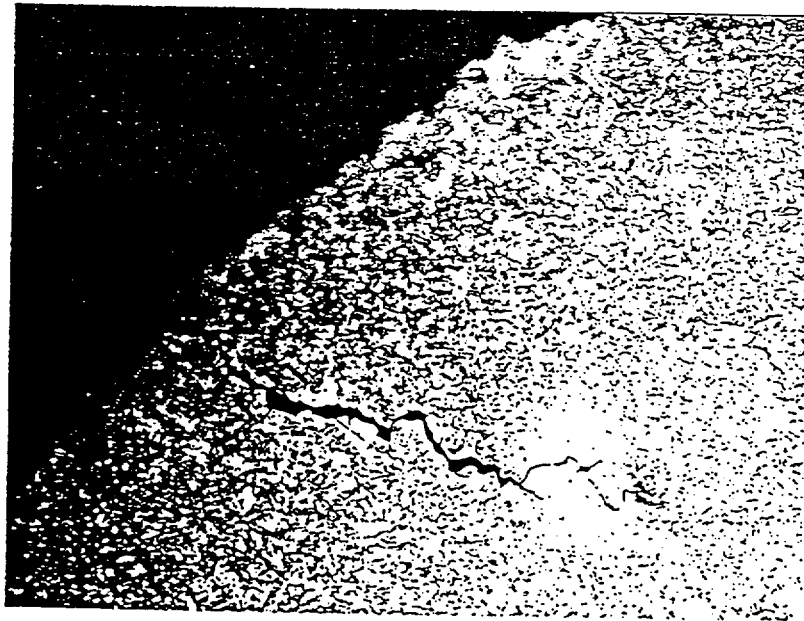
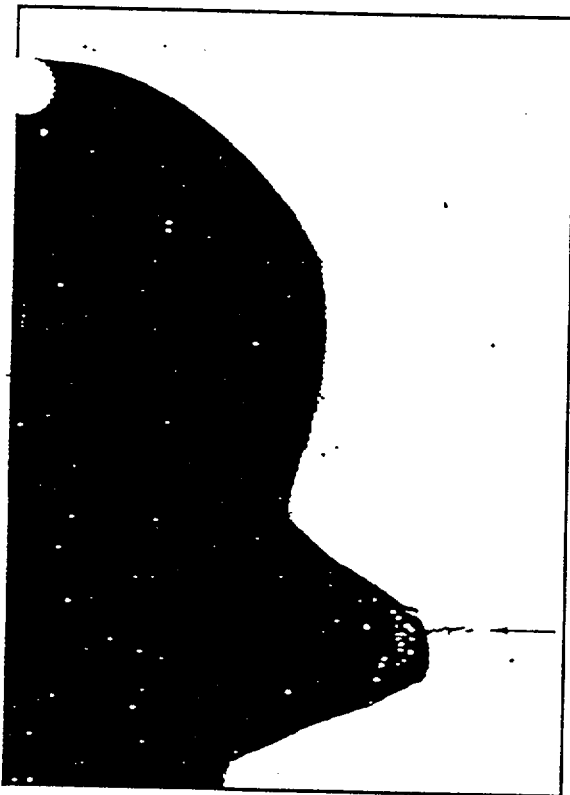
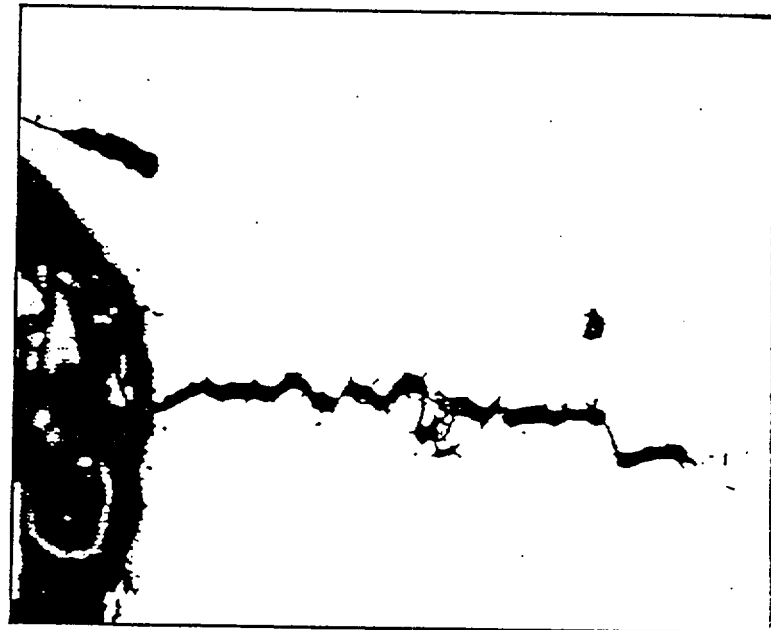
Figure 7:

Transverse cross-sectional view of a crack present in the screw that was not in service from set "A". 400X. Vilella's etch.

Intergranular crack found at thread root of first thread below head in a longitudinal cross section of a screw that was removed from service in set "H". Left: 50X; Right: 500X. As-polished condition.

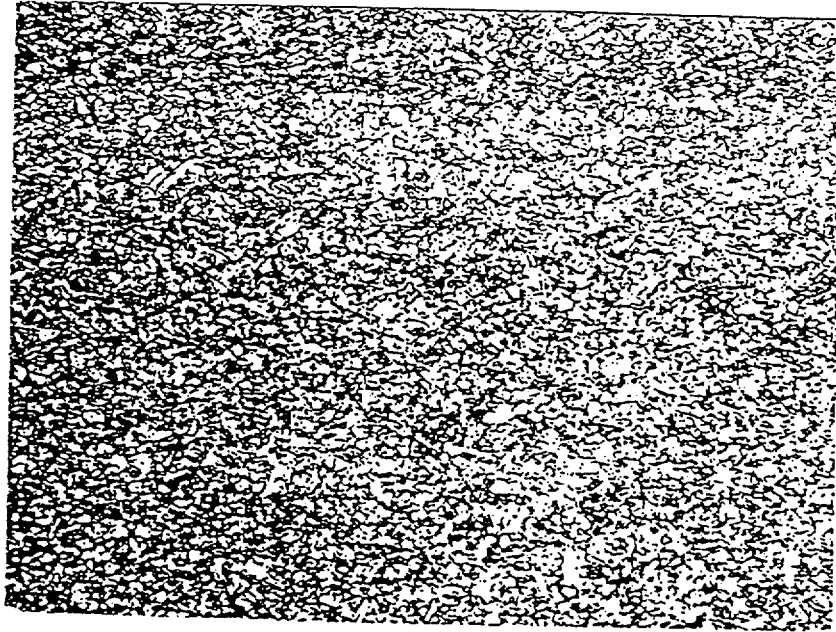
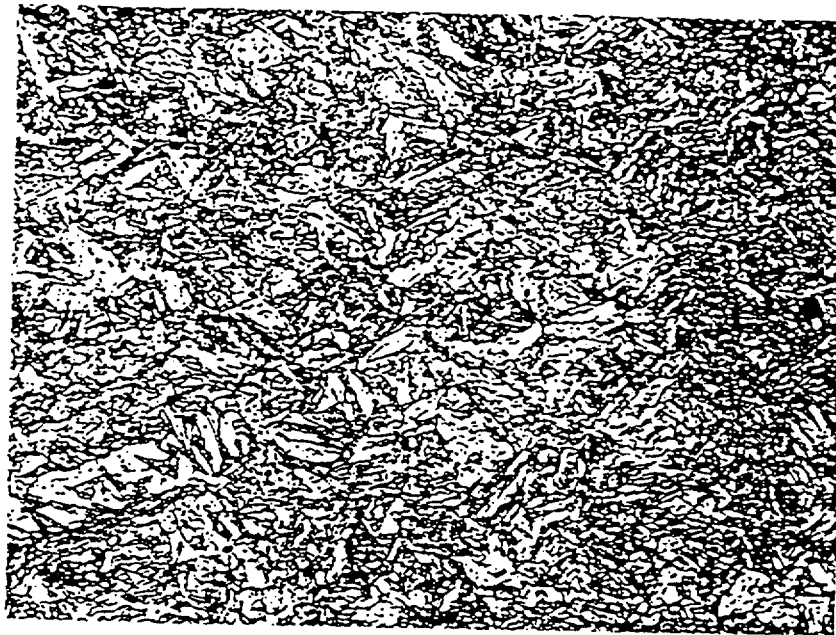
Figure 10: Ice Condenser Basket Screws, Watts Bar Nuclear Plant, Unit No. 1. Customer Identification No. 95-07, Laboratory Report No. 95-1021.

The general microstructure of representative screws from each set was determined to be tempered martensite (see Figures 10 and 11). Note in Figure 12 that slack-quenched areas consisting of ferrite networks on prior-austenite grain boundaries in a matrix of intermediate transformation products was discovered near the thread roots of four new screws from set "B" and one screw from set "H". The screw samples from set "G" were destroyed for other testing and could not be checked for the presence of the slack-quenched microstructure.

General microstructure of a typical new screw: tempered martensite. Top: 100X; Bottom: 500X.

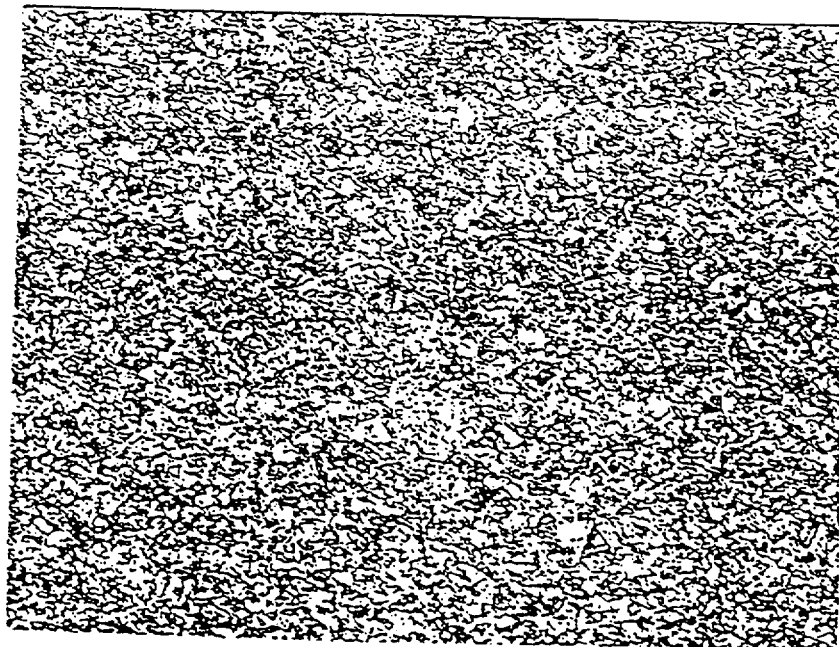
Figure 11: Ice Condenser Basket Screws, Watts Bar Nuclear Plant, Unit No. 1. Customer Identification No. 95-07, Laboratory Report No. 95-1021.

General microstructure of a typical screw that was removed from service in set "G": tempered martensite. Note microstructure was similar for screws in each set that was removed from service. Top: 100X; Bottom: 500X.

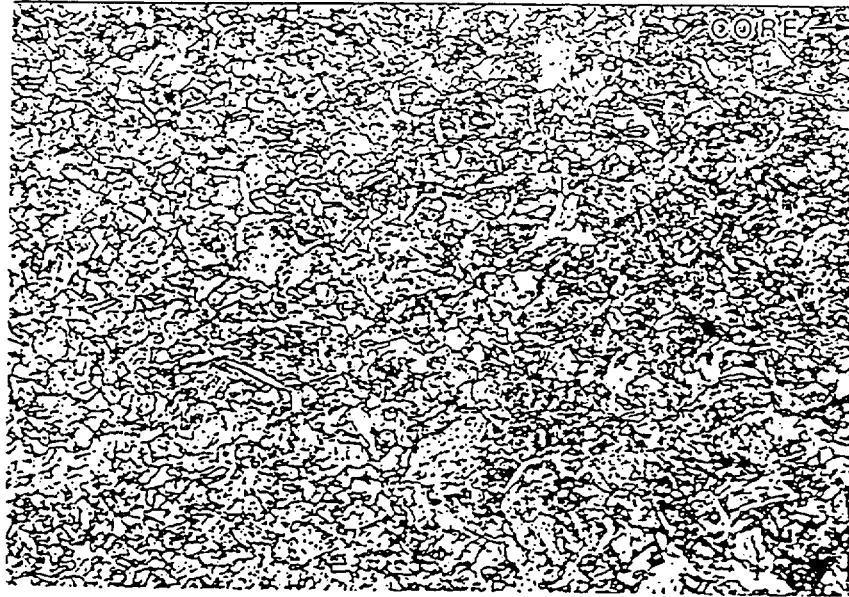
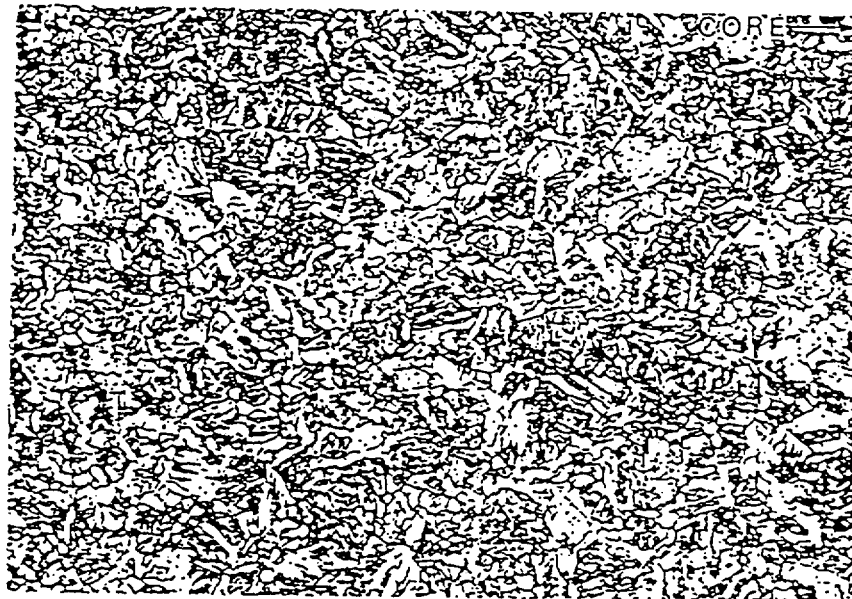
Figure 12: Ice Condenser Basket Screws, Watts Bar Nuclear Plant, Unit No. 1. Customer Identification No. 95-07, Laboratory Report No. 95-1021.

Slack-quenched areas near thread roots consisting of pro-eutectoid ferrite on prior-austenite grain boundaries in a matrix of intermediate transformation products. Top: Longitudinal cross section of a new screw from set "B". Bottom: Longitudinal cross section of a screw removed from service in set "H". 500X. 2% nital etch.
