**CORRECTIVE ACTION
DOCUMENT
CLOSURE PACKAGE**

TRACKING NO: WBPER950246 R0

Figure 1 - Ice Condenser Basket Screws, Watts Bar Nuclear Plant, Unit No. 1. Customer Identification No. 95-07. Laboratory Report No. 95-1021.

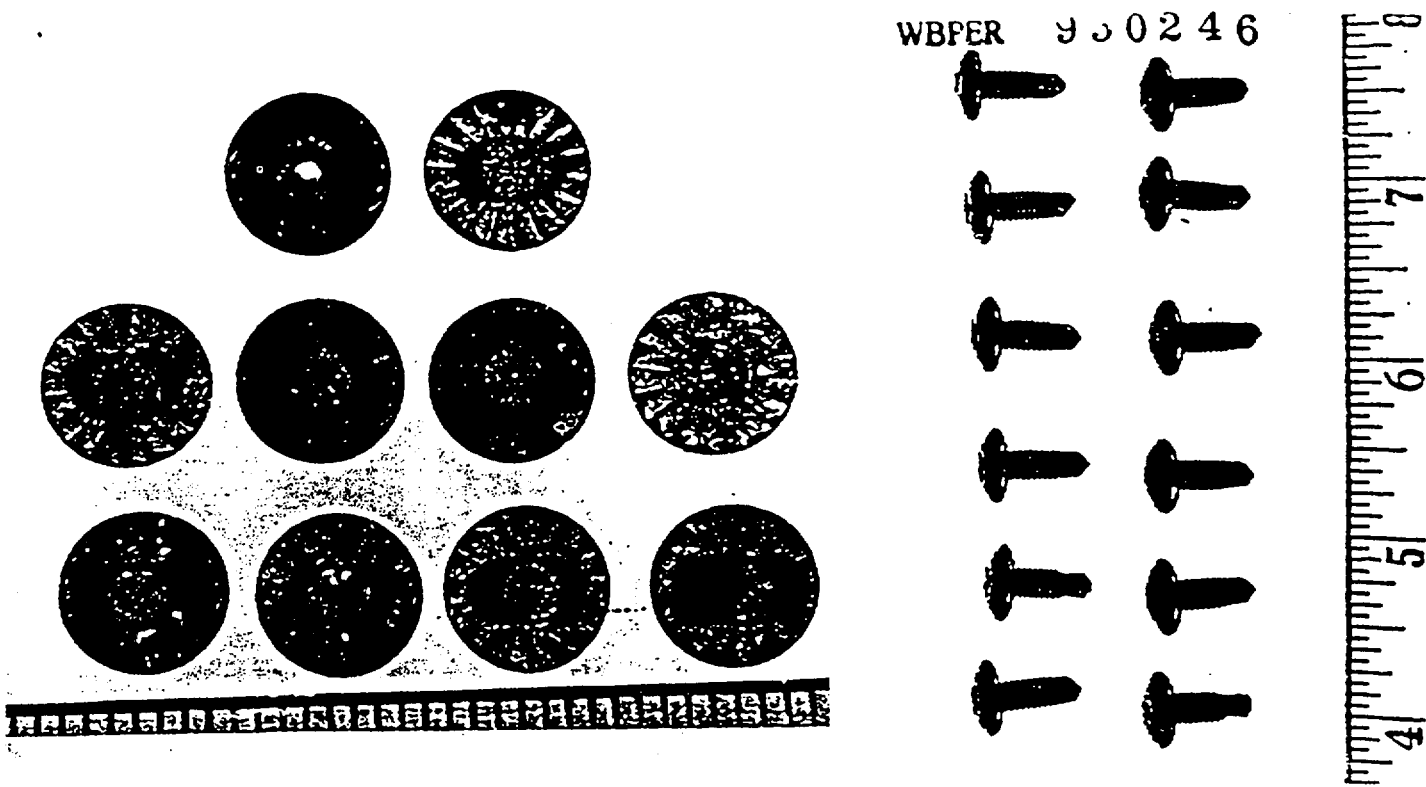
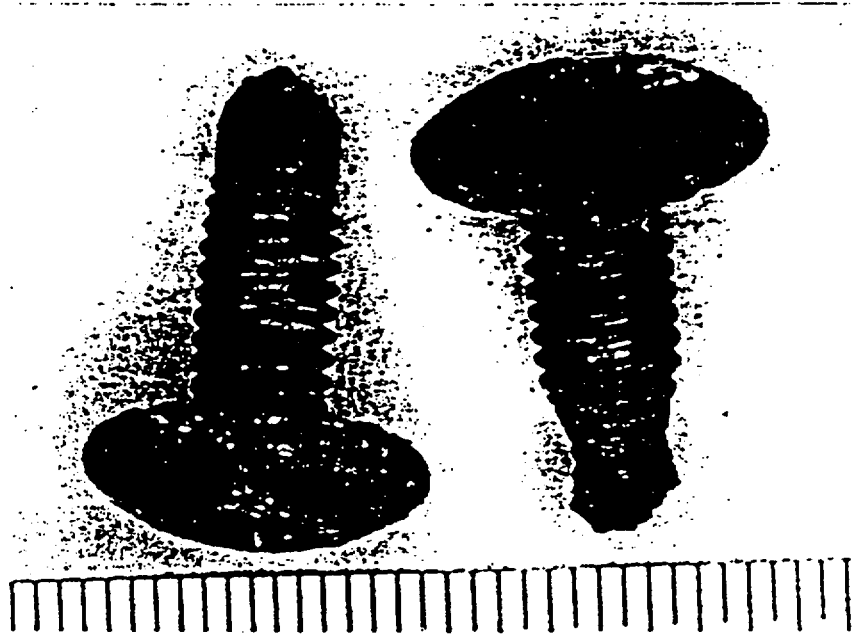
- Set "A" : Ten fractured screw heads that were in service (seen in the upper left view of Figure 1) , and one whole screw that was not in service (not shown).
- Set "B" : Twelve new screws, seen in the upper right view of Figure 1.
- Set "C" : Two screws removed from service, labeled "Bay '24' Top Ring D-6".
- Set "D" : Two screws removed from service, labeled "Bay '24' Bottom Ring D-6".
- Set "E" : Two screws removed from service, labeled "Bay '12' Top Ring A-6".
- Set "F" : Two screws removed from service, labeled "Bay '12' Bottom Ring A-6".
- Set "G" : Two screws removed from service, labeled "Bay '1' Top Ring A-6".
- Set "H" : Two screws removed from service, labeled "Bay '1' Bottom Ring A-6".

All screws removed from service had varying amounts of corrosion products on them, mostly in the threaded region. The lower view of Figure 1 shows a typical set of screws that were removed from service.

Left: As-received photograph of the fractured screws (set "A"). Note that the unfractured screw from this set is not shown. Right: As-received photograph of the new screws (set "B").

As-received photograph of a typical pair of used screws. Note that each set of used screws (set "C" through set "H") varied in degree of corrosion.

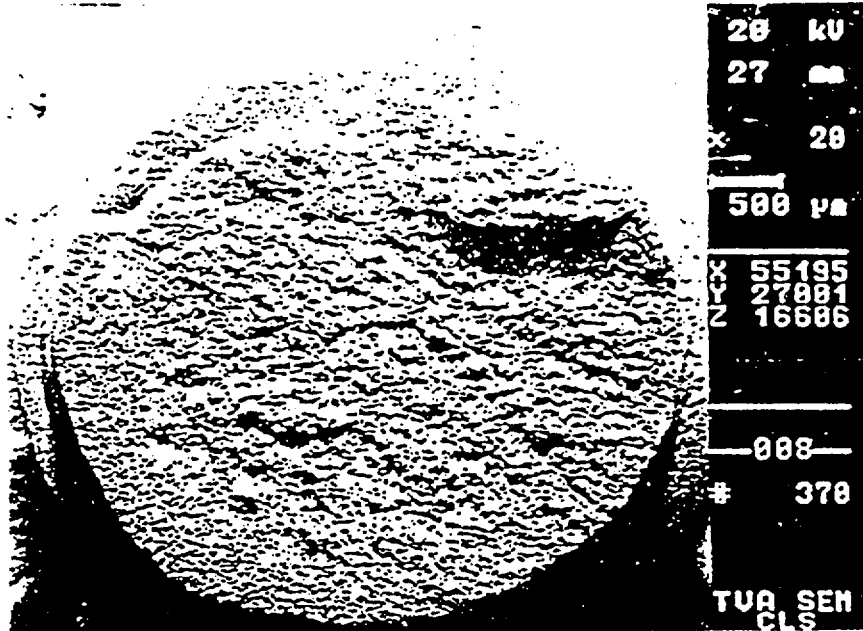
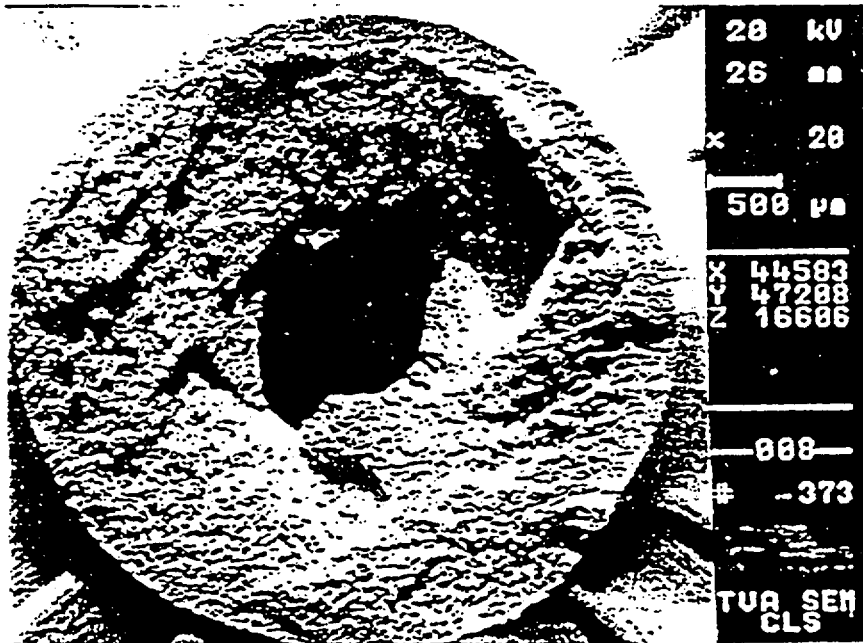
Figure 2 - Ice Condenser Basket Screws, Watts Bar Nuclear Plant, Unit No. 1. Customer Identification No. 95-07. Laboratory Report No. 95-1021.

The fractured screws that were in service in set "A" were examined in a Scanning Electron Microscope (SEM) in order to determine the mode of failure. Figures 2 and 3 show that the screws fractured in a brittle manner

as indicated by the intergranular failure mode seen on the screws that were examined. There was usually a small final-fracture area on the fracture surface near the center of the neck that failed in a ductile manner.

SEM photographs of typical fracture surfaces taken from fractures screws (set "A"). Note that all fractured screws received in set "A" failed in a brittle manner (except for the small final fracture area near the center, which failed in a ductile manner). 20X.

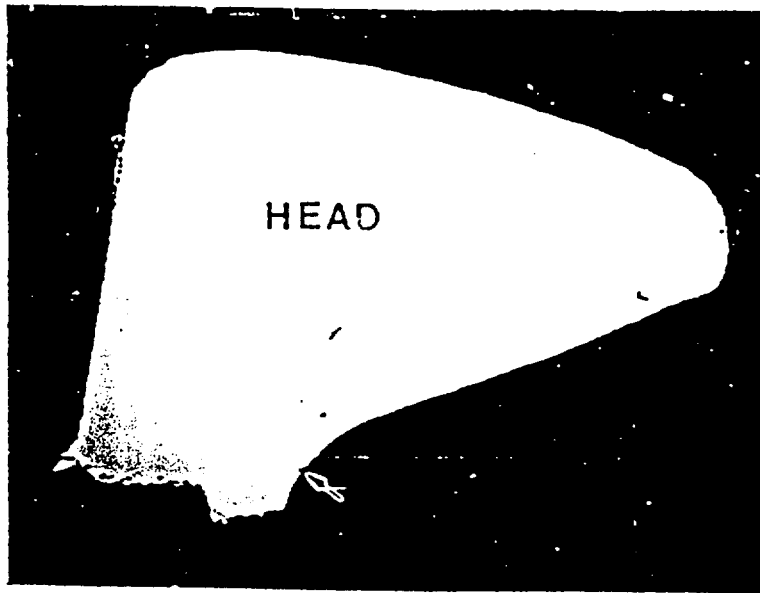
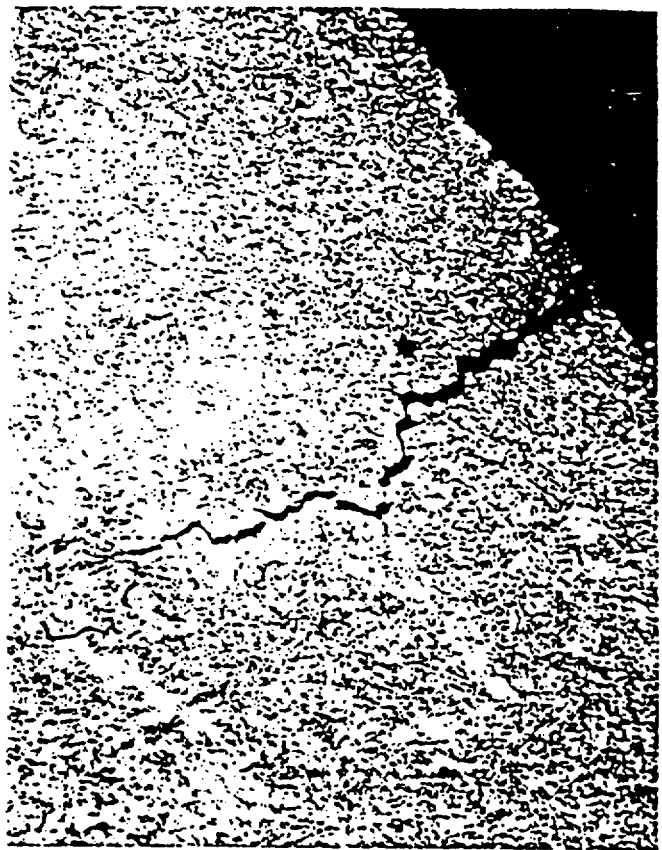
Figure 4 - Ice Condenser Basket Screws, Watts Bar Nuclear Plant, Unit No. 1. Customer Identification No. 95-07. Laboratory Report No. 95-1021.

An arbitrarily selected fractured screw (that was in service) from set "A" was cut so that a longitudinal cross-section through the fracture surface could be examined. Note that a secondary crack of intergranular nature was noticed above the fracture surface as seen in Figure 4. A screw from set "G" was similarly sectioned, and two cracks were found in adjacent thread roots as seen in Figures 5 and 6. Similar intergranular cracks were discovered in a transverse section of the whole screw from set "A" and at the thread roots of a screw from set "H" (Figure 7).

Screws from sets "C", "G", and "H" contained intergranular cracks similar to those seen in Figures 5, 6, and 7. Note that the intergranular crack found in a representative sample taken from a fractured screw in set "A" seen in Figure 4 differed from the intergranular cracks seen in Figures 5 through 7 because it was probably a secondary crack (since it is above the primary fracture and perpendicular to the curved neck of the screw rather than at the thread roots).

Longitudinal cross-section through a fractured screw. The arrow points to a secondary crack above the fracture surface. 20X. As-polished.

Close-up views of secondary crack seen in the upper view of this Figure. Left: As-polished, 125X; Right: Vilella's etch, 400X.

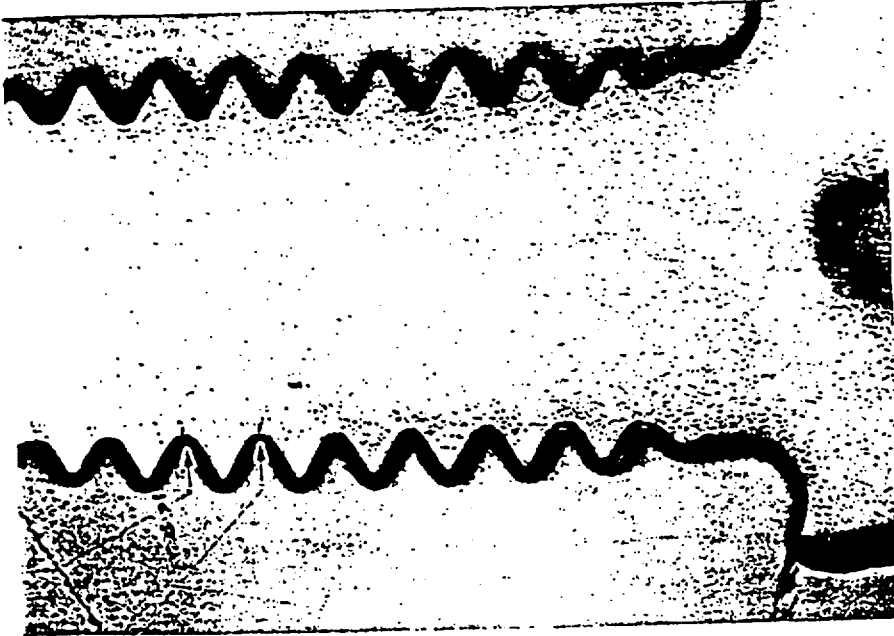
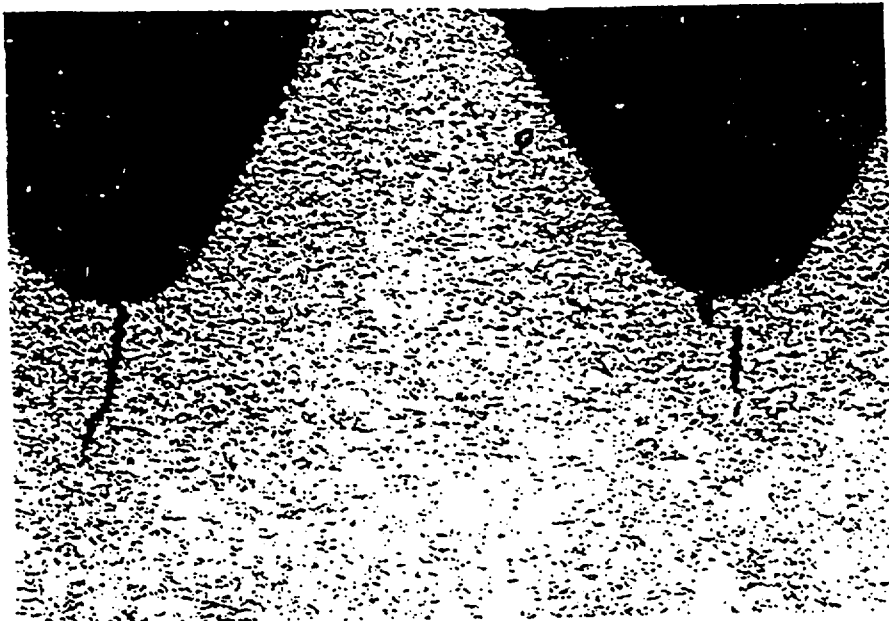
Figure 5 - Ice Condenser Basket Screws, Watts Bar Nuclear Plant, Unit No. 1. Customer Identification No. 95-07. Laboratory Report No. 95-1021.

EDX* analysis of the material in one of the cracks seen in the longitudinal cross section of a screw from set "G" revealed the presence of zinc as seen in Table I. Note in the upper view of Figure 6 that a lapped area was present at the thread roots of a screw from set "G". Similar lapped regions were discovered at the tip, face, and roots of every screw that was examined and is typical of the thread rolling process.

Longitudinal view of cracks present in one of the screws that were removed from service in set "G". Top: 12X; Bottom: 100X.

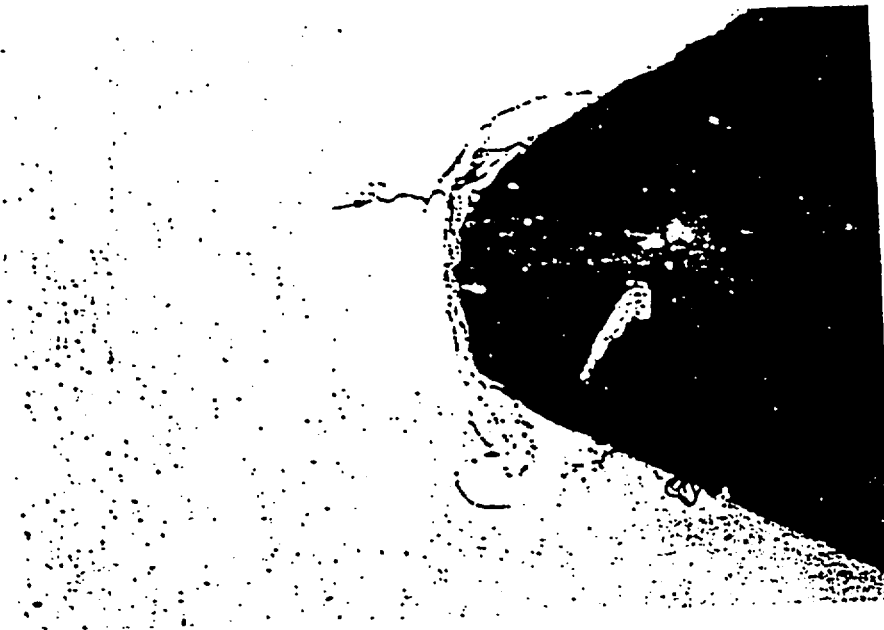
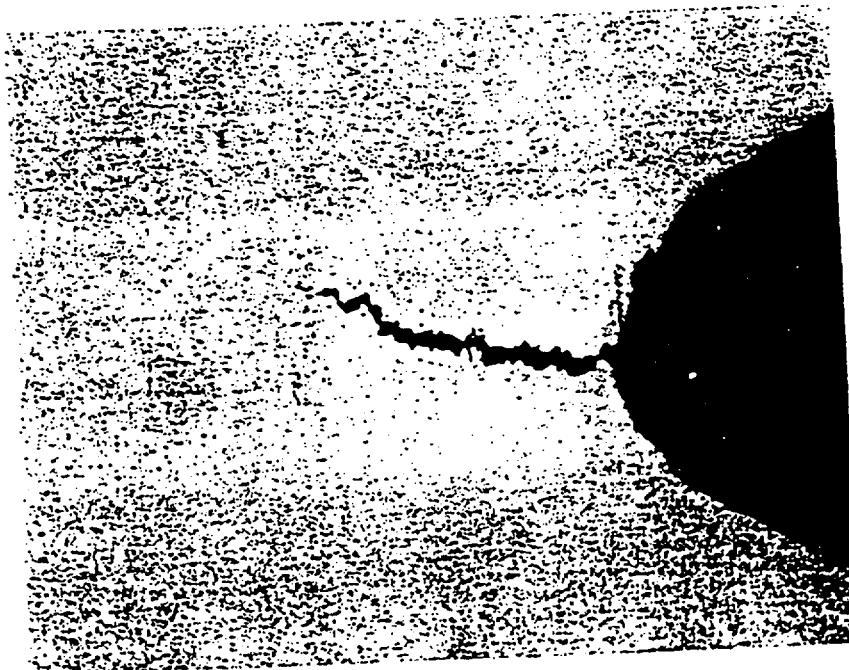
Figure 6 - Ice Condenser Basket Screws, Watts Bar Nuclear Plant, Unit No. 1. Customer Identification No. 95-07. Laboratory Report No. 95-1021.

As-polished, longitudinal view of lapping present at tooth root of a screw that was removed from service in set "G". 200X.

As-polished, longitudinal view of crack present at tooth root of a screw that was removed from service in set "G". 200X.

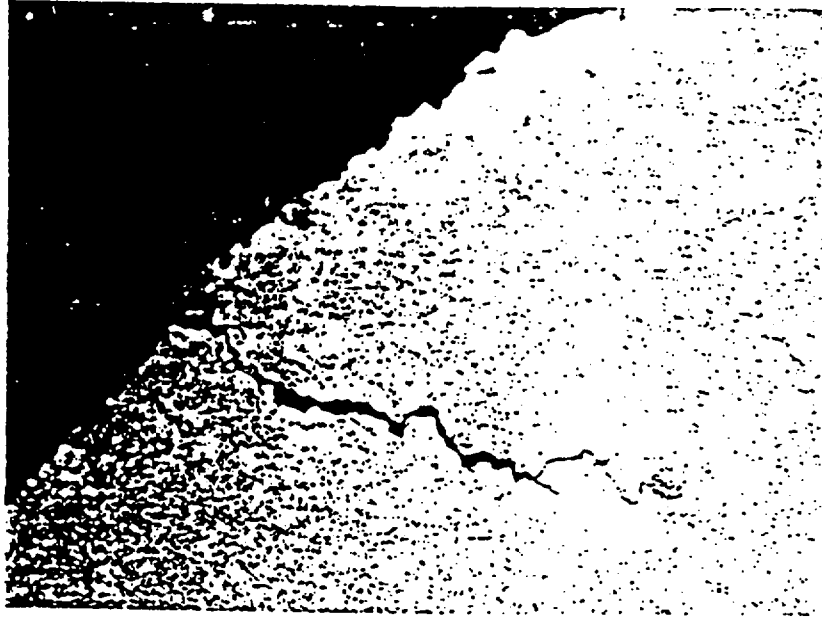
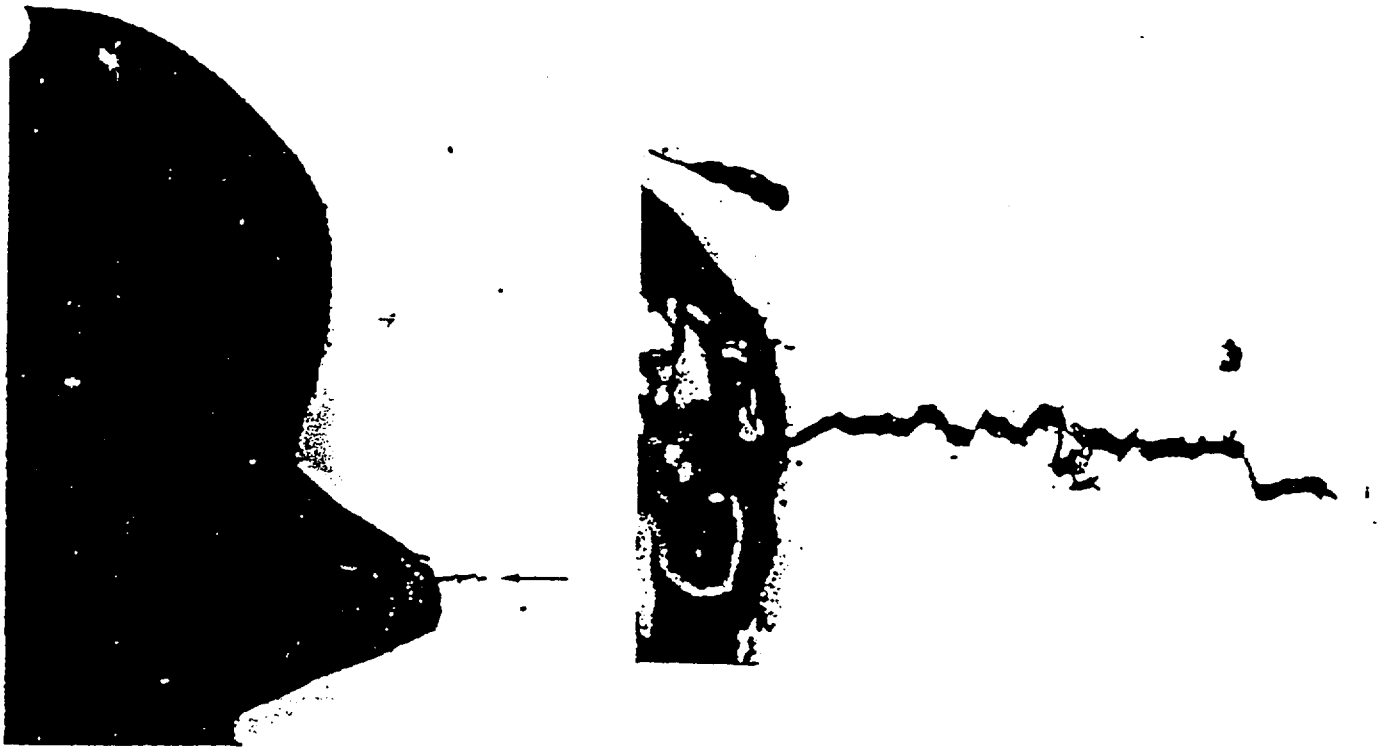
Figure 7 - Ice Condenser Basket Screws, Watts Bar Nuclear Plant, Unit No. 1. Customer Identification No. 95-07. Laboratory Report No. 95-1021.

Transverse cross-sectional view of a crack present in the screw that was not in service from set "A". 400X. Vilella's etch.

Intergranular crack found at thread root of first thread below head in a longitudinal cross section of a screw that was removed from service in set "H". Left: 50X; Right: 500X. As-polished condition.

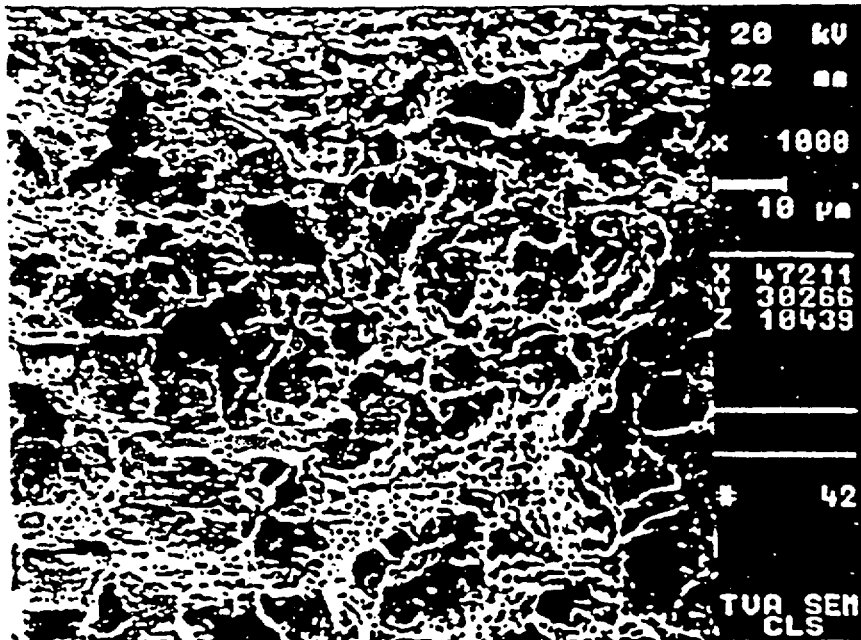
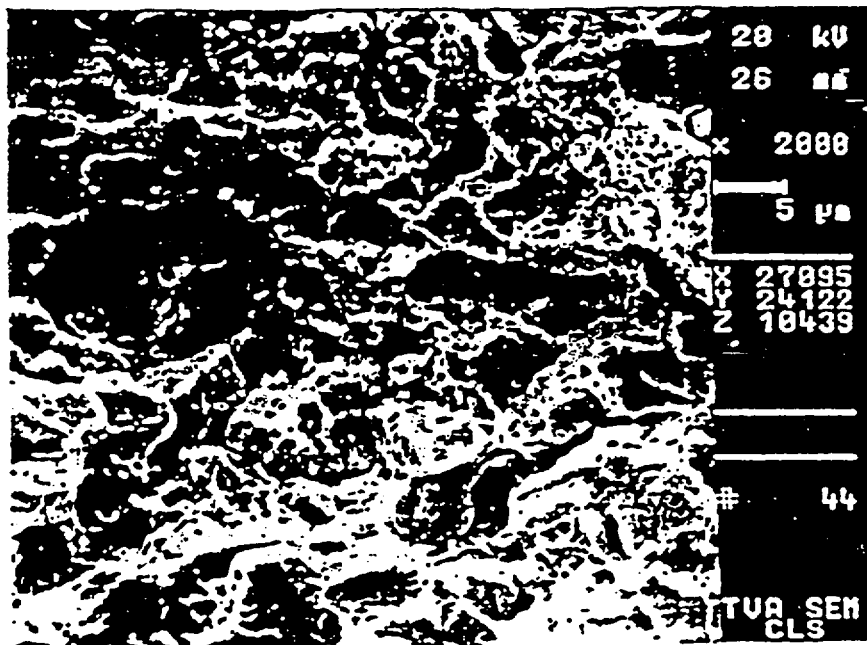
Figure 8 - Ice Condenser Basket Screws, Watts Bar Nuclear Plant, Unit No. 1. Customer Identification No. 95-07. Laboratory Report No. 95-1021.

Two screws, one from set "A" and one from set "G," were intentionally fractured with a hammer in order to determine the failure mode. SEM photography shows in Figures 8 and 9 that the screw from set "G" failed by intergranular fracture in the case and mixed-mode fracture (cleavage and void coalescence) in the core, while the whole screw from set "A" failed by quasi-cleavage in the case and void coalescence in the core. At the customer's request, additional screws were broken (two from set "C" and two new screws from set "B") in the same manner, except at 15°F. Subsequent SEM analysis of the resultant fracture surfaces revealed that the screws failed by void coalescence.

SEM photograph of fresh fracture surface showing quasi-cleavage in the case of a new screw. 1000X.

SEM photograph of fresh fracture surface showing intergranular separation (with some void coalescence) in the case of a screw that was removed from service in set "D". 2000X.

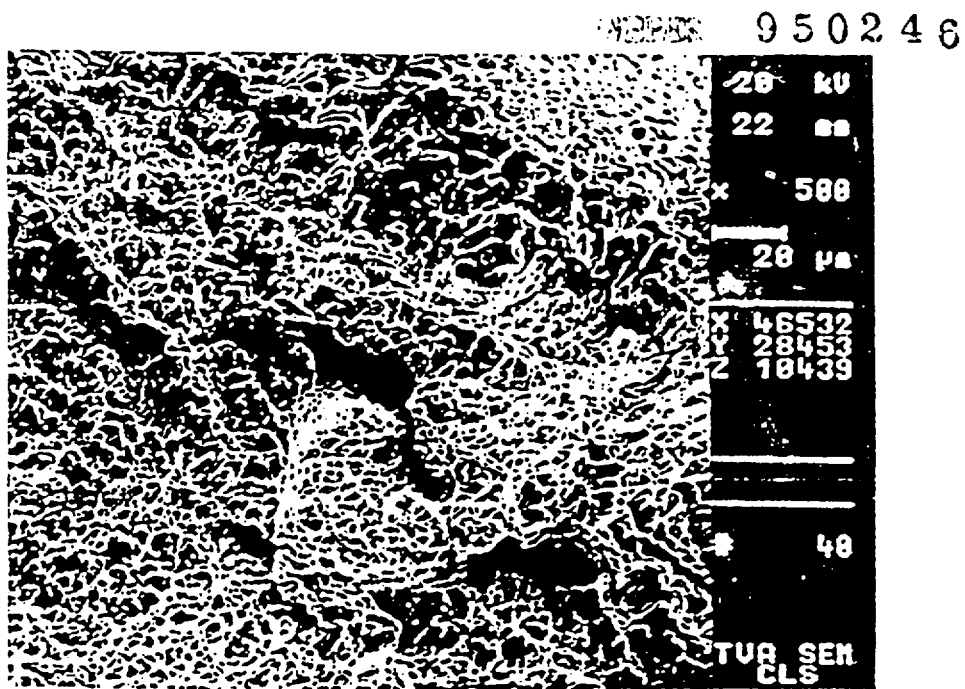
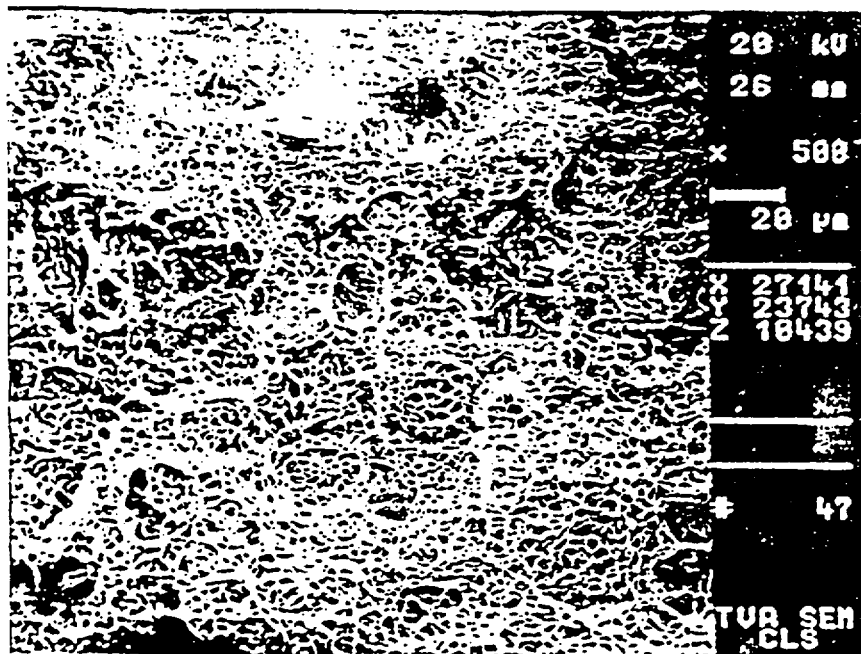
Figure 9 - Ice Condenser Basket Screws, Watts Bar Nuclear Plant, Unit No. 1. Customer Identification No. 95-07. Laboratory Report No. 95-1021.

SEM photograph of fresh fracture surface showing void coalescence in the core of a new screw. 500X.

SEM photograph of fresh fracture surface showing mixed-mode separation (cleavage and void coalescence) in the core of a screw that was removed from service in set "D". 500X.

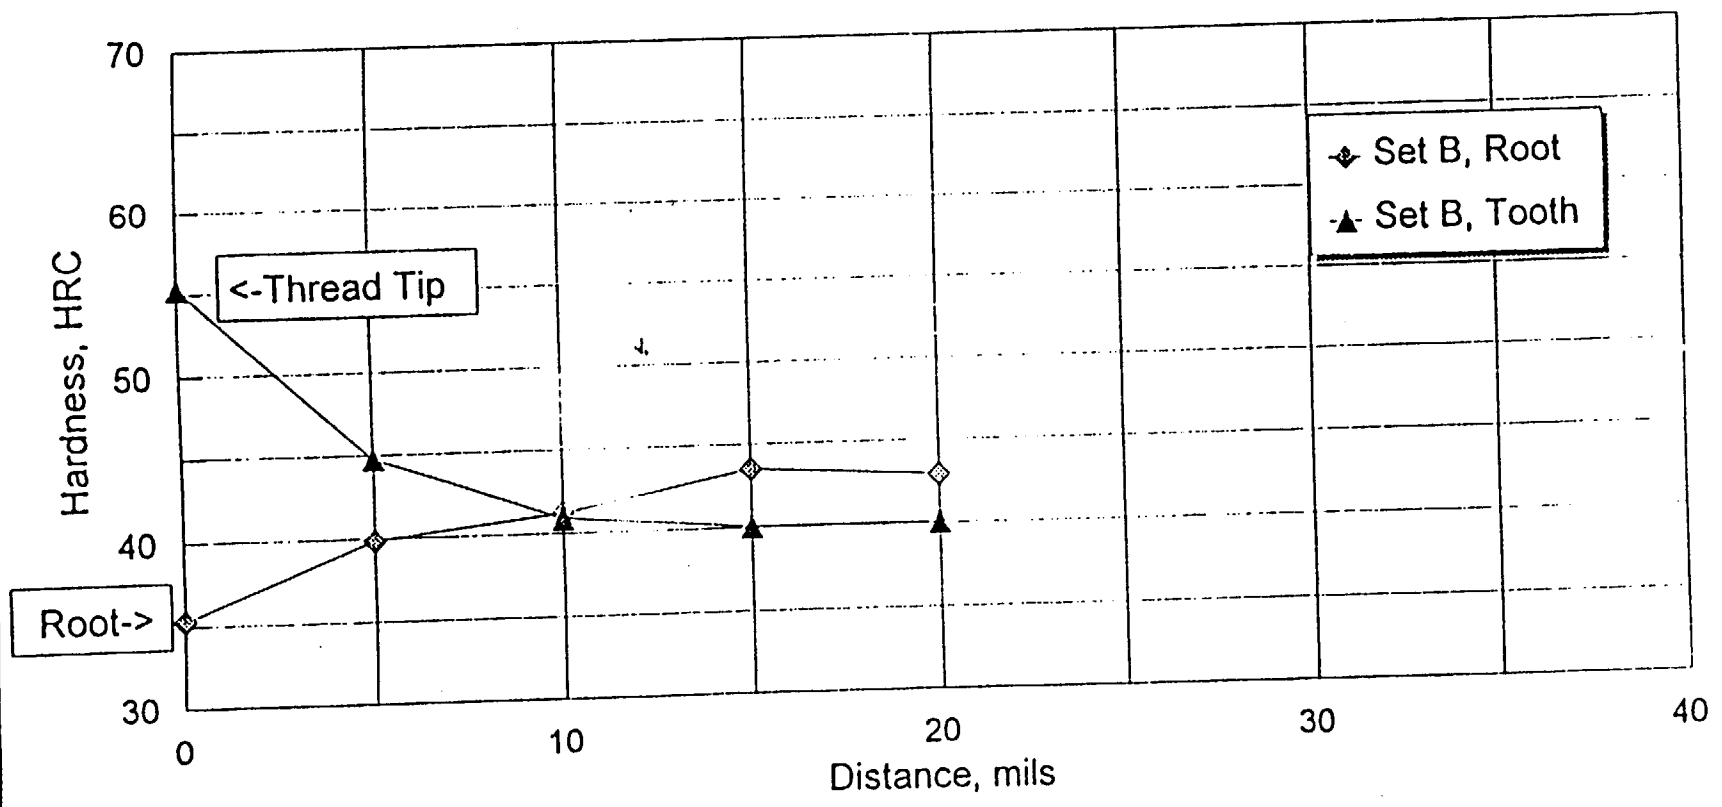
Figure 13 - Ice Condenser Basket Screws, Watts Bar Nuclear Plant, Unit No. 1. Customer Identification No. 95-07. Laboratory Report No. 95-1021.

New Screw (Set B) Hardness Traverses

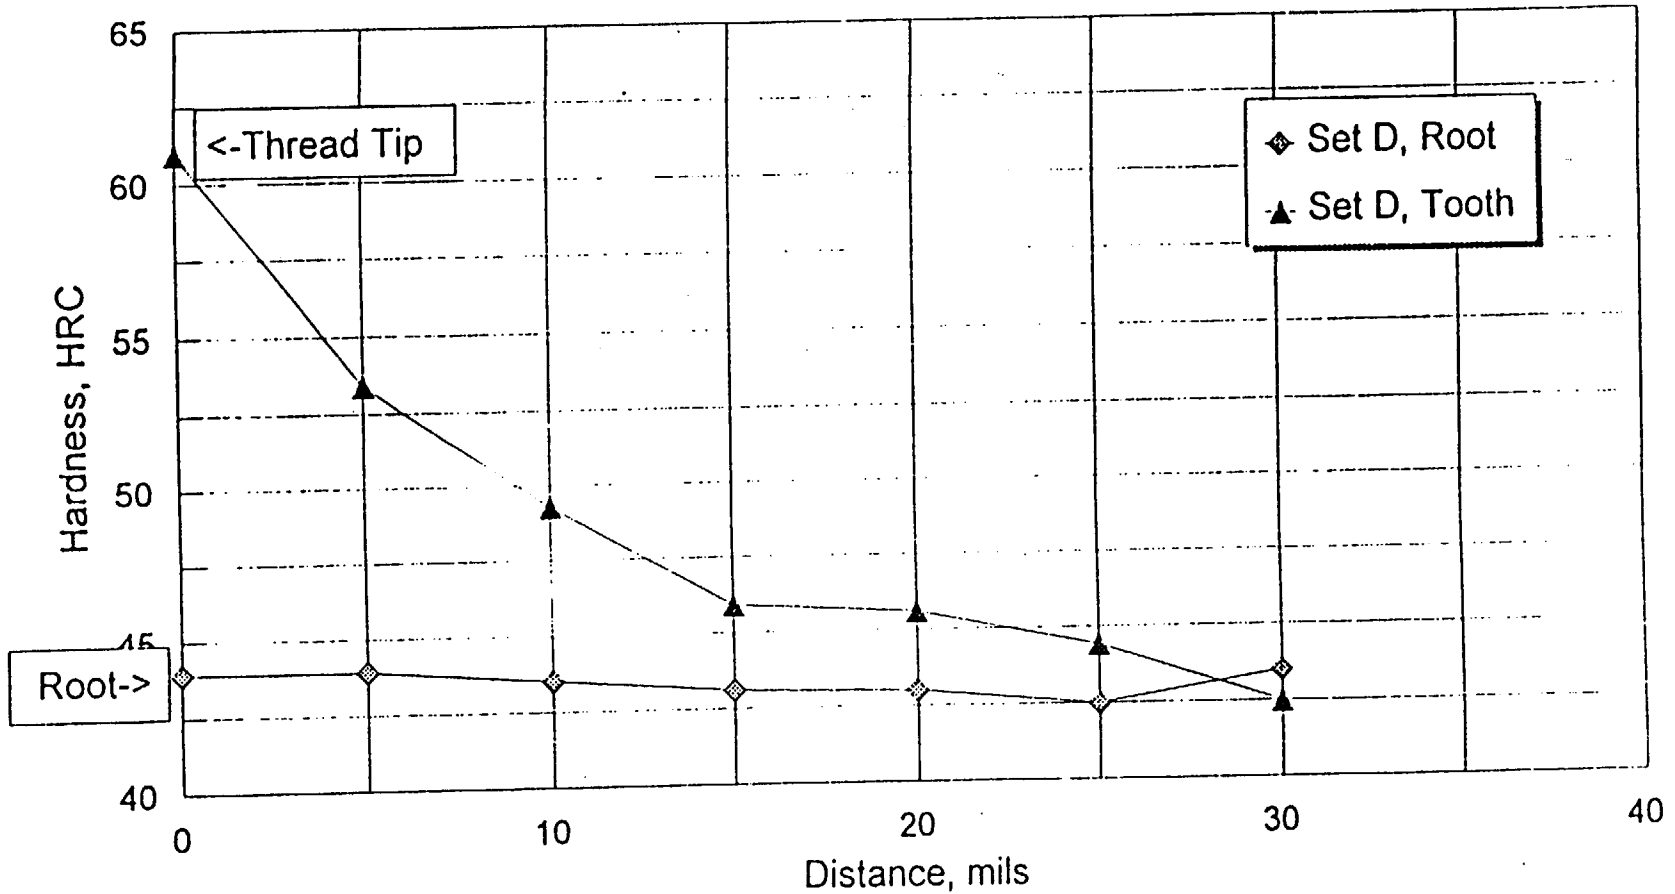
Figure 14 - Ice Condenser Basket Screws, Watts Bar Nuclear Plant, Unit No. 1. Customer Identification No. 95-07. Laboratory Report No. 95-1021.

Uncracked Screw (Set D) Hardness Traverses

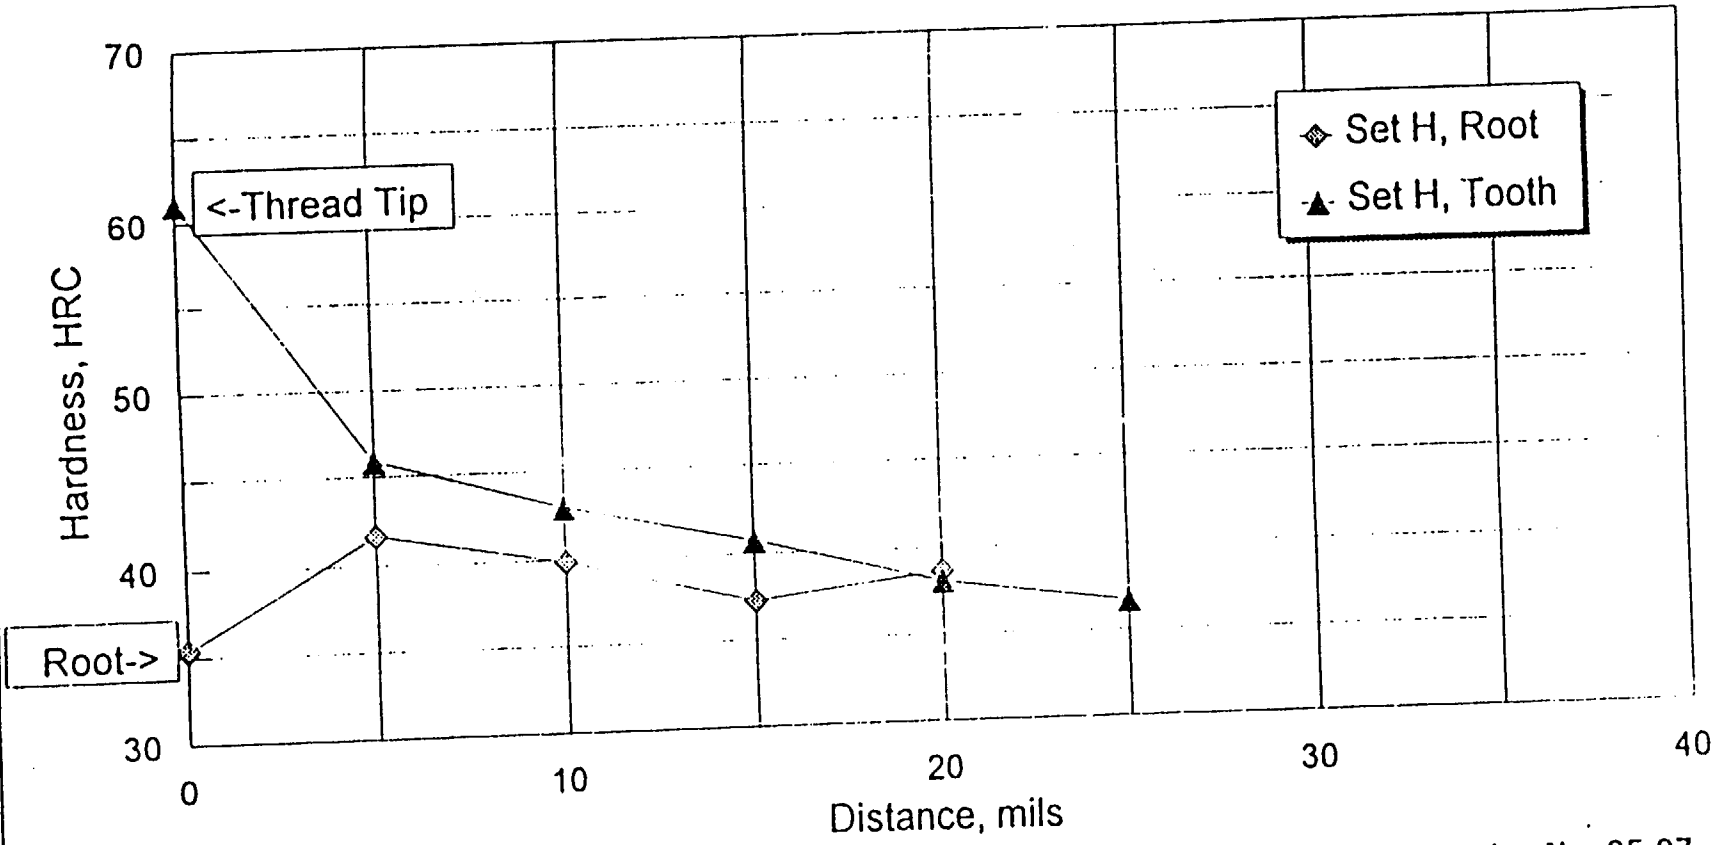
Figure 15 - Ice Condenser Basket Screws, Watts Bar Nuclear Plant, Unit No. 1. Customer Identification No. 95-07. Laboratory Report No. 95-1021.

Cracked Screw (Set H) Hardness Traverses
