CENTRAL LABORATORIES SERVICES TECHNICAL REPORT	Report No. 95-1021
	Sheet No.: 1 of 2
	Date of Report: 6/2/95
Plant/Project: Watts Bar Nuclear Plant	
Subject: ICE CONDENSER BASKET SCREWS	
Standards Used: 904694, 901387	
Copies Sent to: Vonda Sisson, IOB 1M-WBN (4); RIMS; Lab Files	
Prepared by: Daryl A. Smith / LAB	Approved by: <i>Delsa L. Frazier</i> Delsa L. Frazier

Ice Condenser Basket Screws, Watts Bar Nuclear Plant, Unit No. 1. Customer Identification No. 95-07, Laboratory Report No. 95-1021.

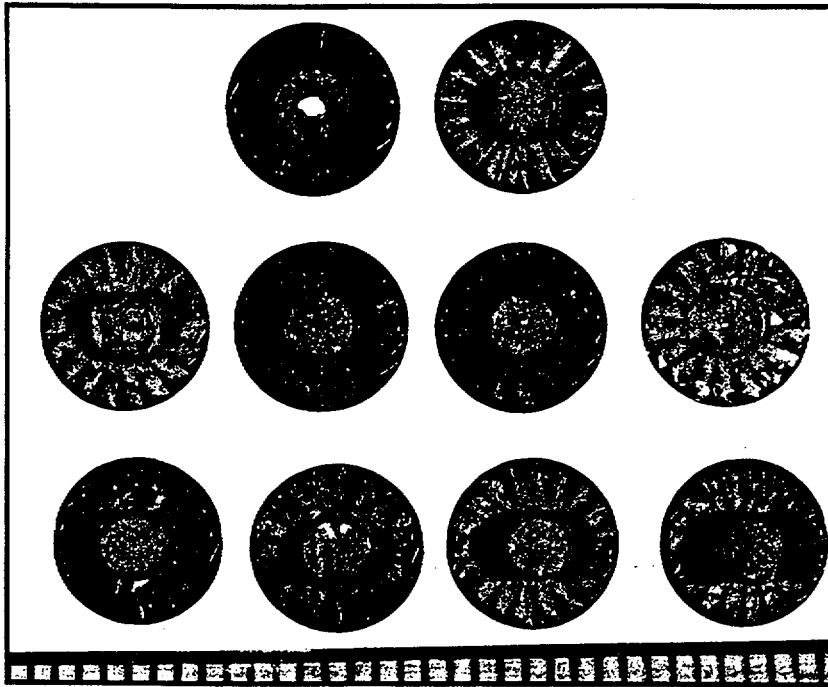
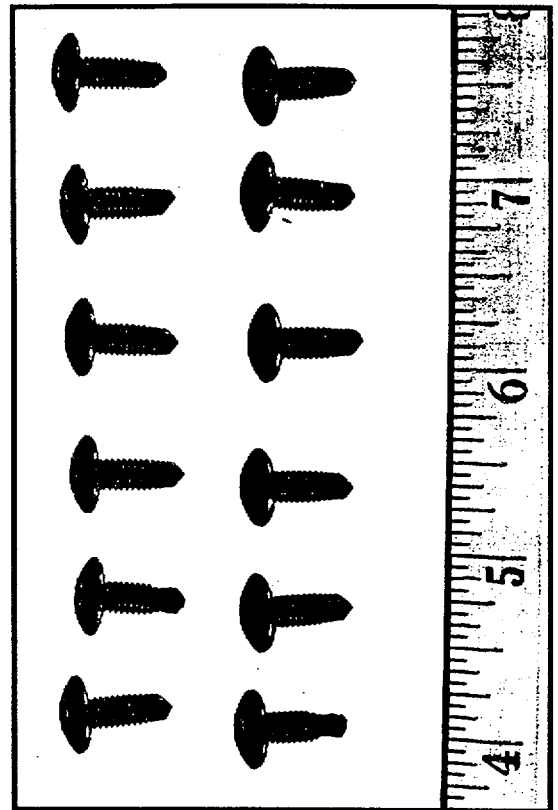
Figure 1:

- Set "A": Ten fractured screw heads, seen in the upper left view of Figure 1, and one new screw (not shown).
- Set "B": Twelve new screws, seen in the upper right view of Figure 1.
- Set "C": Two screws removed from service, labeled "Bay '24' Top Ring D-6".
- Set "D": Two screws removed from service, labeled "Bay '24' Bottom Ring D-6".
- Set "E": Two screws removed from service, labeled "Bay '12' Top Ring A-6".
- Set "F": Two screws removed from service, labeled "Bay '12' Bottom Ring A-6".
- Set "G": Two screws removed from service, labeled "Bay '1' Top Ring A-6".
- Set "H": Two screws removed from service, labeled "Bay '1' Bottom Ring A-6".

Left: As-received photograph of the fractured screws (set "A"). Note that the unfractured screw from this set is not shown. Right: As-received photograph of the new screws (set "B").

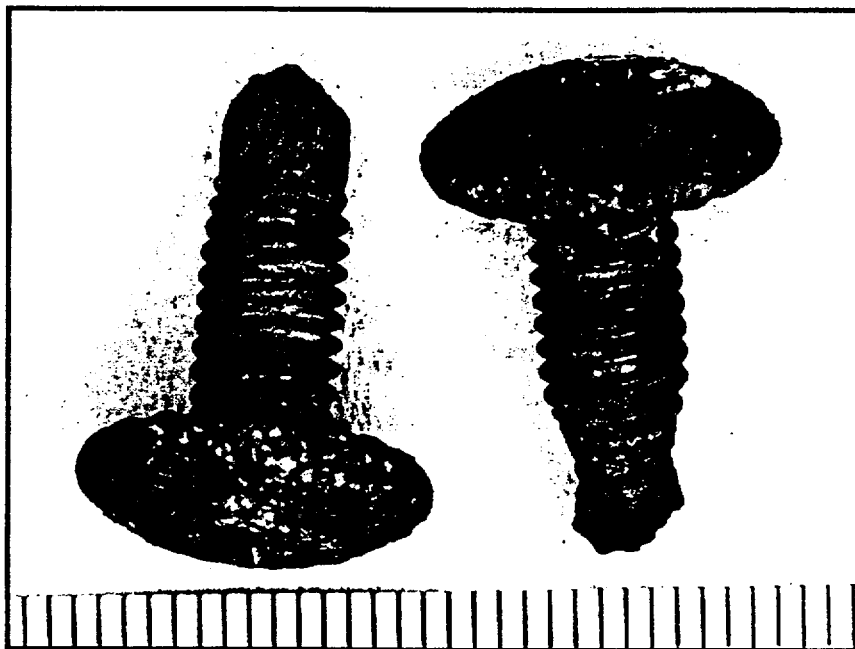
All screws removed from service had varying amounts of corrosion products on them, mostly in the threaded region. The lower view of Figure 1 shows a typical set of screws that were removed from service. The customer indicated that the screws were cyclically cooled and warmed between 15°F and room temperature. The customer also indicated that the screws were probably over-torqued when installed.

As-received photograph of a typical pair of used screws. Note that each set of used screws (set "C" through set "H") varied in degree of corrosion.

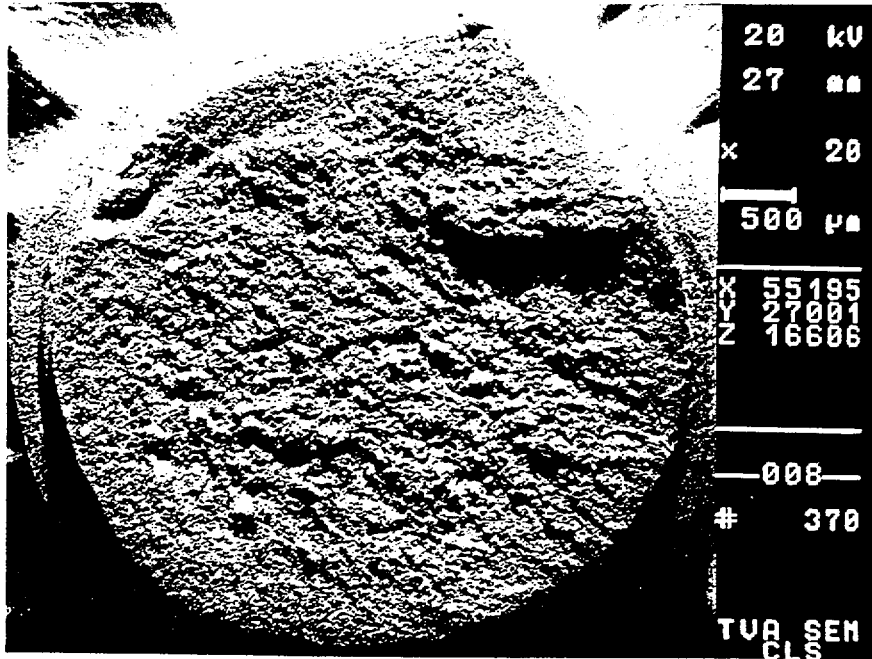
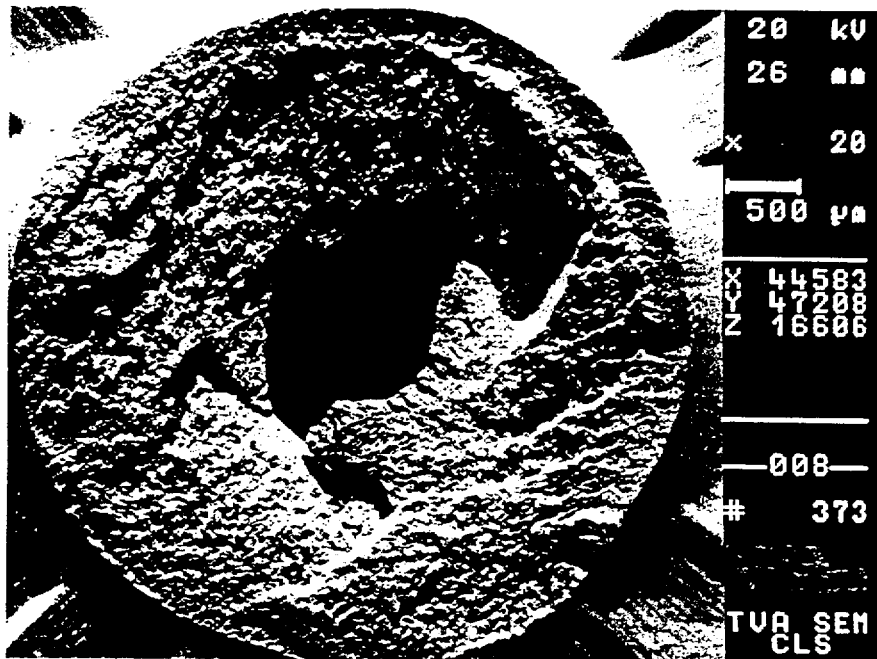
Figure 2:

All of the fractured screws received in set "A" were examined in a Scanning Electron Microscope (SEM) in order to determine the mode of failure. Figures 2 and 3 show that the screws fractured in a brittle manner as indicated by the intergranular failure mode seen on all screws examined. There was usually a small final-fracture area on the fracture surface near the center of the shank that failed in a ductile manner.

SEM photographs of typical fracture surfaces taken from fractures screws (set "A"). Note that all fractured screws received in set "A" failed in a brittle manner (except for the small final fracture area near the center which failed in a ductile manner). 20X.

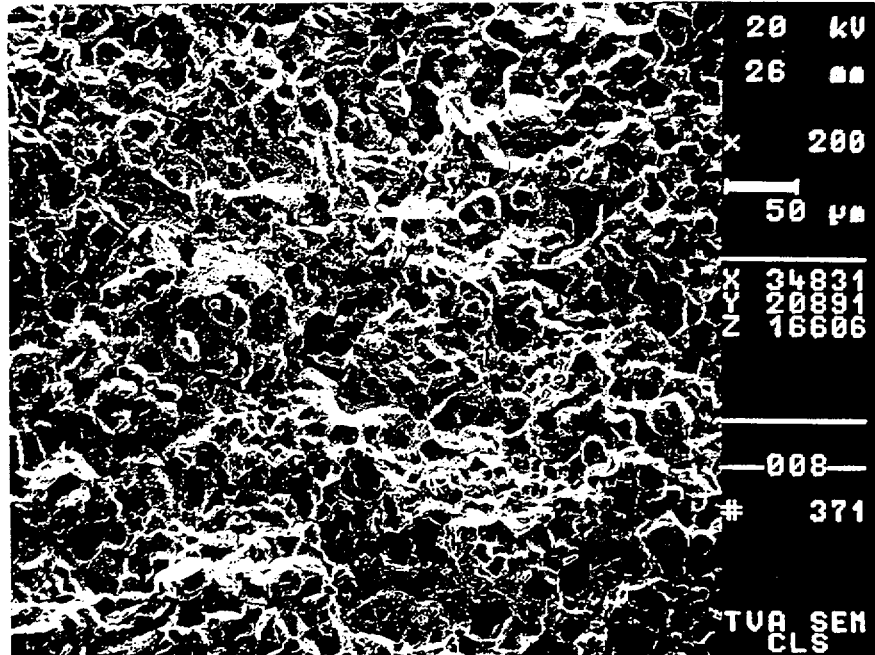
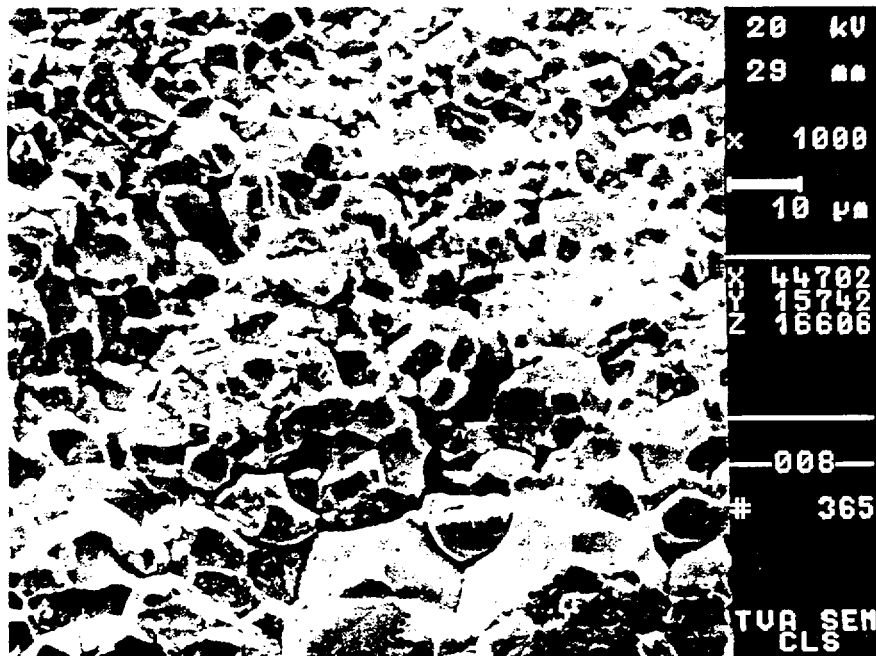
Figure 3: Ice Condenser Basket Screws, Watts Bar Nuclear Plant, Unit No. 1. Customer Identification No. 95-07, Laboratory Report No. 95-1021.

SEM photographs of typical fracture topography seen on failed screws in set "A." The "rock-candy" appearance indicates that these screws failed in a brittle, intergranular manner. Top: 200X; Bottom: 1000X.

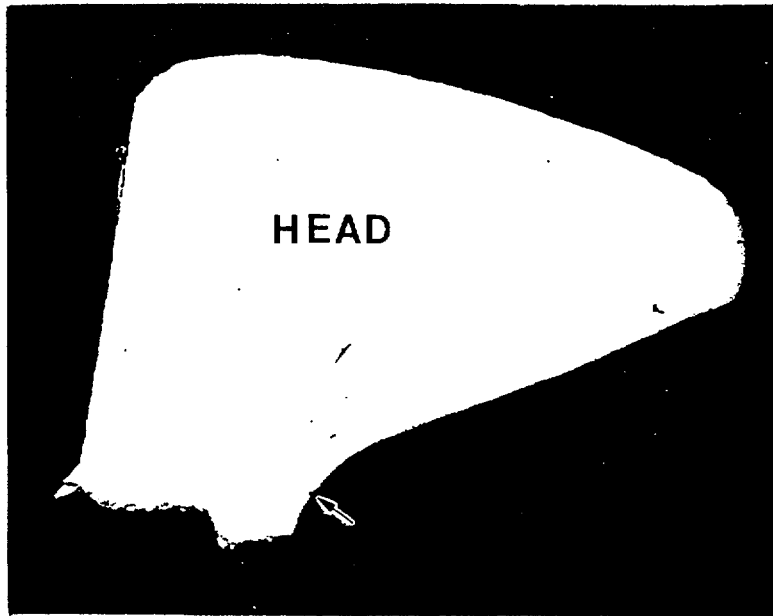
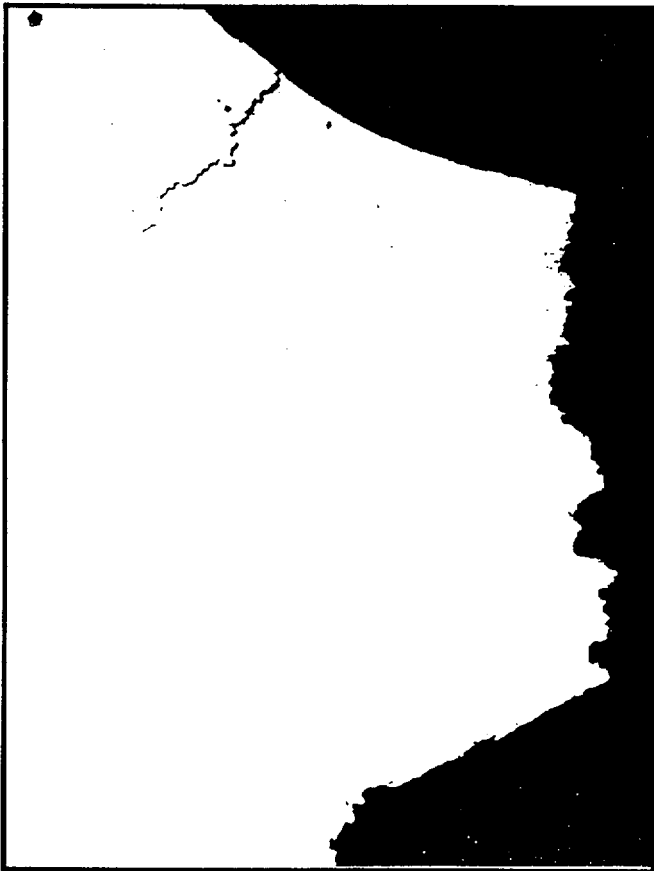
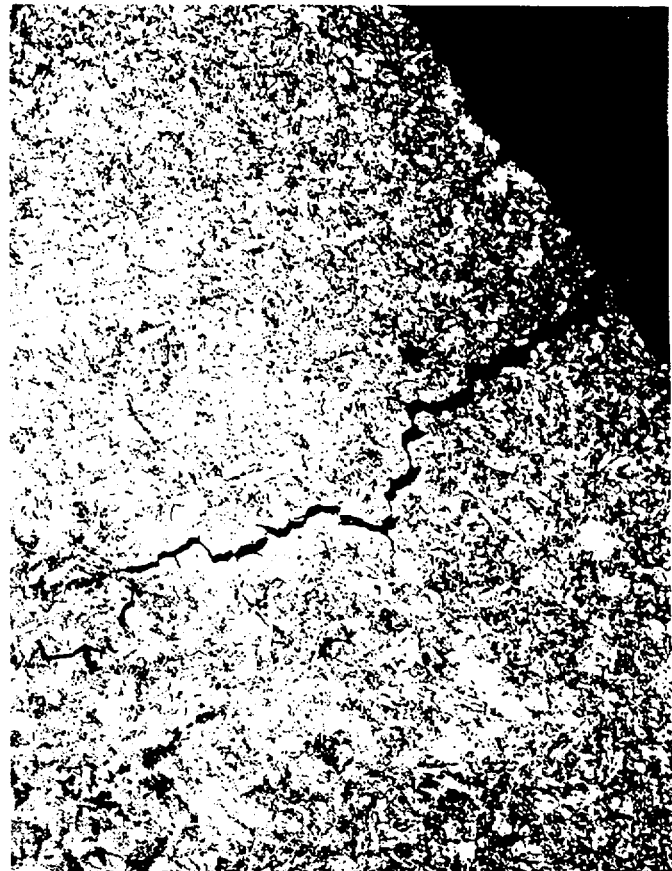
Figure 4:

An arbitrarily selected fractured screw from set "A" was cut so that a longitudinal cross-section through the fracture surface could be examined (as seen in Figure 4). Note that a secondary crack was noticed above the fracture surface. Closer examination of this crack revealed that it traveled in an intergranular manner. A screw that was removed from service (set "G") was similarly sectioned as seen in Figure 5. Note that two cracks were found in adjacent tooth roots. Similar cracks were discovered in the new screw received in set "A" and in the transverse section of a new screw sample examined from set "B" (see Figure 7). EDX analysis

Longitudinal cross section through a fractured screw. The arrow points to a secondary crack above the fracture surface. 20X. As-polished.

Close-up views of secondary crack seen in the upper view of this Figure. Left: As-polished, 125X; Right: Vilella's etch, 400X.

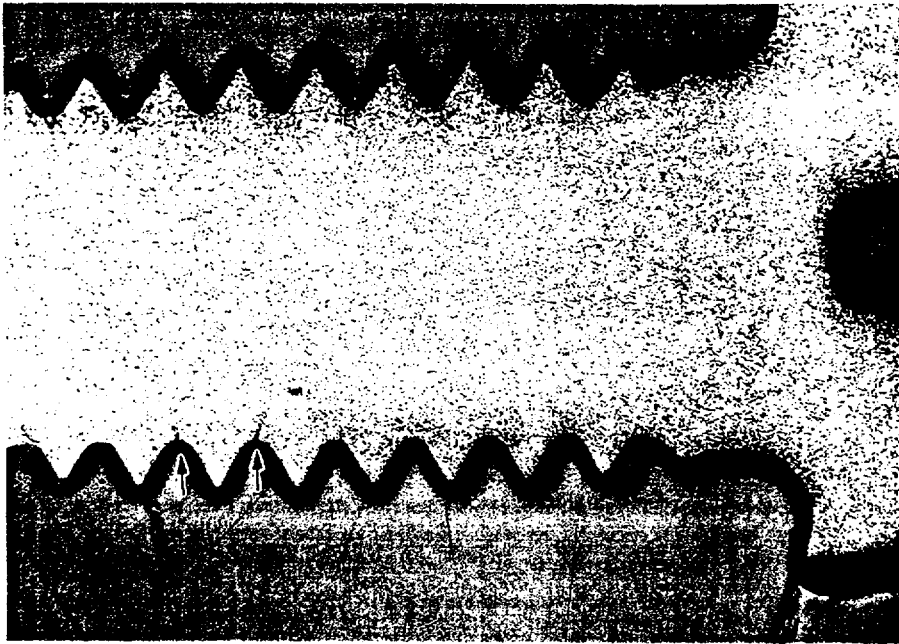
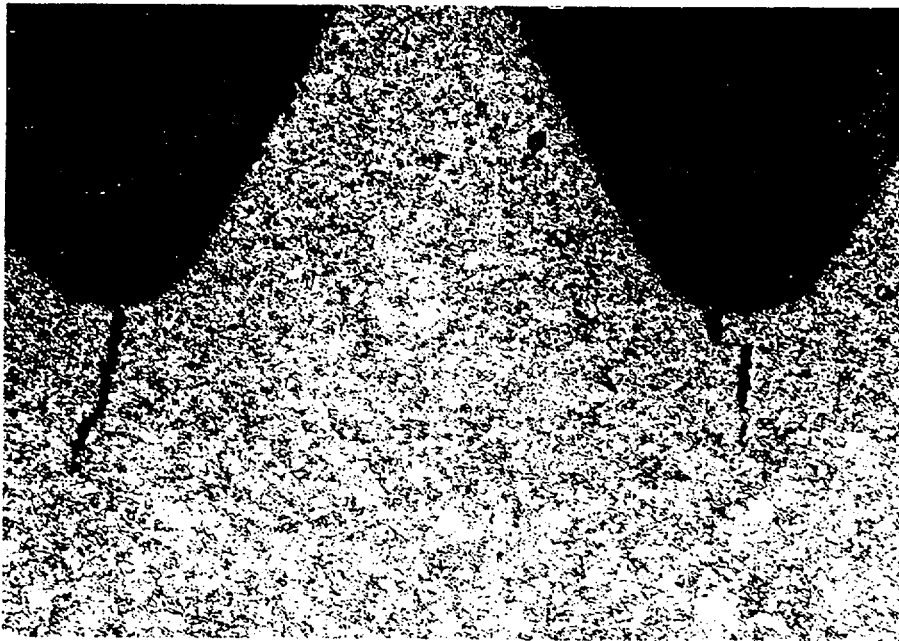
Longitudinal view of cracks present in one of the screws that were removed from service in set "G". Top: 12X; Bottom: 100X.

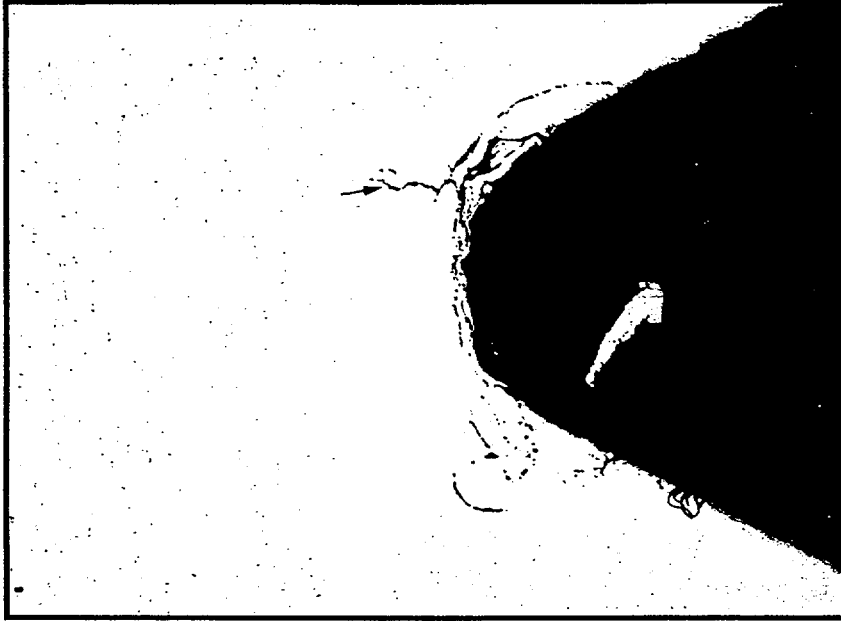
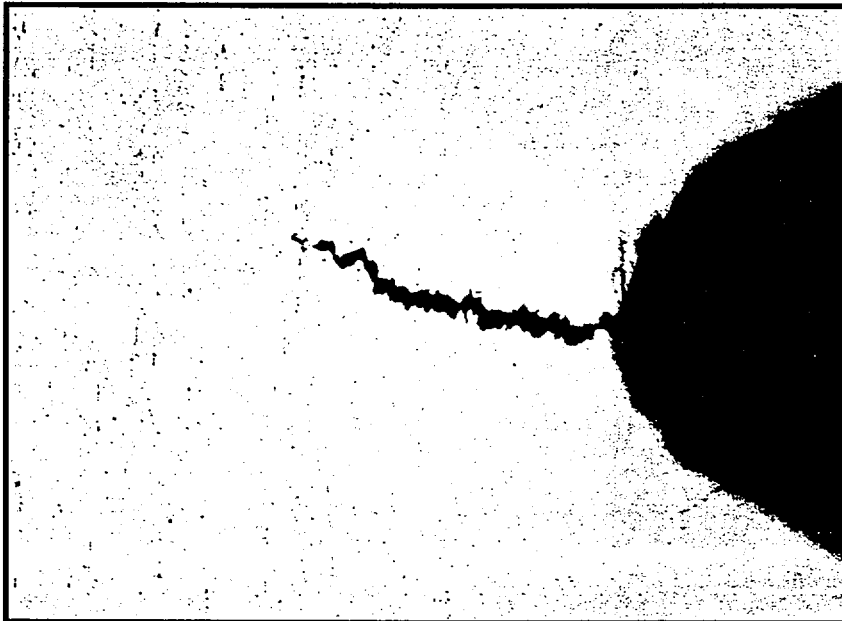
All screws examined had lapping from the thread-rolling process in the pitch, face, and root vicinities (see upper view of Figure 6). Lapping at the roots of the threads would be undesirable due to the fact that this is usually an area of high stress, and the lapping may initiate a fatigue crack. The lower view of Figure 6 shows a crack at a tooth root of one screw that was removed from service (set "G") that may have propagated by intergranular fatigue. Note that similar cracks were found both in the new and used screws (see Figure 7).

As-polished, longitudinal view of lapping present at tooth root of a screw that was removed from service in set "G". 200X.

As-polished, longitudinal view of crack present at tooth root of a screw that was removed from service in set "G". 200X.

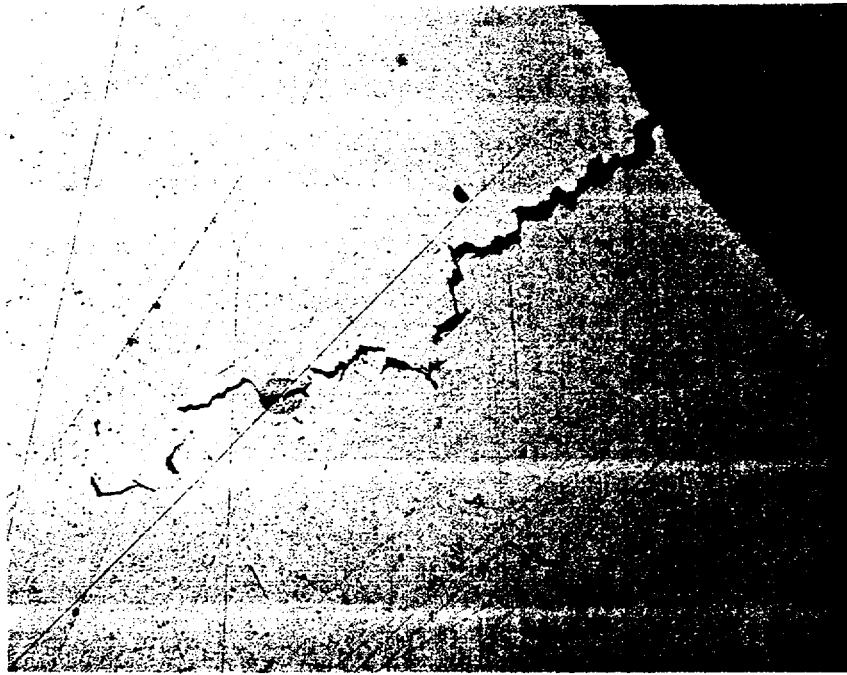
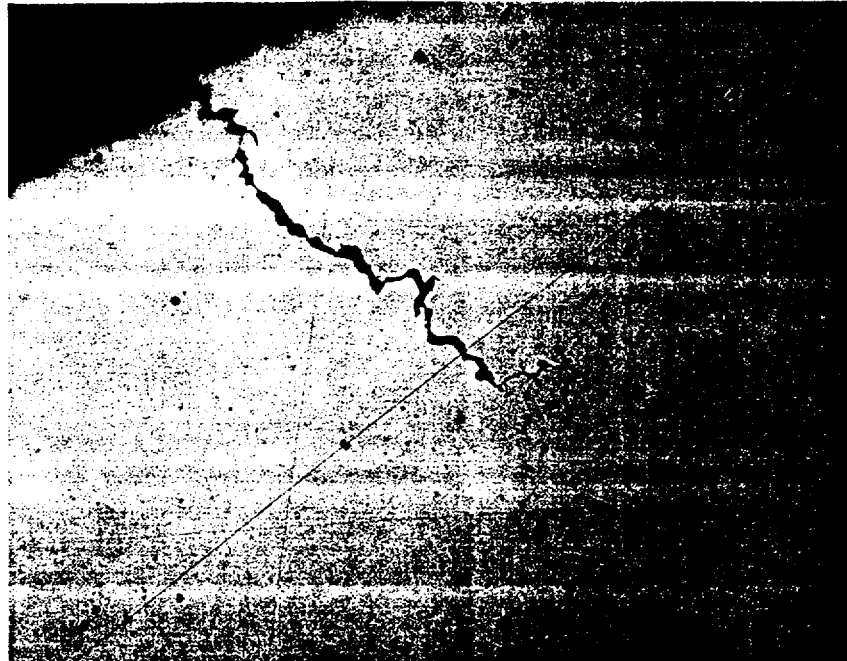
Figure 7:

of the crack revealed the presence of zinc (see Table I) indicating that the crack may have been present prior to plating (possibly formed when quenched during the manufacturer's heat treatment).

As-polished, longitudinal view of crack present in shank, near head of a screw that was fractured in set "A" (see Figure 4). 400X.

As-polished, transverse view of crack present in a new screw that was received in set "B". 400X.

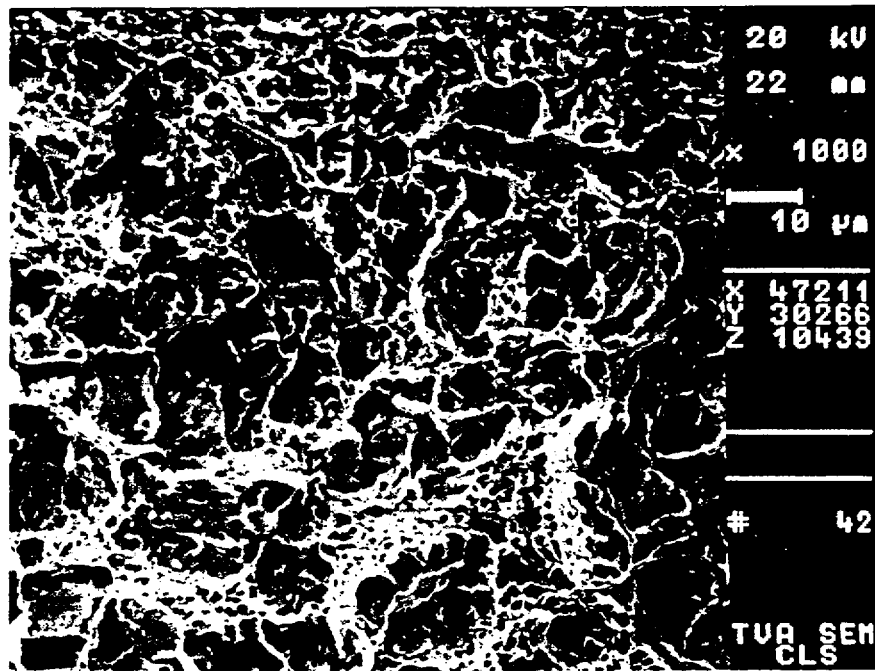
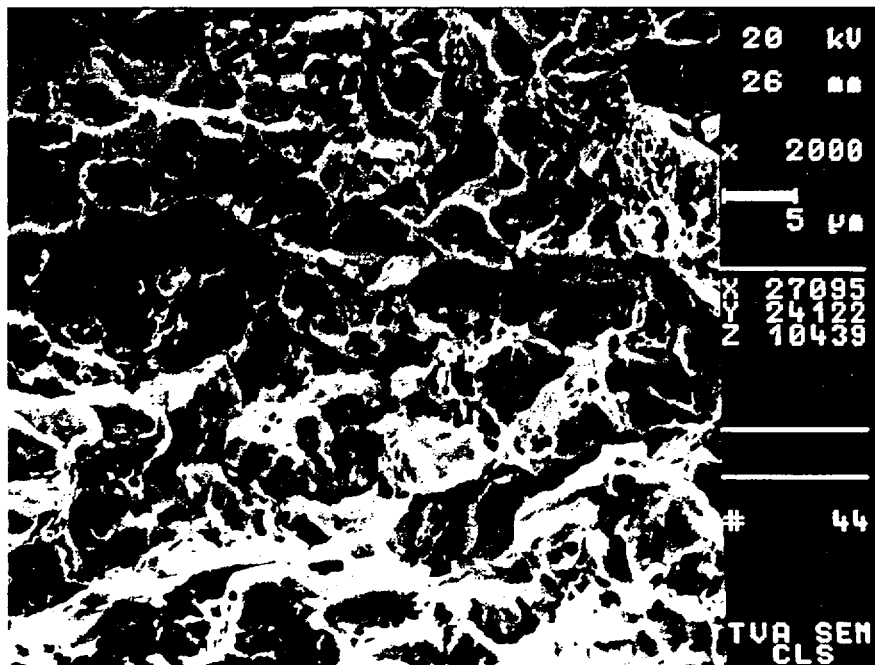
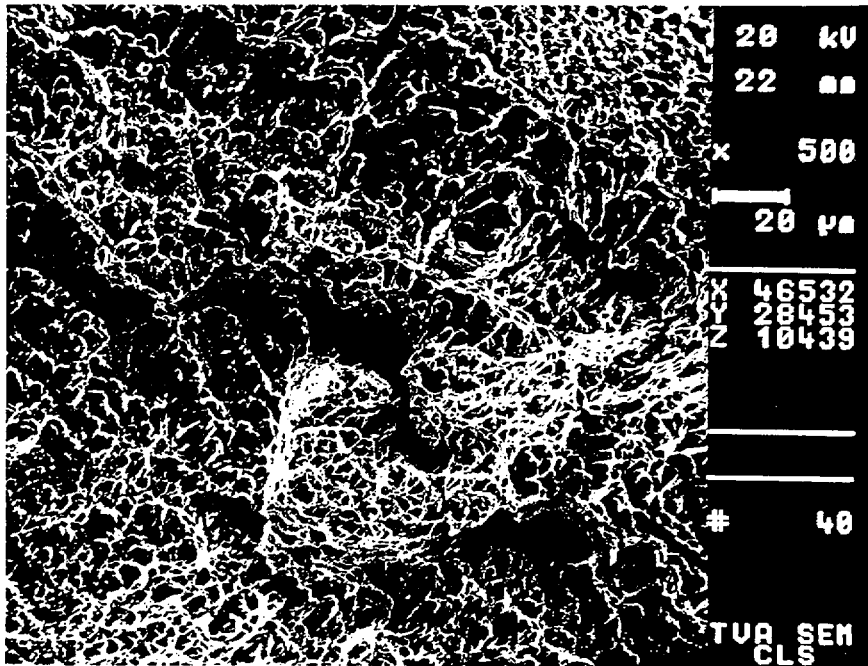
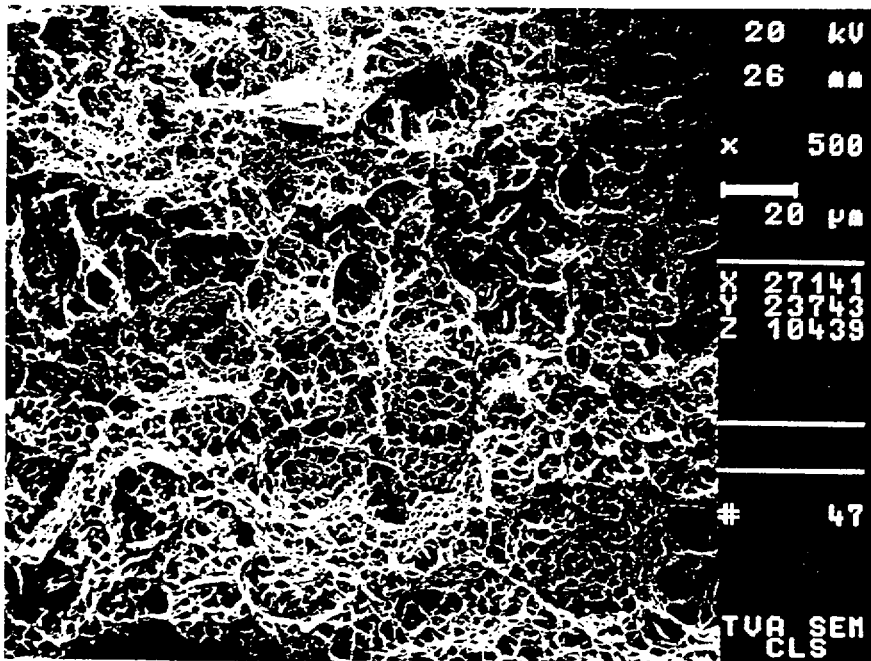
Two screws, one new and one used, were intentionally fractured with a hammer in order to determine the failure mechanism. SEM photography shows in Figures 8 and 9 that the used screw failed by intergranular fracture in the case and mixed-mode fracture (cleavage and void coalescence) in the core, while the new screw failed by quasi-cleavage in the case and void coalescence in the core. Three conclusions were drawn after this test was performed: 1) The fact that the new screw failed in a manner that was more ductile than the used screw corresponds to the lower hardness values of the new screws compared to those of the used screws. 2) Since both the new and used screw had ductile features on their fracture surfaces, hydrogen embrittlement from the plating process and Tempered Martensitic Embrittlement (TME) from the heat treatment were probably not factors in the failure of the screws in service. 3) The fact that the in-service screws were more brittle than the new screws can also be attributed to the used screws having a higher carbon content as compared to the new screws (see Table II).

SEM photograph of fresh fracture surface showing quasi-cleavage in the case of a new screw. 1000X.

SEM photograph of fresh fracture surface showing intergranular separation (with some void coalescence) in the case of a screw that was removed from service in set "D". 2000X.

SEM photograph of fresh fracture surface showing void coalescence in the core of a new screw. 500X.

SEM photograph of fresh fracture surface showing mixed-mode separation (cleavage and void coalescence) in the core of a screw that was removed from service in set "D". 500X.

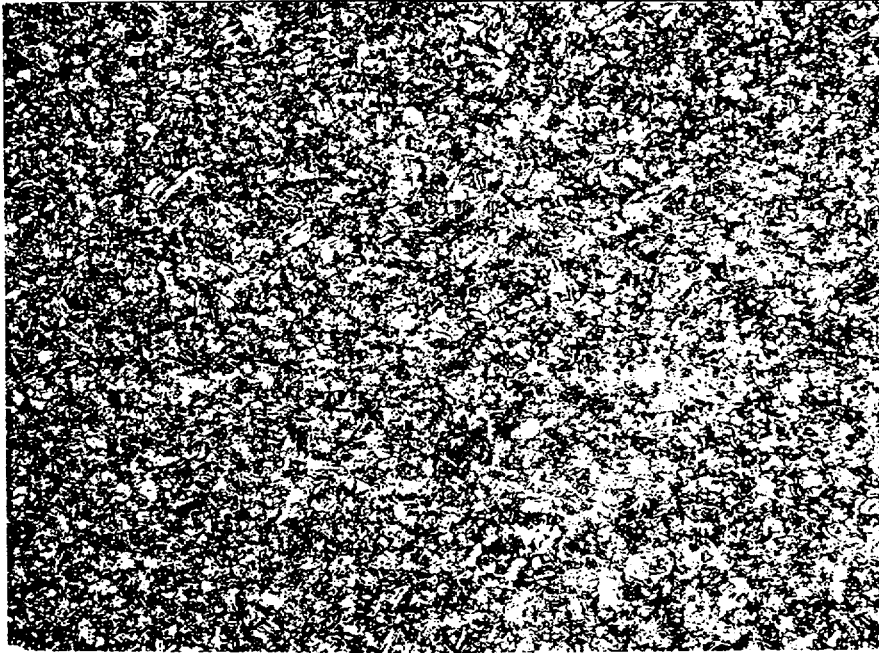
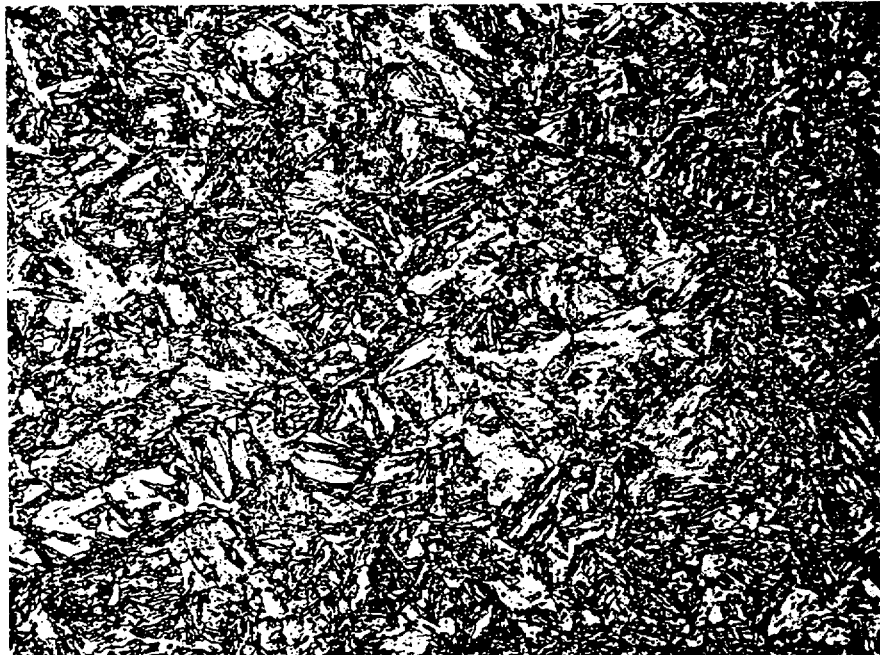
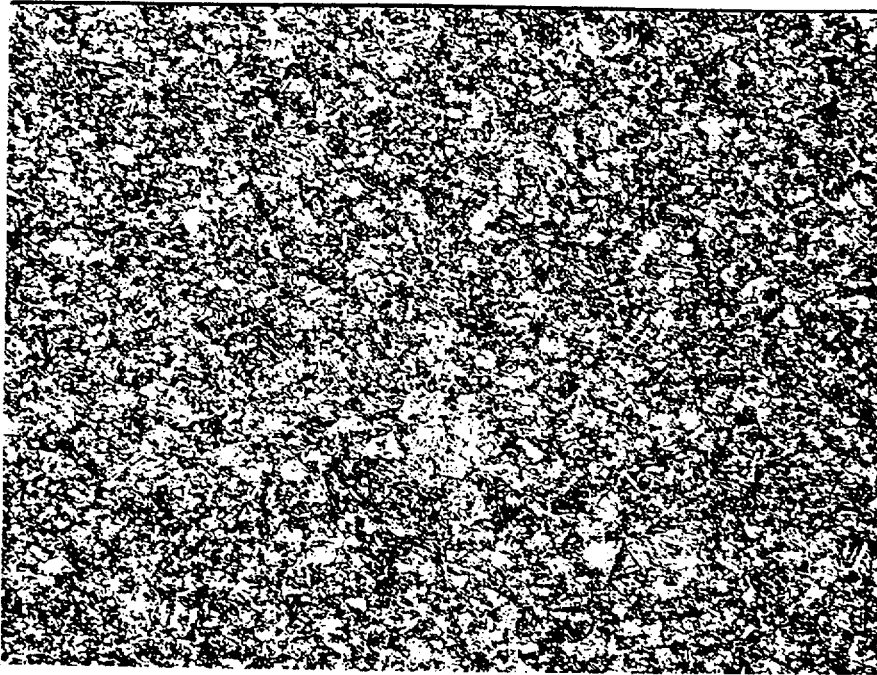
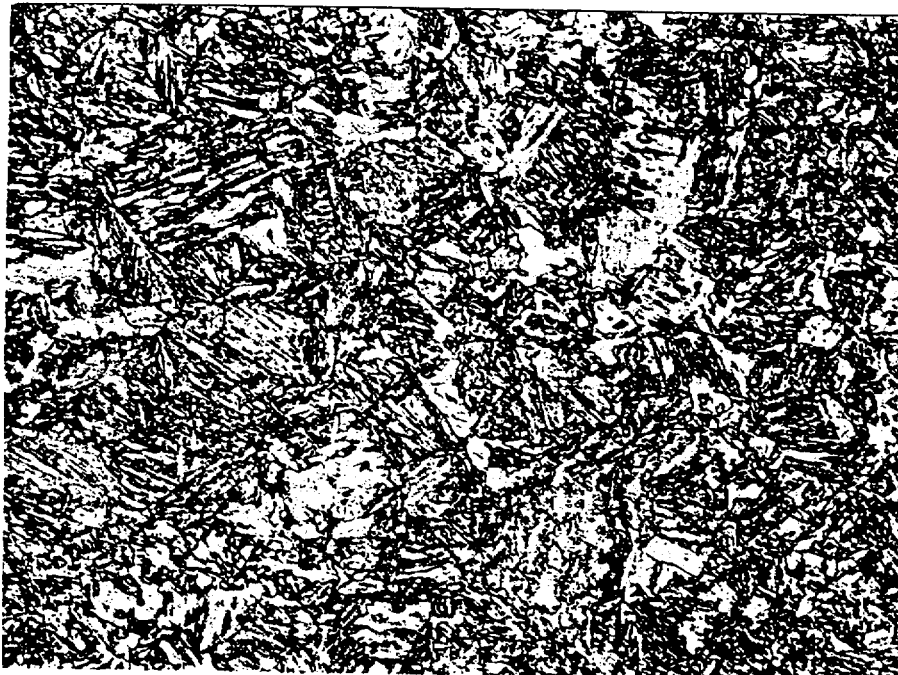
The general microstructure of all screws was determined to be tempered martensite (see Figures 10 and 11). Note that the hardness of martensite is determined by carbon content, thus the used screws with higher carbon contents (except set "H") were harder than the new screws with lower carbon contents (the hardness values of screws in set "H" were not obtained due to lack of time).

General microstructure of a typical new screw: tempered martensite. Top: 100X; Bottom: 500X.

General microstructure of a typical screw that was removed from service in set "G": tempered martensite. Note microstructure was similar for screws in each set that was removed from service. Top: 100X; Bottom: 500X.
