Case No. 2-1998-023

CENTRAL LABORATORIES SERVICES TECHNICAL REPORT	Report No. 95-1021
	Sheet No.: 1 of 2
	Date of Report: JUN 19 1995
Plant/Project: Watts Bar Nuclear Plant	
Subject: ICE CONDENSER BASKET SCREWS	
Standards Used: 904694, 901387, 516825	
Copies Sent to: Vonda Sisson, IOB 1M-WBN (4); RIMS; Lab Files	
Prepared by: Daryl A. Smith / LAB	Approved by: <i>Delsa L. Frazier</i>

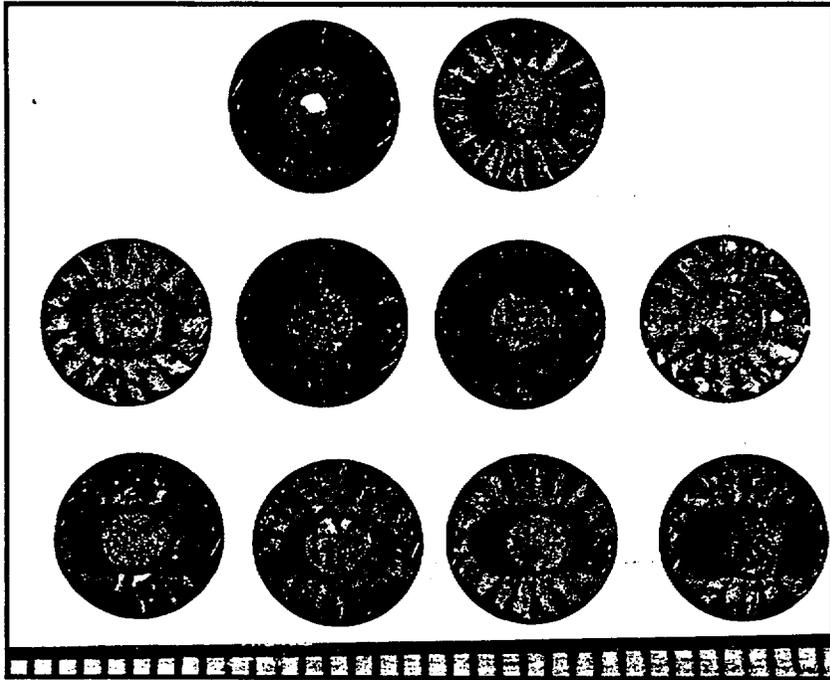
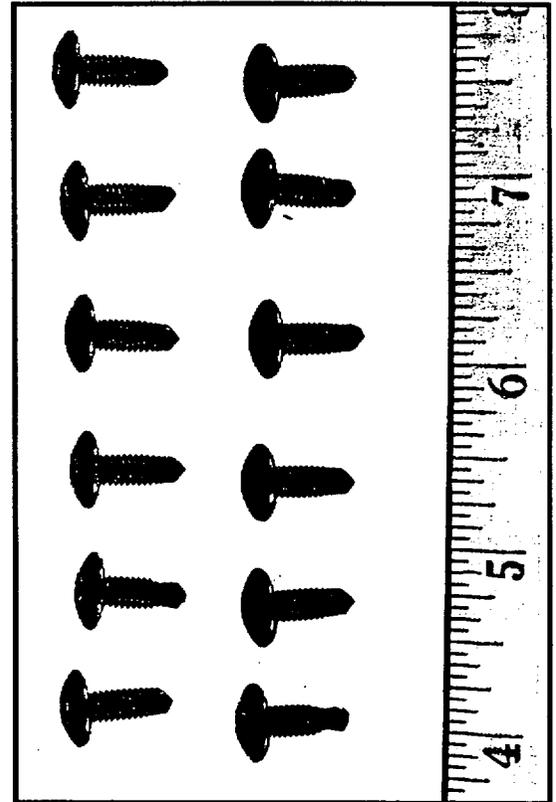
- Set "A" : Ten fractured screw heads that were in service (seen in the upper left view of Figure 1) , and one whole screw that was not in service (not shown).
- Set "B" : Twelve new screws, seen in the upper right view of Figure 1.
- Set "C" : Two screws removed from service, labeled "Bay '24' Top Ring D-6".
- Set "D" : Two screws removed from service, labeled "Bay '24' Bottom Ring D-6".
- Set "E" : Two screws removed from service, labeled "Bay '12' Top Ring A-6".
- Set "F" : Two screws removed from service, labeled "Bay '12' Bottom Ring A-6".
- Set "G" : Two screws removed from service, labeled "Bay '1' Top Ring A-6".
- Set "H" : Two screws removed from service, labeled "Bay '1' Bottom Ring A-6".

Left: As-received photograph of the fractured screws (set "A"). Note that the unfractured screw from this set is not shown. Right: As-received photograph of the new screws (set "B").

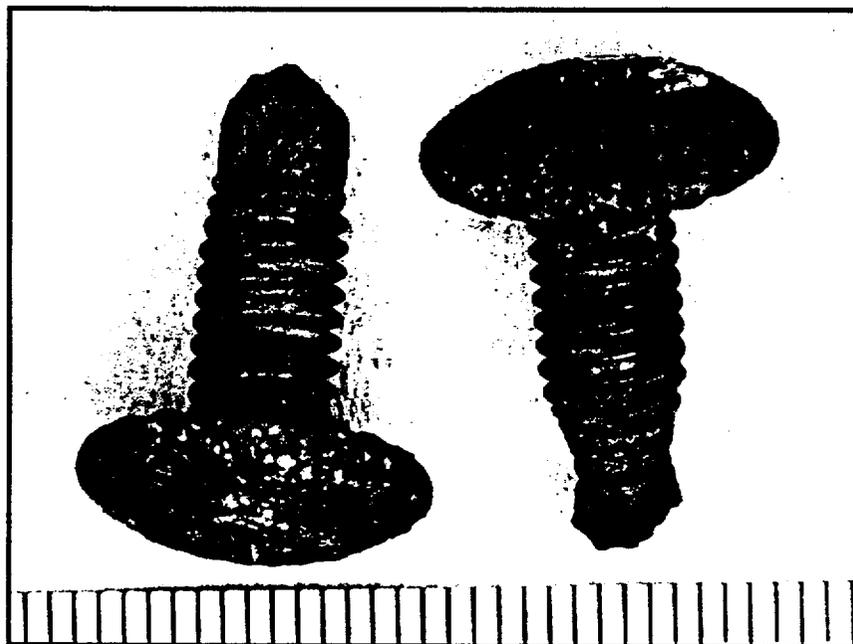
All screws removed from service had varying amounts of corrosion products on them, mostly in the threaded region. The lower view of Figure 1 shows a typical set of screws that were removed from service.

As-received photograph of a typical pair of used screws. Note that each set of used screws (set "C" through set "H") varied in degree of corrosion.

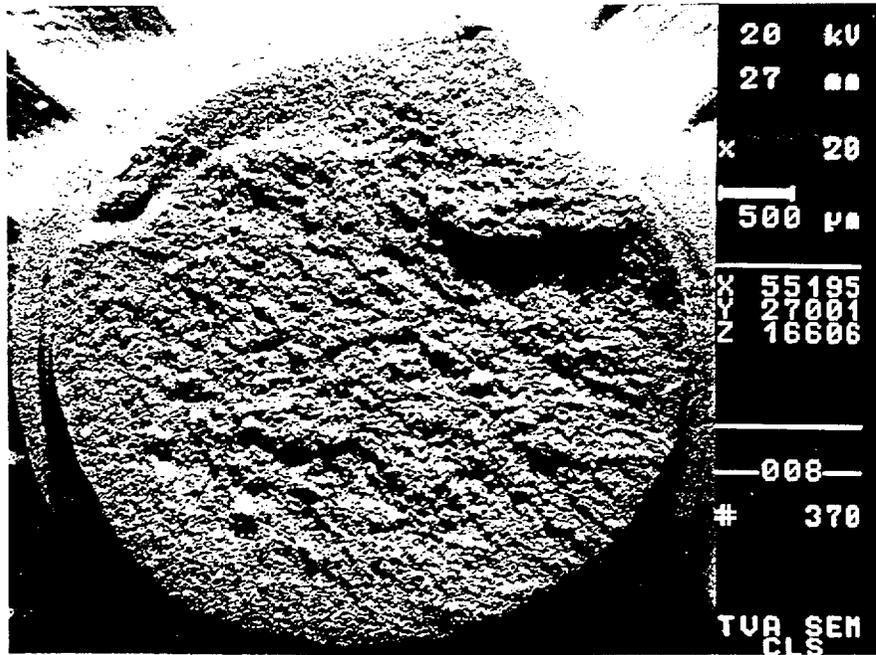
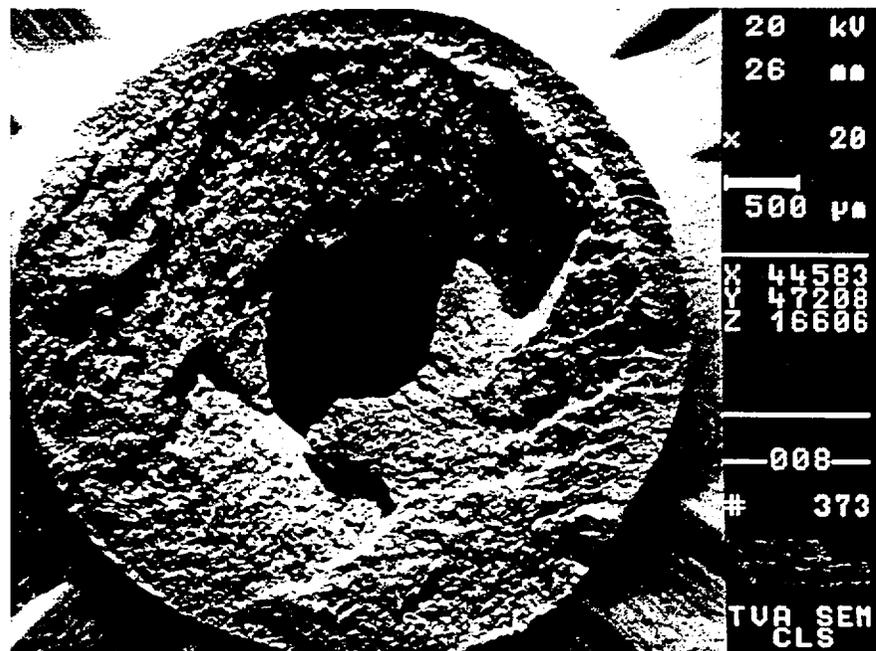
The fractured screws that were in service in set "A" were examined in a Scanning Electron Microscope (SEM) in order to determine the mode of failure. Figures 2 and 3 show that the screws fractured in a brittle manner

as indicated by the intergranular failure mode seen on the screws that were examined. There was usually a small final-fracture area on the fracture surface near the center of the shank that failed in a ductile manner.

SEM photographs of typical fracture surfaces taken from fractures screws (set "A"). Note that all fractured screws received in set "A" failed in a brittle manner (except for the small final fracture area near the center which failed in a ductile manner). 20X.

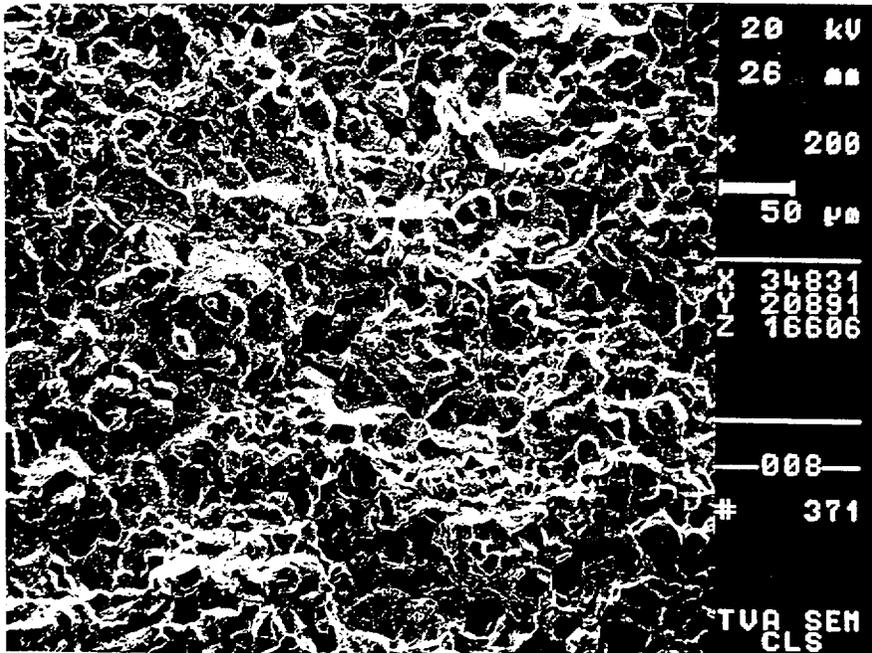
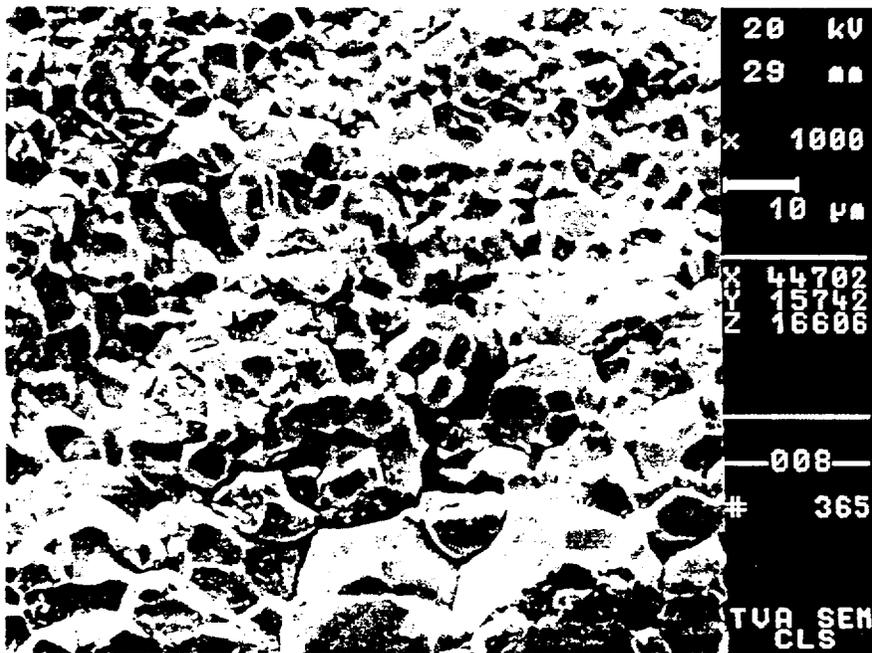
Figure 3: Ice Condenser Basket Screws, Watts Bar Nuclear Plant, Unit No. 1. Customer Identification No. 95-07, Laboratory Report No. 95-1021.

In conclusion, the failure mode of the fractured screws from set "A" was intergranular separation. The screws that were checked for chemistry were similar to the 1022 carbon steel which was specified in Westinghouse Equipment Specification No. 678956.

SEM photographs of typical fracture topography seen on failed screws in set "A." The "rock-candy" appearance indicates that these screws failed in a brittle, intergranular manner. Top: 200X; Bottom: 1000X.

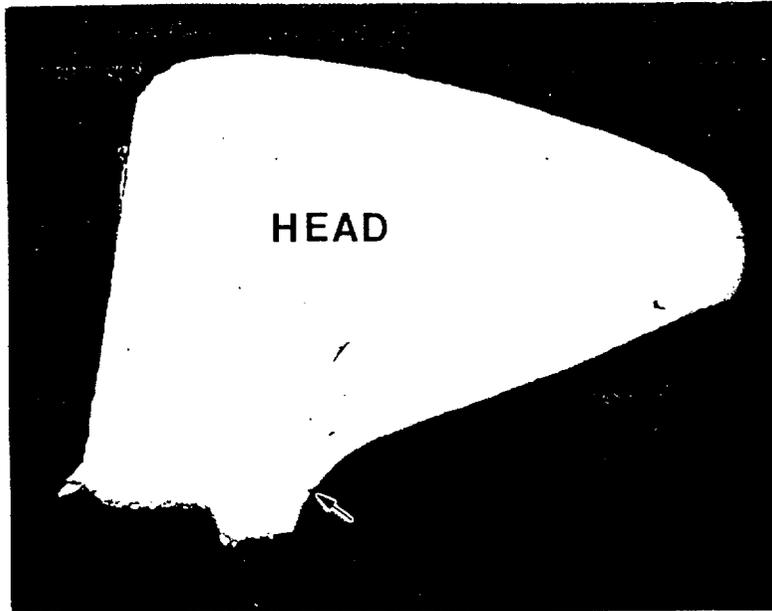
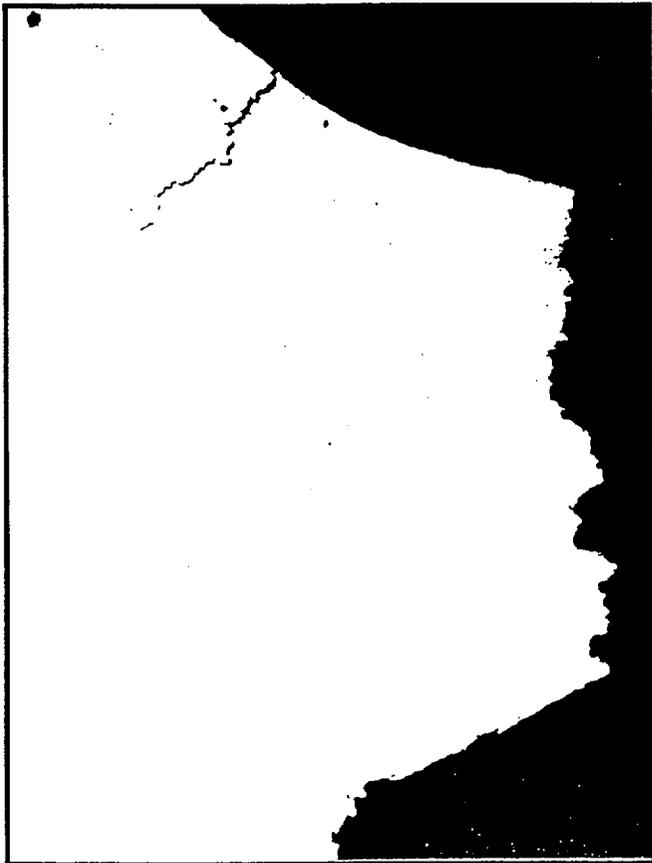
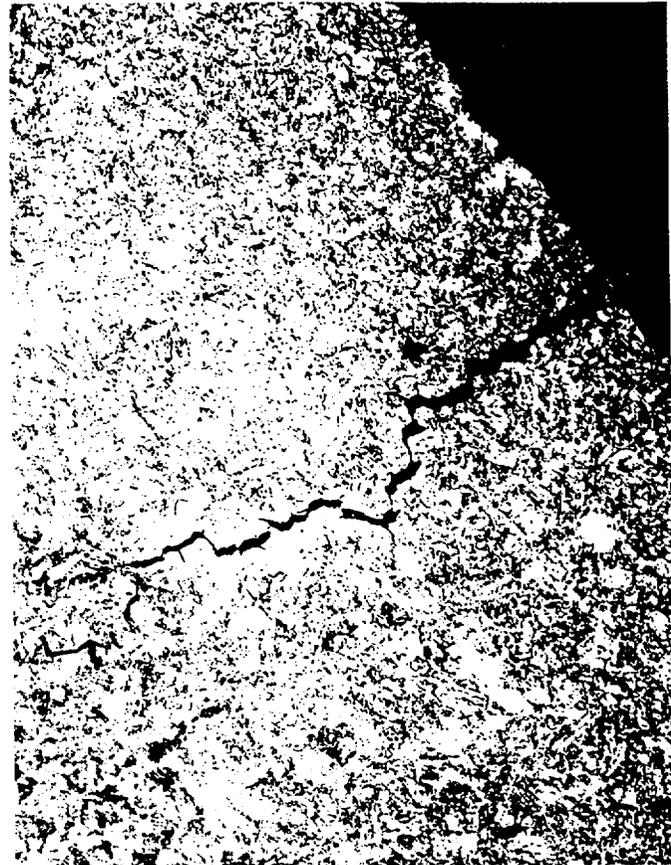
Figure 4:

An arbitrarily selected fractured screw (that was in service) from set "A" was cut so that a longitudinal cross-section through the fracture surface could be examined. Note that a secondary crack of intergranular nature was noticed above the fracture surface as seen in Figure 4. A screw from set "G" was similarly sectioned, and two cracks were found in adjacent thread roots as seen in Figures 5 and 6. Similar intergranular cracks were discovered in a transverse section of the whole screw from set "A" and at the thread roots of a screw from set "H" (Figure 7).

Screws from sets "C", "G", and "H" contained intergranular cracks similar to those seen in Figures 5, 6, and 7. Note that the intergranular crack found in a representative sample taken from a fractured screw in set "A" seen in Figure 4 differed from the intergranular cracks seen in Figures 5 through 7 because it was probably a secondary crack (since it is above the primary fracture and perpendicular to the curved neck of the screw rather than at the thread roots).

Longitudinal cross section through a fractured screw. The arrow points to a secondary crack above the fracture surface. 20X. As-polished.

Close-up views of secondary crack seen in the upper view of this Figure. Left: As-polished, 125X; Right: Vilella's etch, 400X.

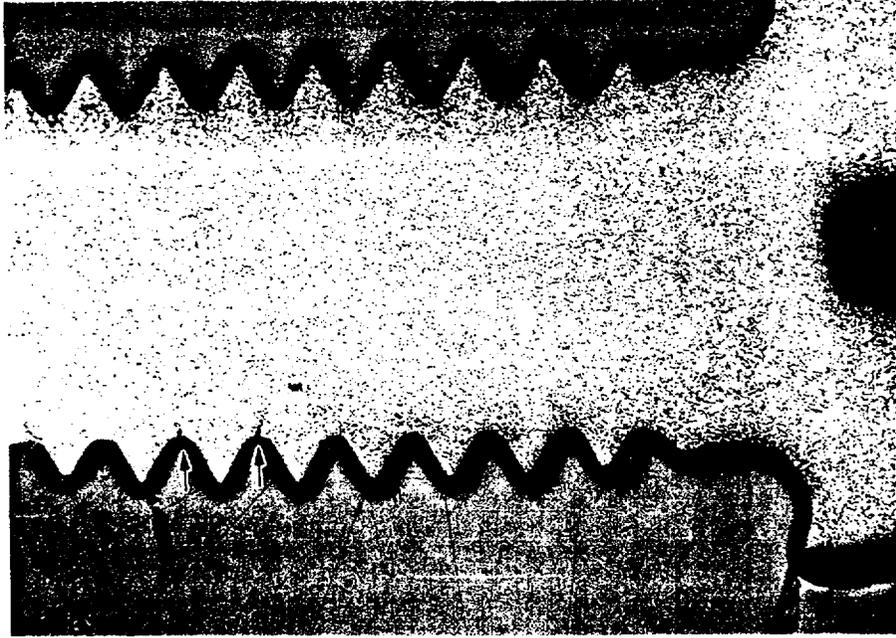
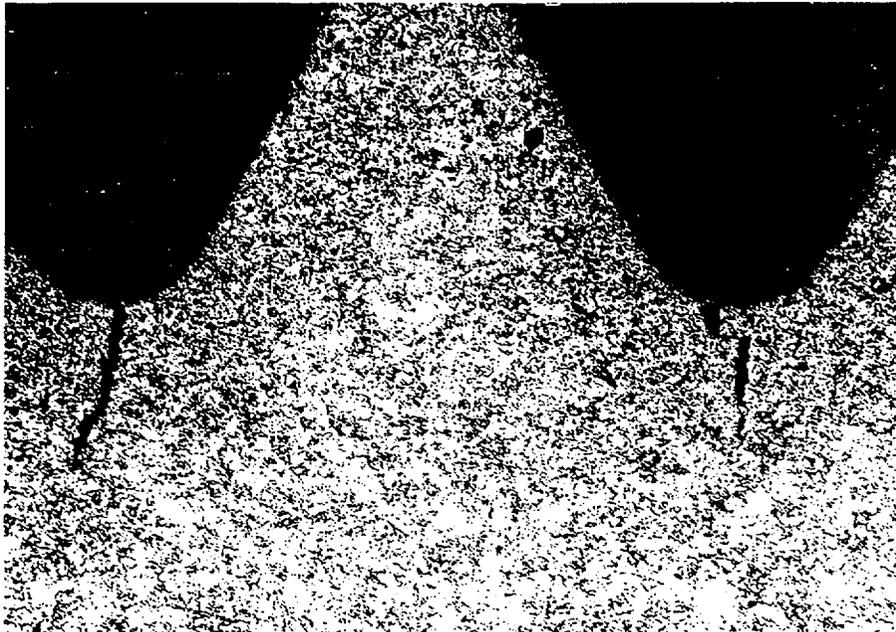
Longitudinal view of cracks present in one of the screws that were removed from service in set "G". Top: 12X; Bottom: 100X.

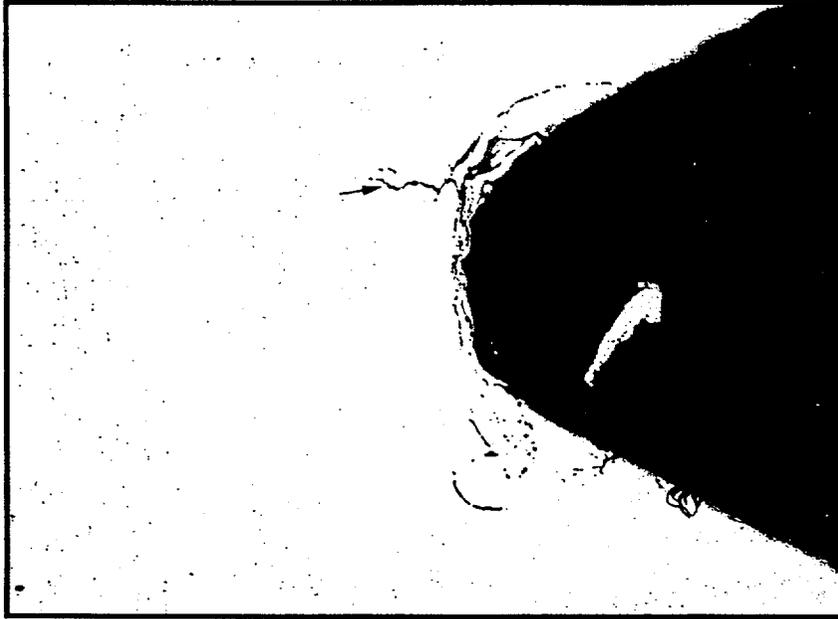
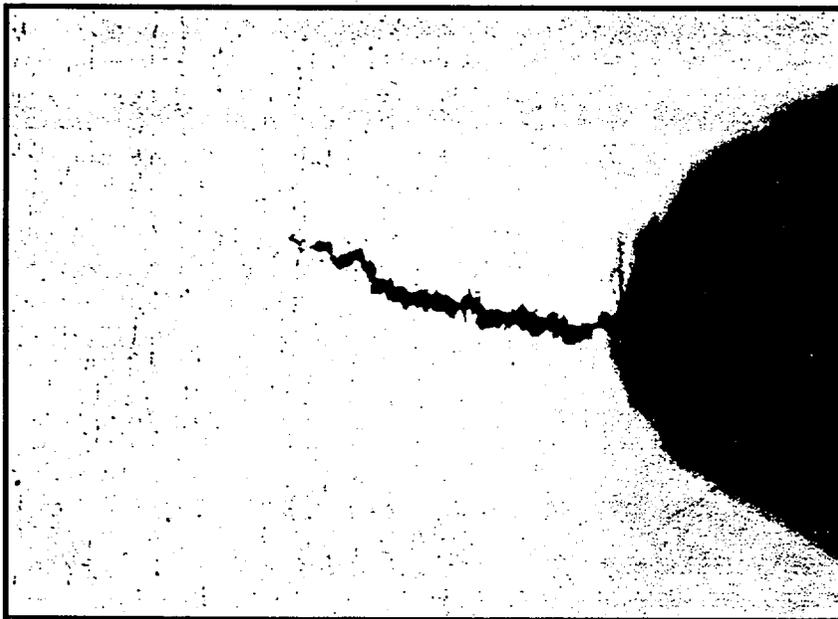
Figure 6:

EDX* analysis of the material in one of the cracks seen in the longitudinal cross section of a screw from set "G" revealed the presence of zinc as seen in Table I. Note in the upper view of Figure 6 that a lapped area was present at the thread roots of a screw from set "G". Similar lapped regions were discovered at the tip, face, and roots of every screw that was examined and is typical of the thread rolling process.

As-polished, longitudinal view of lapping present at tooth root of a screw that was removed from service in set "G". 200X.

As-polished, longitudinal view of crack present at tooth root of a screw that was removed from service in set "G". 200X.

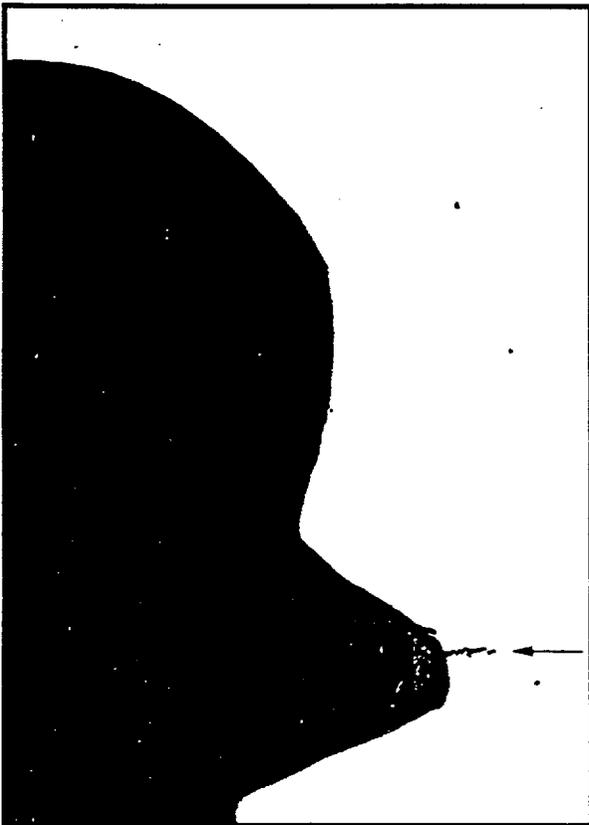
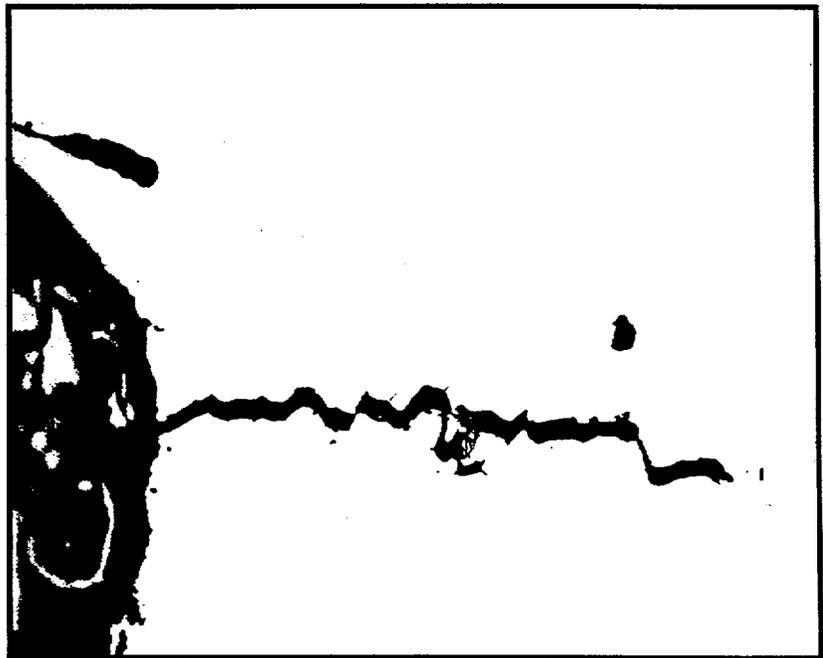
Figure 7:

Intergranular crack found at thread root of first thread below head in a longitudinal cross section of a screw that was removed from service in set "H". Left: 50X; Right: 500X. As-polished condition.

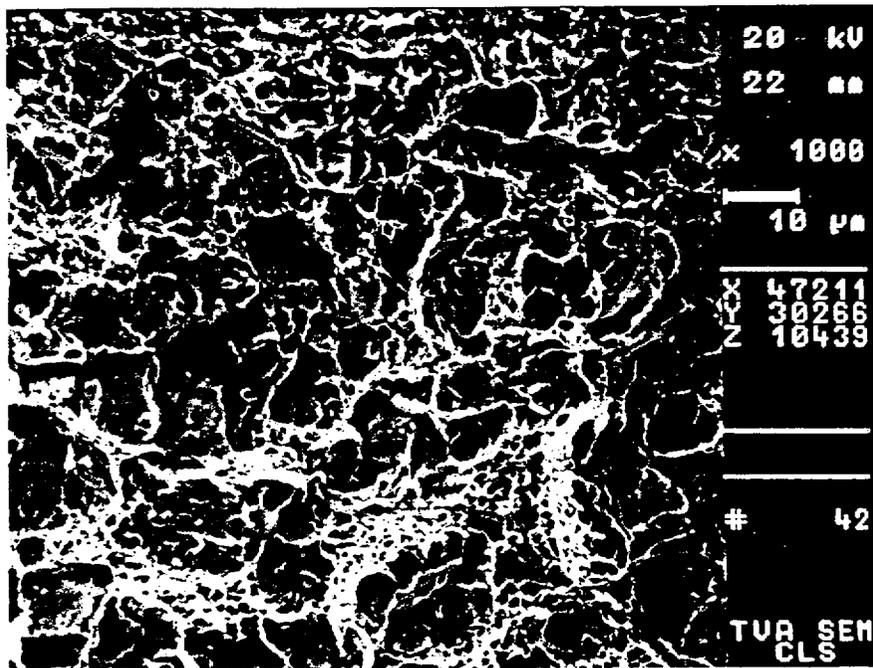
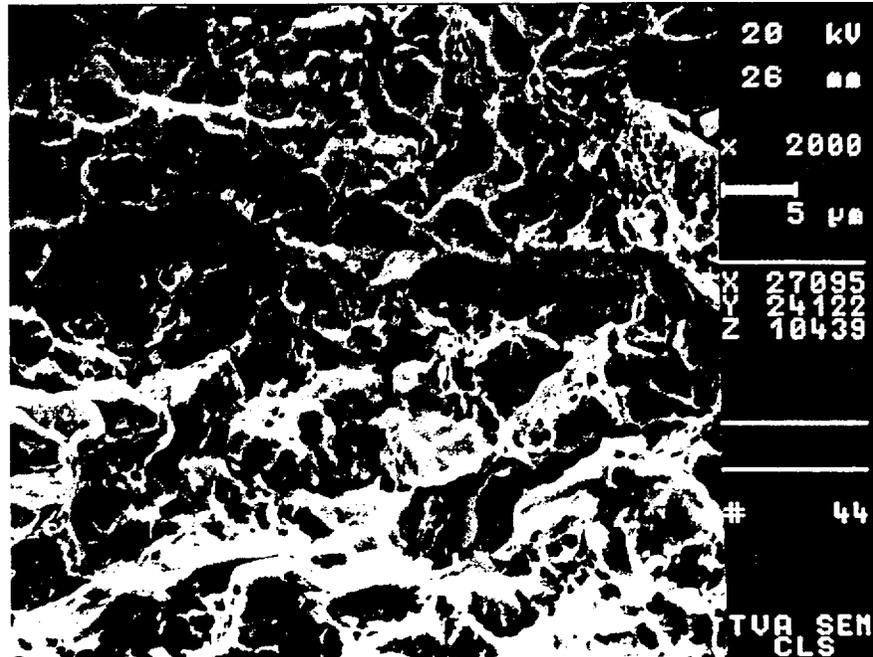
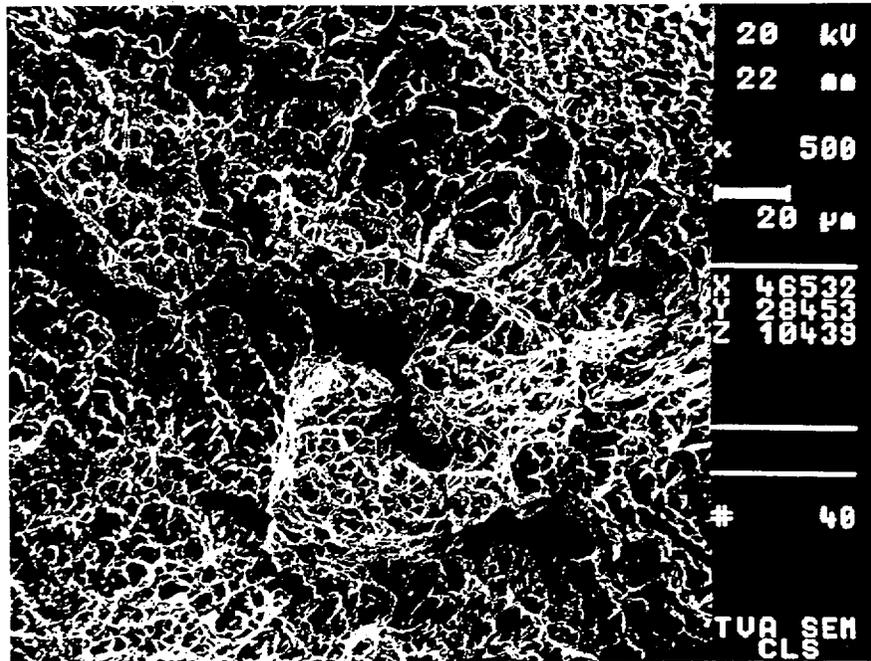
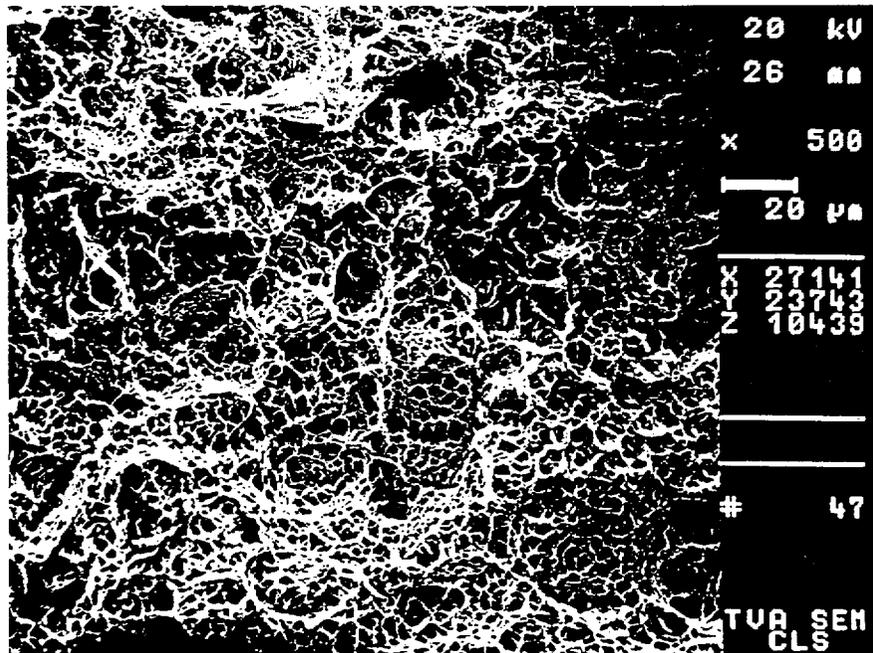
Two screws, one from set "A" and one from set "G," were intentionally fractured with a hammer in order to determine the failure mode. SEM photography shows in Figures 8 and 9 that the screw from set "G" failed by intergranular fracture in the case and mixed-mode fracture (cleavage and void coalescence) in the core, while the whole screw from set "A" failed by quasi-cleavage in the case and void coalescence in the core. At the customer's request, additional screws were broken (two from set "C" and two new screws from set "B") in the same manner, except at 15°F. Subsequent SEM analysis of the resultant fracture surfaces revealed that the screws failed by void coalescence.

SEM photograph of fresh fracture surface showing quasi-cleavage in the case of a new screw. 1000X.

SEM photograph of fresh fracture surface showing intergranular separation (with some void coalescence) in the case of a screw that was removed from service in set "D". 2000X.

SEM photograph of fresh fracture surface showing void coalescence in the core of a new screw. 500X.

SEM photograph of fresh fracture surface showing mixed-mode separation (cleavage and void coalescence) in the core of a screw that was removed from service in set "D". 500X.

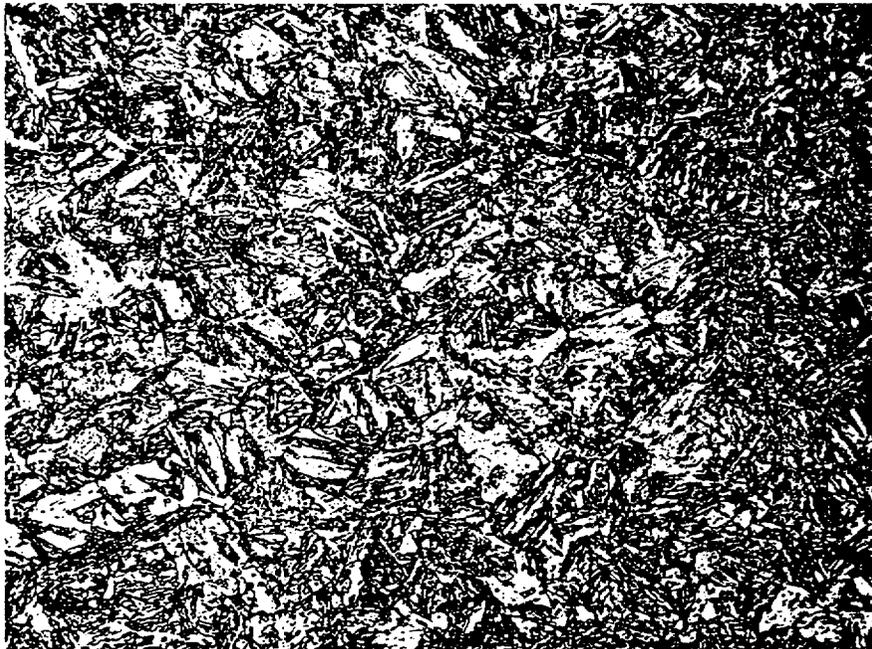
Figure 10: Ice Condenser Basket Screws, Watts Bar Nuclear Plant, Unit No. 1. Customer Identification No. 95-07, Laboratory Report No. 95-1021.

The general microstructure of representative screws from each set was determined to be tempered martensite (see Figures 10 and 11). Note in Figure 12 that slack-quenched areas consisting of ferrite networks on prior-austenite grain boundaries in a matrix of intermediate transformation products was discovered near the thread roots of four new screws from set "B" and one screw from set "H". The screw samples from set "G" were destroyed for other testing and could not be checked for the presence of the slack-quenched microstructure.

General microstructure of a typical new screw: tempered martensite. Top: 100X; Bottom: 500X.
