ORDER FOR MODIFICATION OF LICENSE

SAFETY EVALUATION OF MECHANICAL PLUGS TO BE INSERTED INTO THE BYPASS

HOLES OF THE VERMONT YANKEE NUCLEAR POWER PLANT

**SAFETY EVALUATION OF MECHANICAL PLUGS TO BE
INSERTED INTO THE BYPASS HOLES
OF THE DUANE ARNOLD ENERGY CENTER REACTOR**

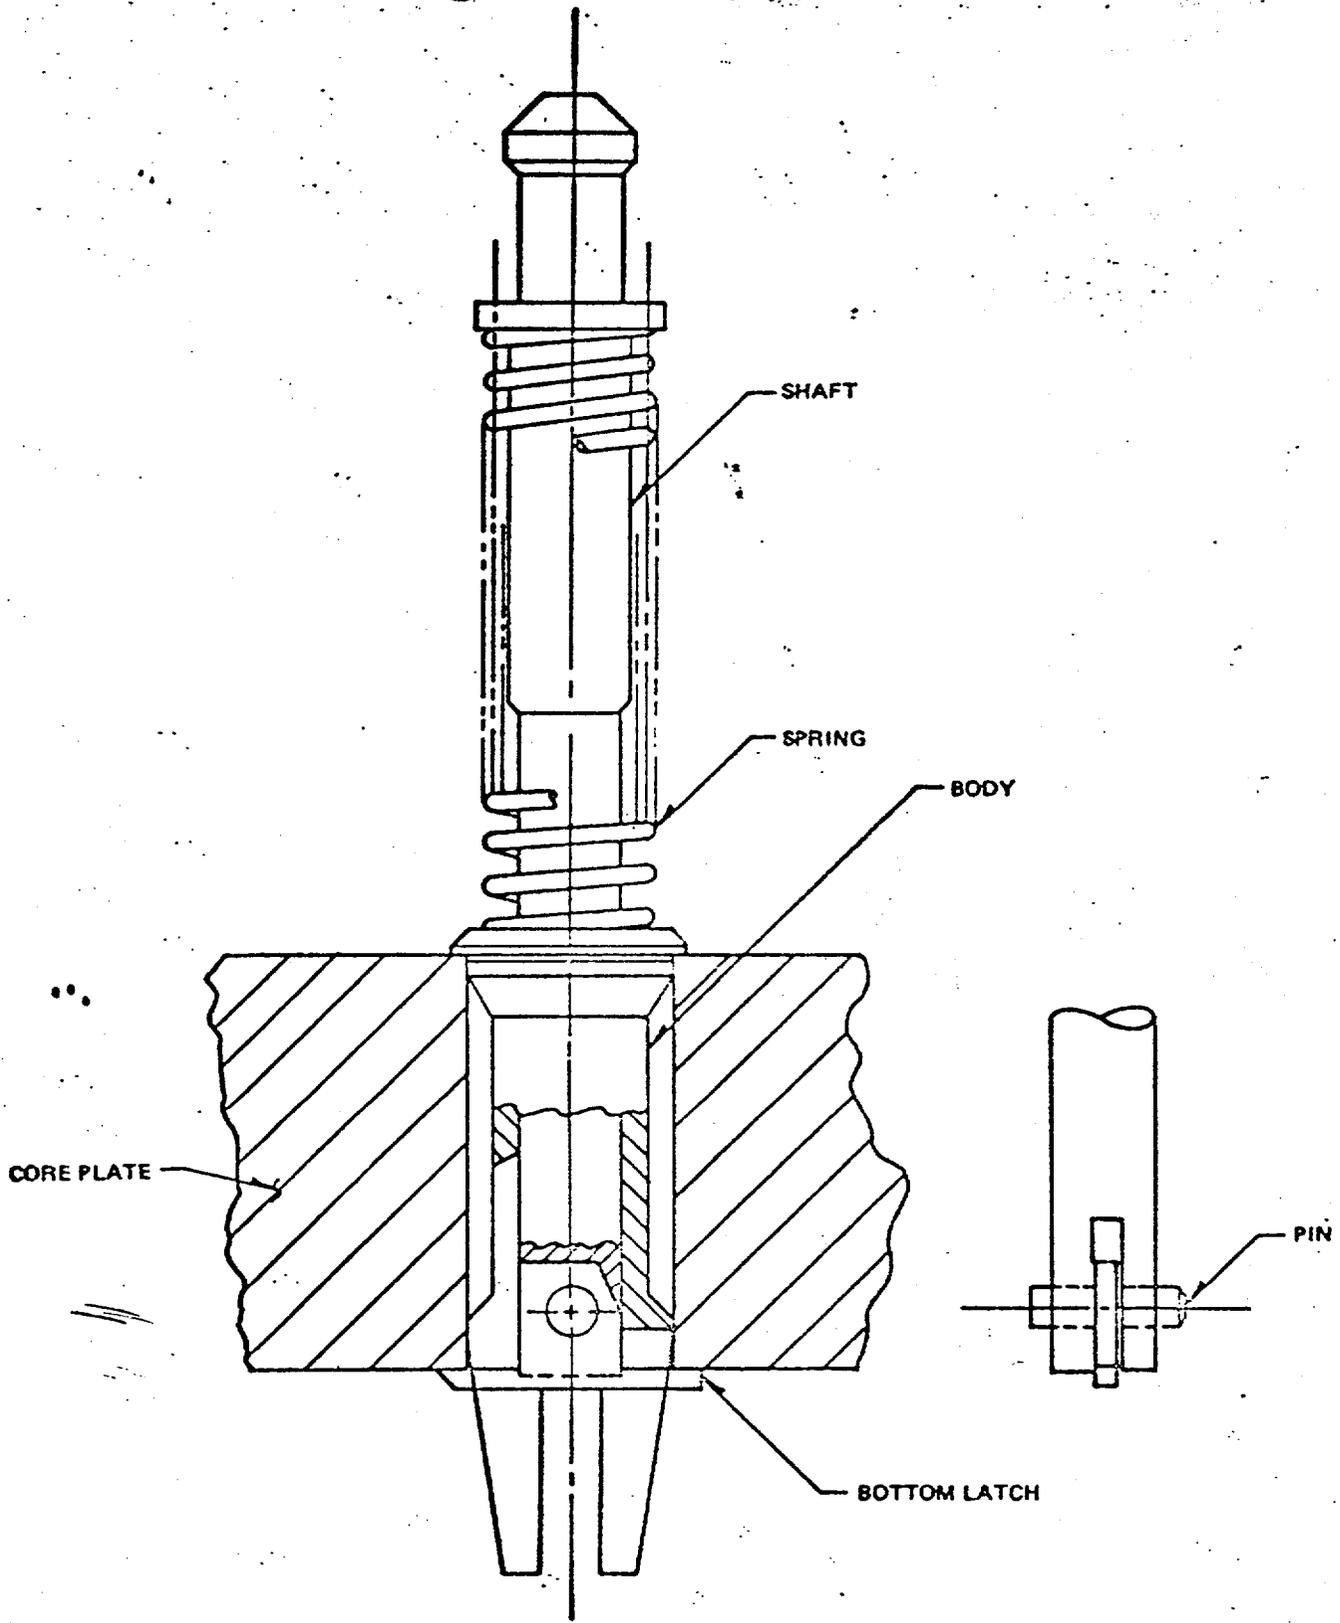
Figure 1. Plug Installed in Core Plate

The plug consists of five basic parts, as shown in Figure 1. Identical plugs have previously been installed at Vermont Yankee, Pilgrim, and Duane Arnold. The body provides a means of guiding the device into the bypass flow holes as well as a shoulder to support the plug and form a seal against water flow. The shaft extends through the body. A knob is provided at the top of the shaft to provide a means of grabbing the plug during installation and extraction. At the bottom, the latch is attached to the shaft by a pin. The latch is free to rotate during installation. The spring acts against the body and shaft during normal operation to provide the force necessary to offset the pressure differential acting on the body.

During installation, the plug has its latch rotated 90 degrees from its installed position and withdrawn and locked in the body. The shaft is gripped by the installation tool, and the plug is inserted into the bypass flow holes. The body engages the rim of the hole. The shaft is pushed to its full extension, thus lowering and unlocking the latch below the underside of the core plate. The latch then rotates 90 degrees and bears on the bottom of the core plate. After insertion, the plug is pulled with about 30-pound force to test the placement.

The plug can be removed by gripping the top of the shaft with an extracting tool and applying a force of about 500 pounds. The latch's legs will be plastically deformed and the entire plug withdrawn. The plugs previously installed at Vermont Yankee were removed with no abnormalities or loose pieces reported. The force required for removal varied from 500 to 1300 pounds

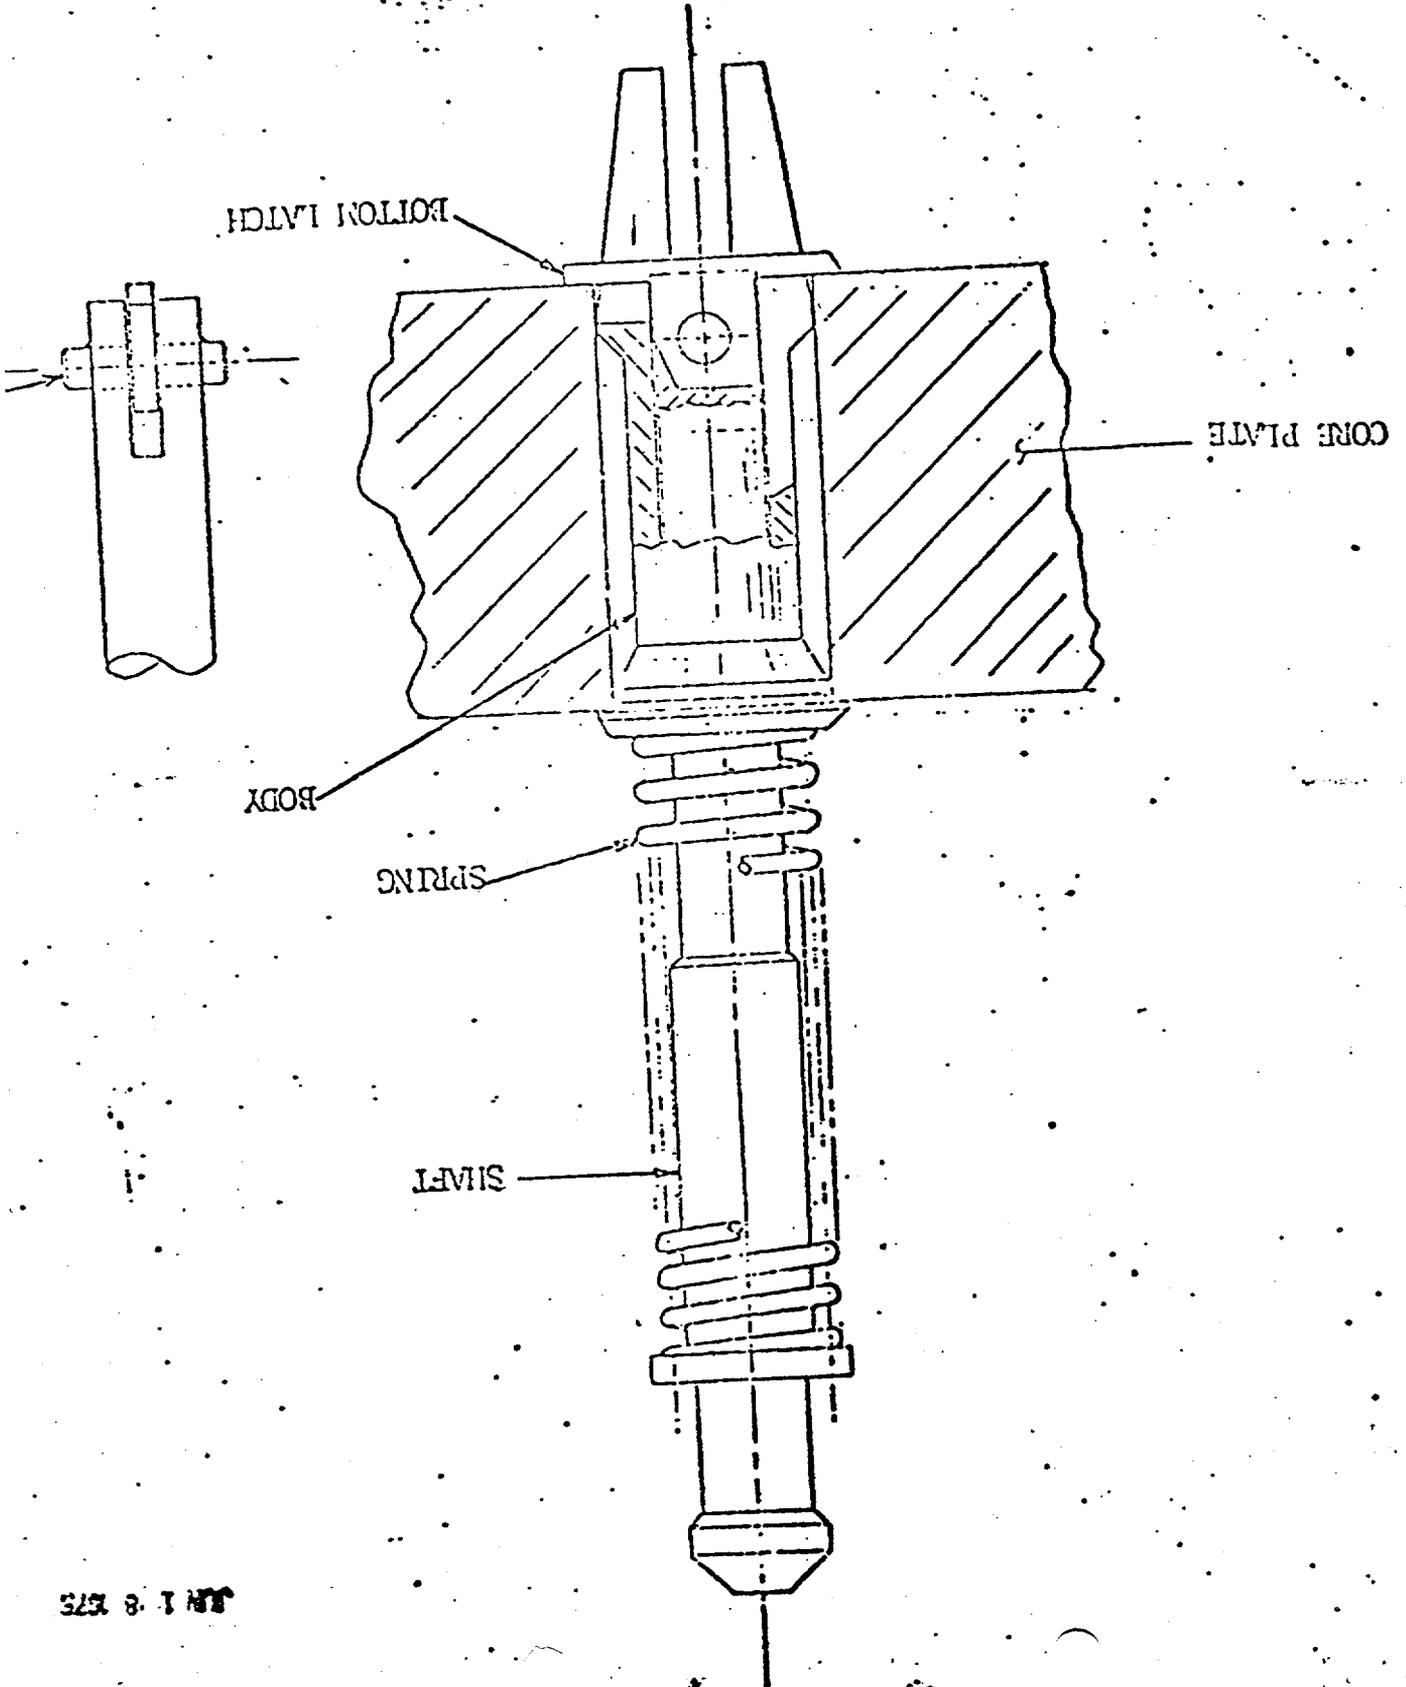
Figure 1
Plug Installed in Core Plate

A correlation between BWR channel box wear and lower core plate bypass flow holes has led to the development of a mechanical plug to fill these holes (Figure 1).

The core plate plug consists of two stainless steel parts (body and shaft) which are connected by an Inconel spring. The shoulder of the body rests on the top of the core plate along the rim of a one-inch bypass hole and is pressed down by the spring. An equal and opposite force is applied on the shaft. A stainless steel latch is connected to the bottom of the shaft by means of a pin. This latch is free to rotate about the pin and latches the shaft to the core plate. The spring exerts a minimum load of 38 lbs on the body and latch and a maximum of 46 lbs (with the worst tolerance combination).

During installation the latch is in a position rotated 90 degrees from its installed position and is withdrawn into the body. The shaft is gripped by the installation tool and the plug is inserted into the bypass flow hole. First the body engages the rim of the hole and then the spring is compressed to push the shaft to its full extension.

The latch then comes out of the body and rotates 90 degrees by means of an eccentric weight with respect to the pin. When the installation tool is relaxed, the latch bears against the bottom of the core plate. After insertion, the plug is pulled with about 30 lbs force to check its placement. At the end of the next fuel cycle (after approximately
