SUBJECT: DIABLO CANYON INSPECTION REPORT NO. 50-275/01-03; 50-323/01-03

Facility: Diablo Canyon Nuclear Power Plant, Unit 1 and 2

Attachment 2 Auxiliary 1-2 Overheated Joint 309

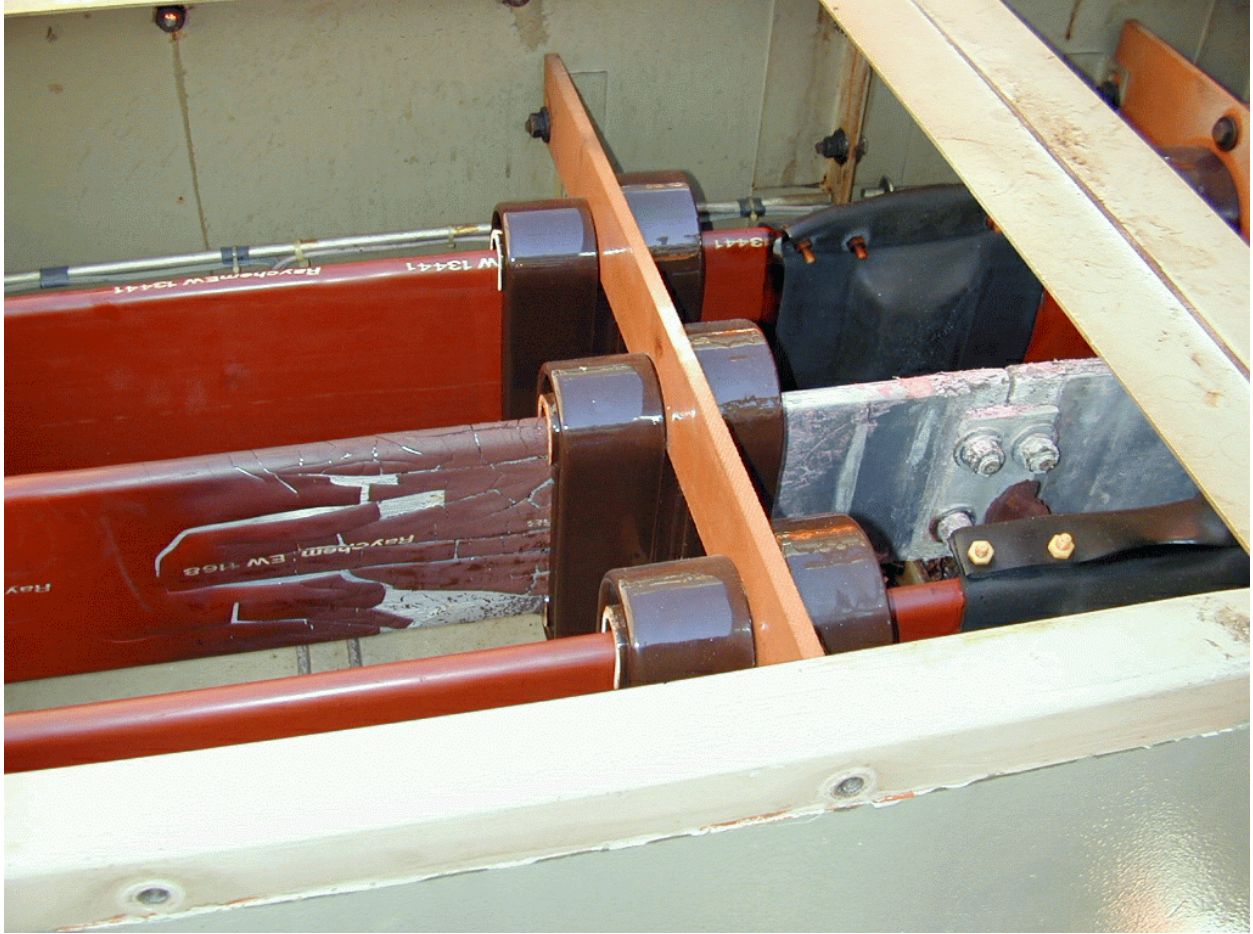
View 2 of BUS 309 Showing degraded Insulation on Bus Bar
