Byron Station, Unit 2  
Facility Operating License No. NPF-66  
NRC Docket No. 50-455

Subject: Steam Generator Inservice Inspection Summary Report

**STEAM GENERATOR EDDY CURRENT INSPECTION REPORT**

**CYCLE 9 REFUELING OUTAGE (B2R09)**

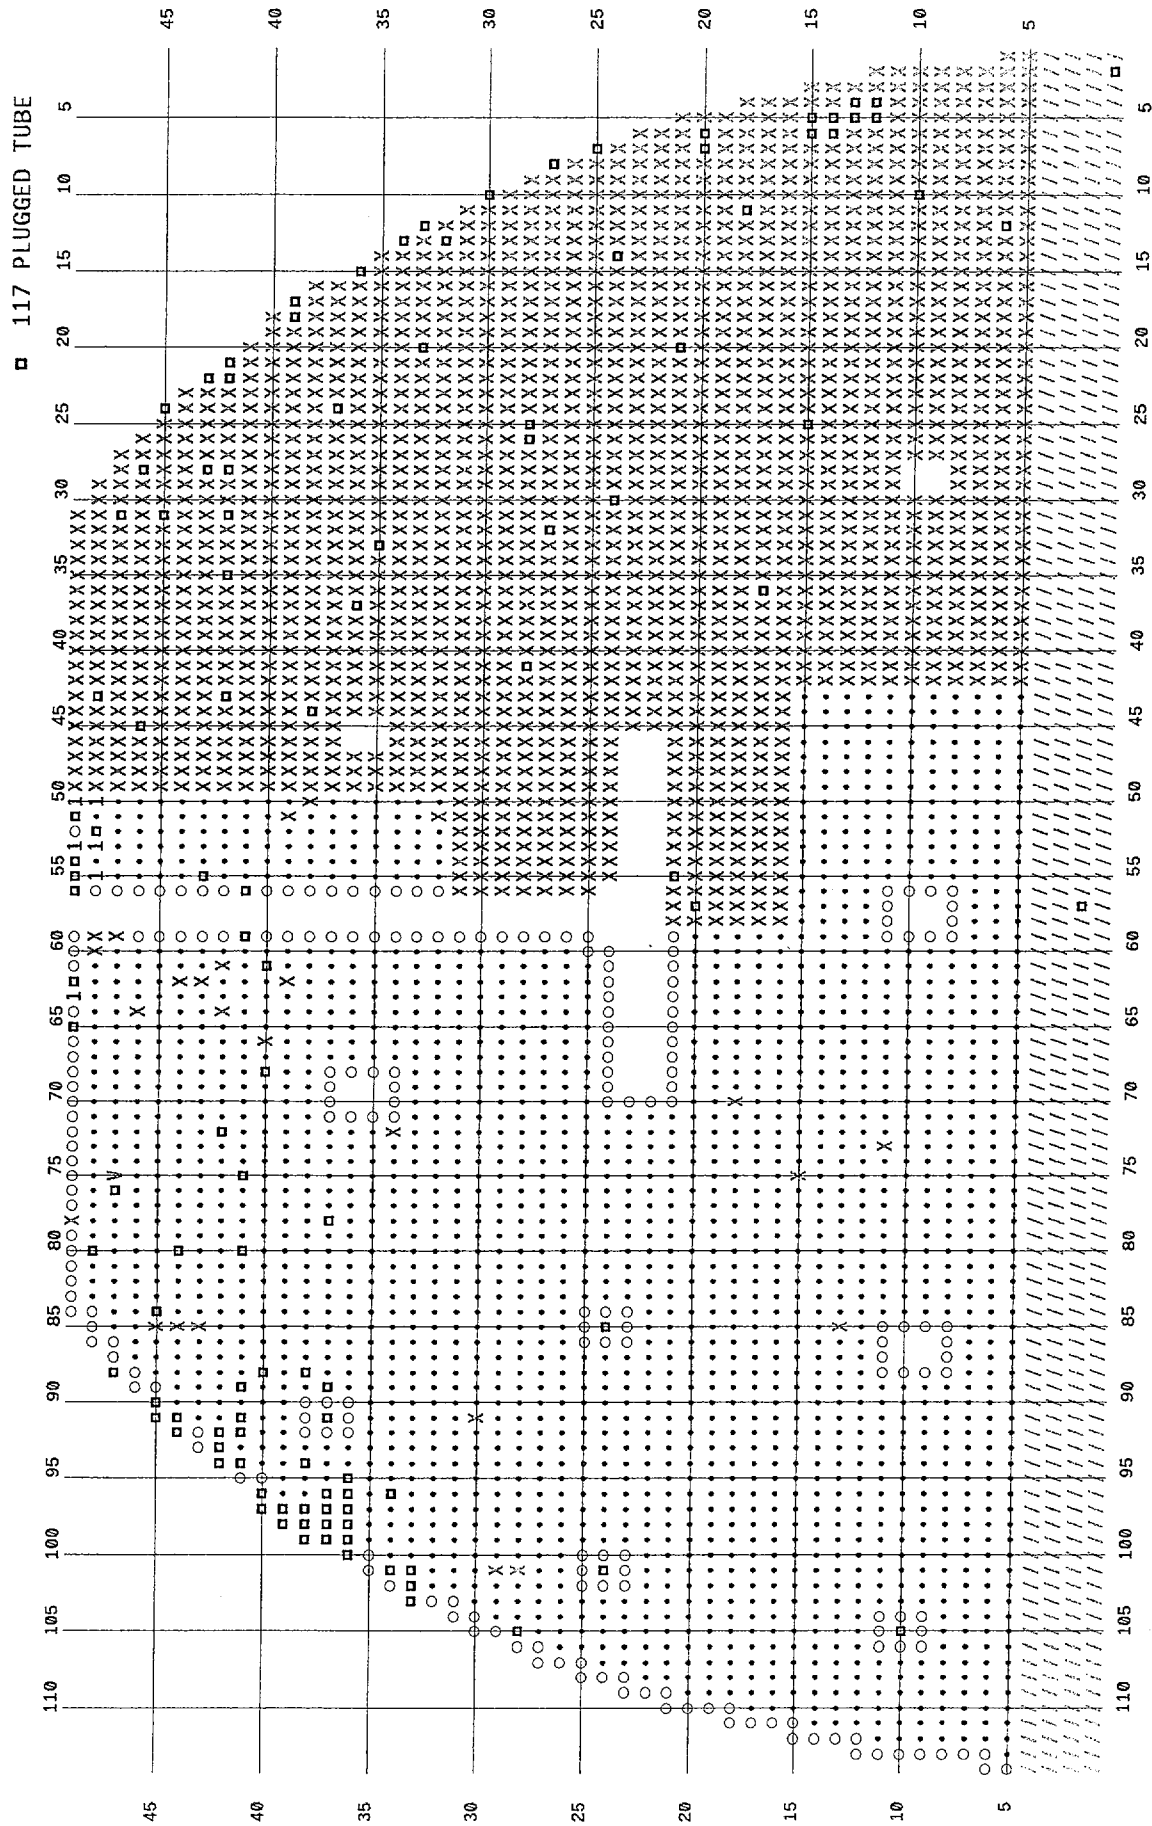
**FIGURE A.2**  
**SG B COLD LEG BOBBIN COIL INSPECTION SCOPE**

X 1751 TESTED TEN THROUGH TEC  
 / 454 TESTED 11H THROUGH TEC  
 1 6 TESTED 11C THROUGH TEC  
 V 1 TESTED AV1 THROUGH TEC

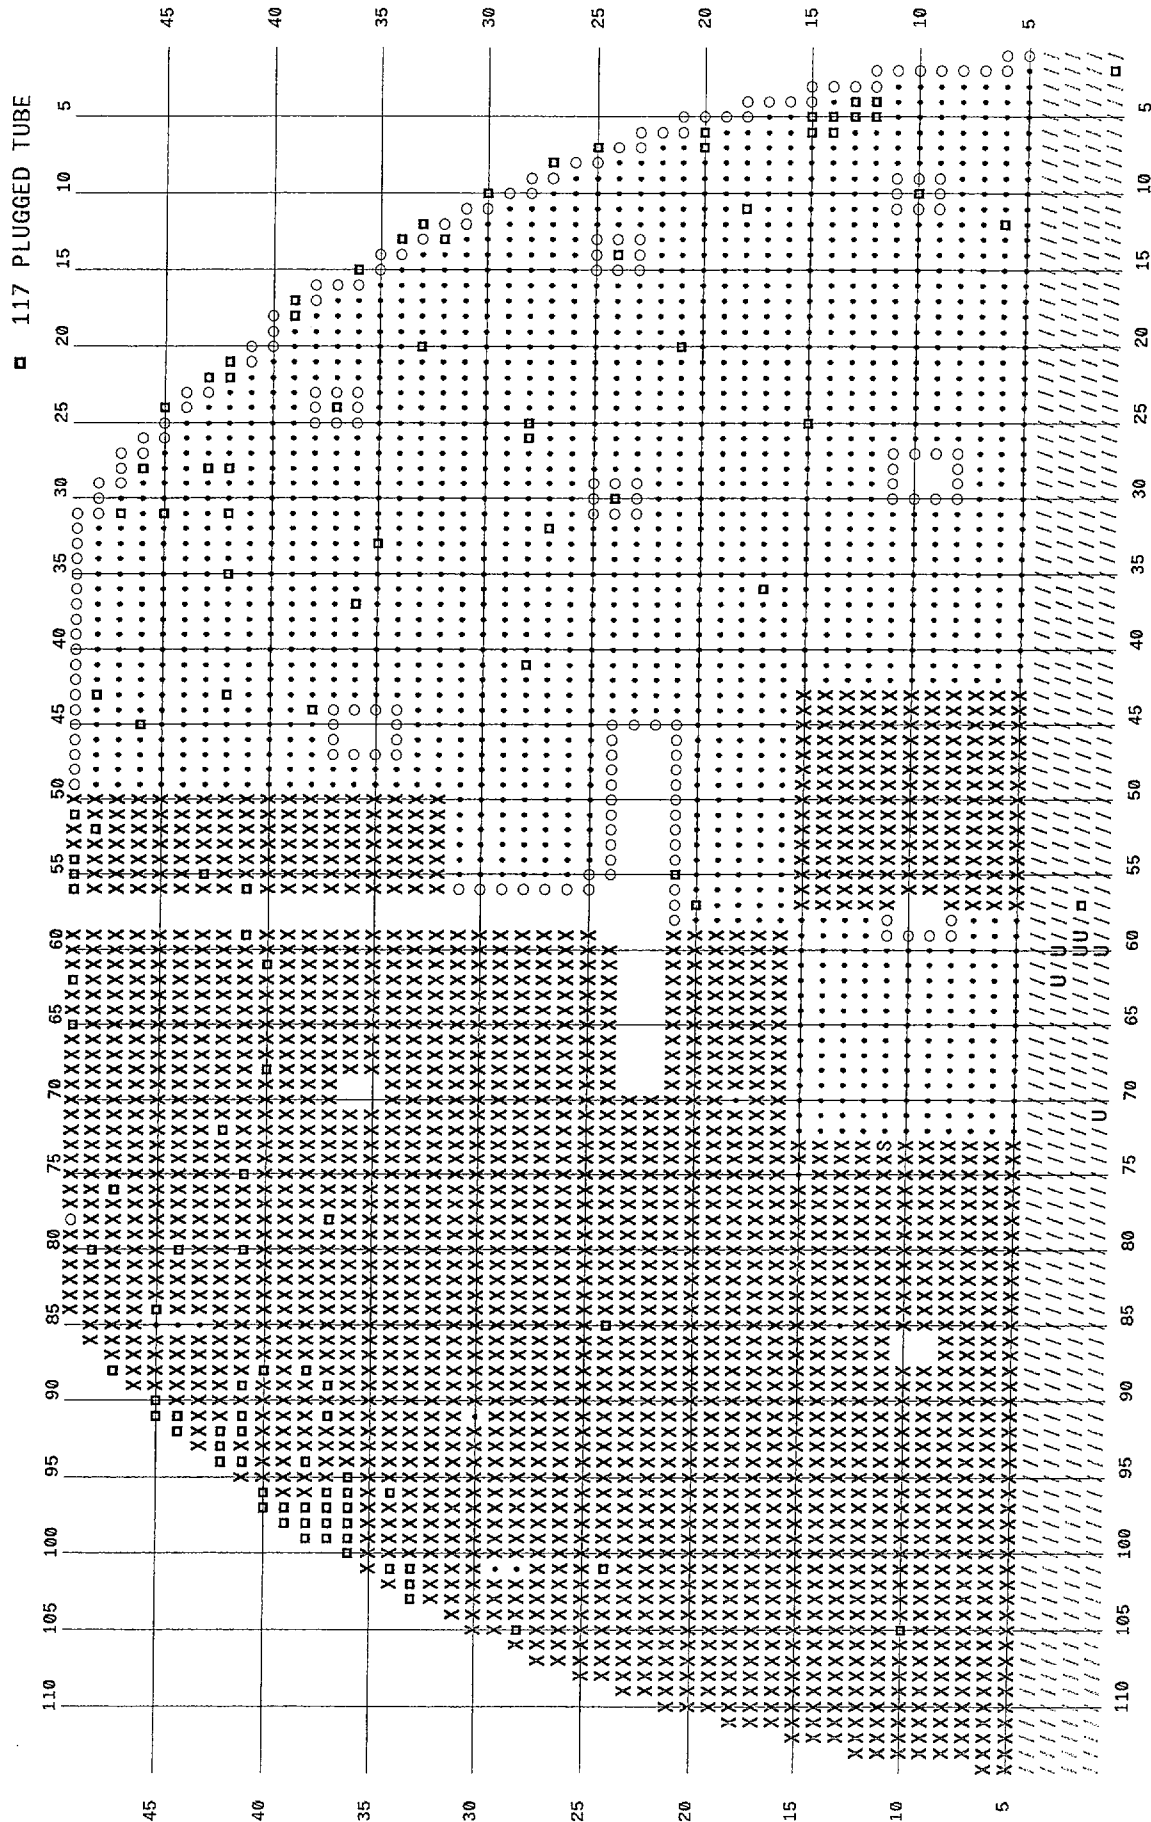
**FIGURE A.3**  
**SG B HOT LEG BOBBIN COIL INSPECTION SCOPE**

X 2107 TESTED TEC THROUGH TEH  
 / 448 TESTED 11H THROUGH TEH  
 U 6 TESTED 11C THROUGH TEH  
 S 1 TESTED TEC THROUGH TSH

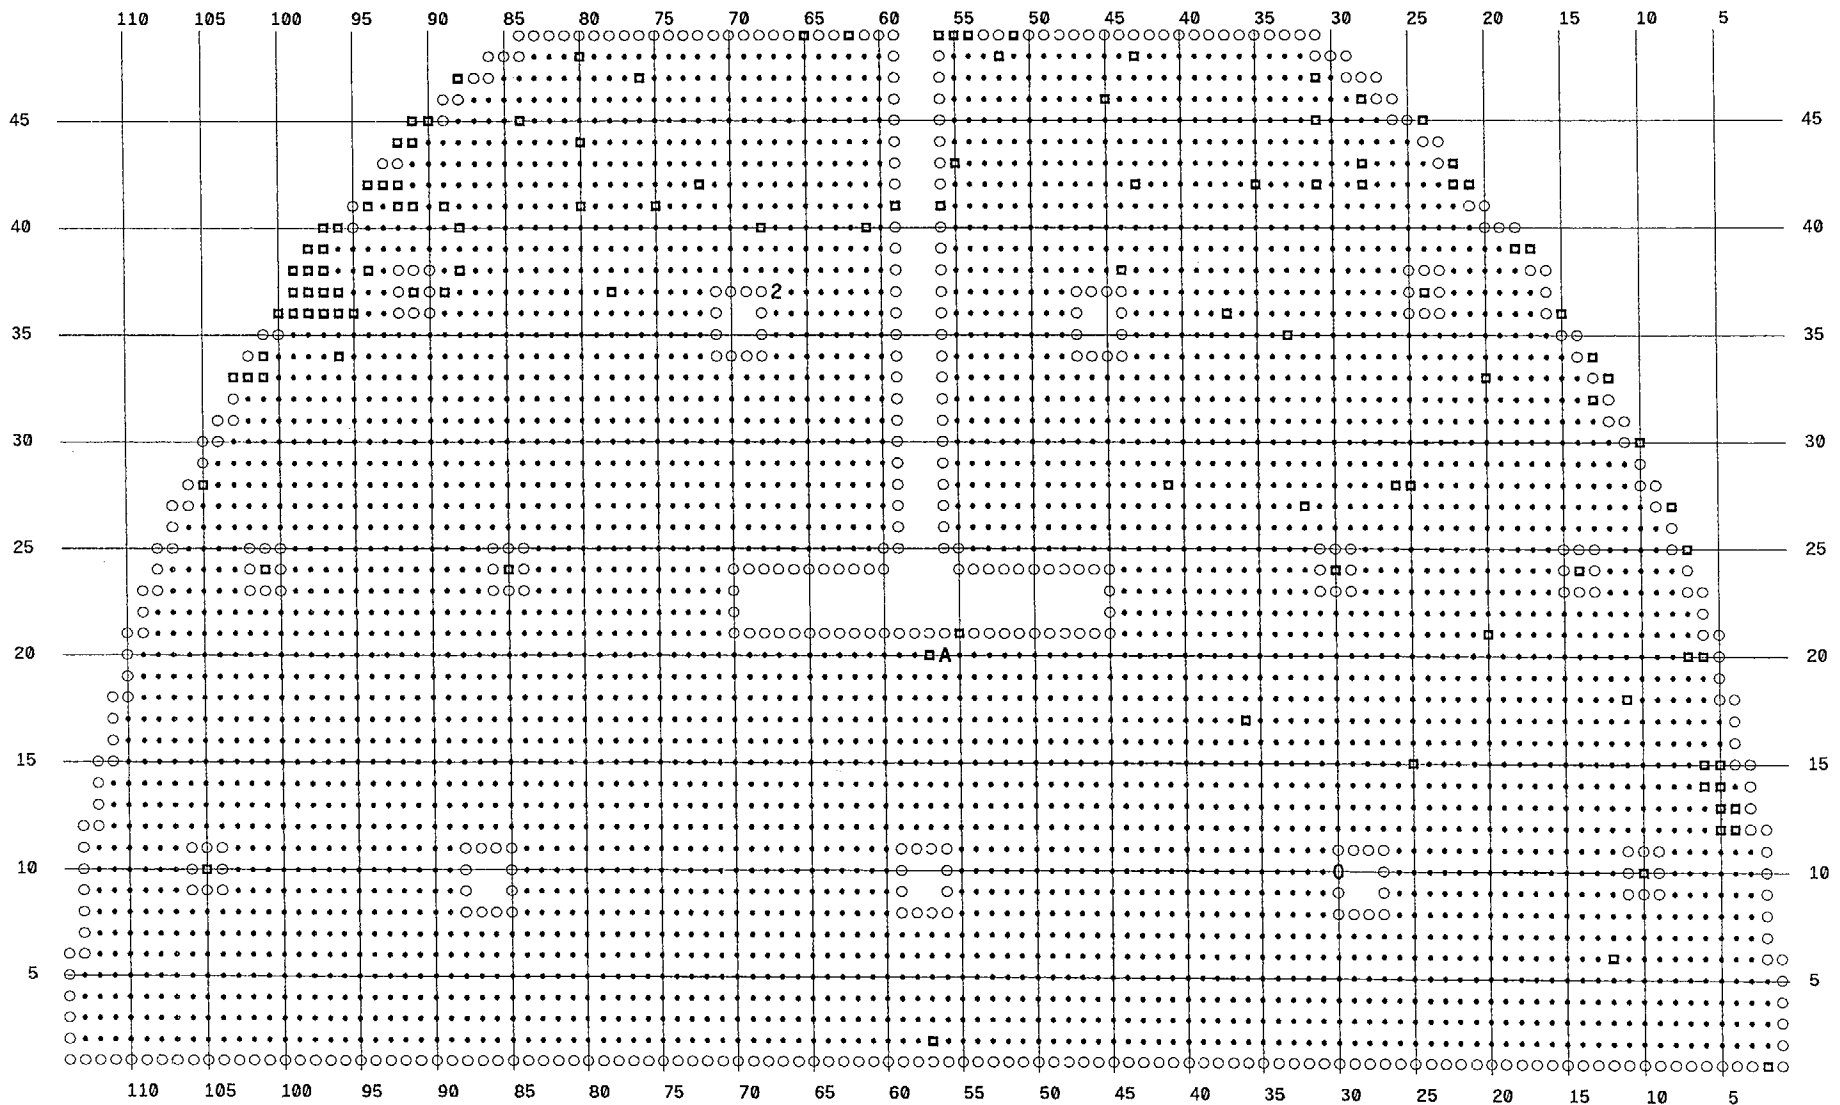
**FIGURE A.4**  
**SG B COLD LEG SPECIAL INTEREST INSPECTION SCOPE**

0 1 TEST 10C +19.00"/+24.00"  
 2 1 TEST 02C -1"/+7"  
 A 1 TEST 02C -1.00"/+3.00"  
 □ 117 PLUGGED TUBE

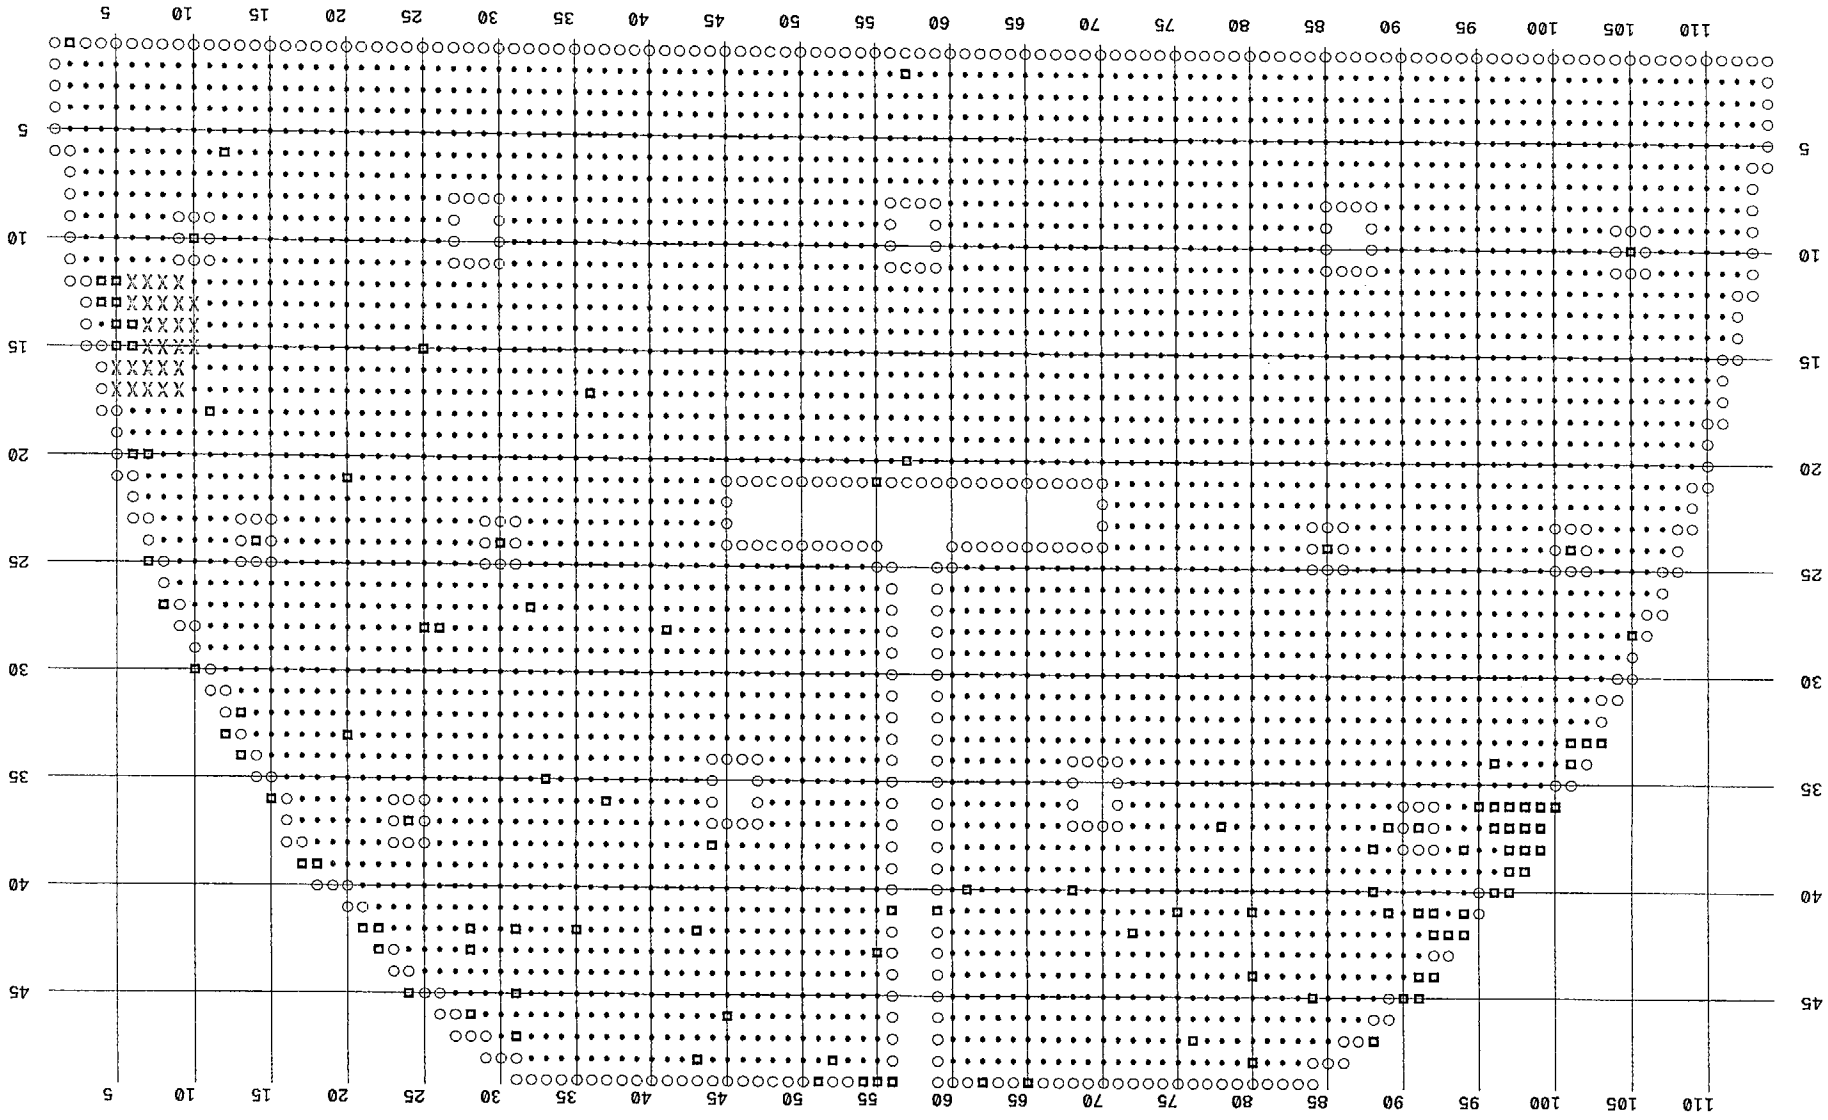
**FIGURE A.5**  
**SG B HOT LEG SPECIAL INTEREST INSPECTION SCOPE**

X 27 TEST Ø5H - 1" / 4"

■ 117 PLUGGED TUBE
