**Subject: Beaver Valley Power Station, Unit No. 1 and No. 2  
BV-1 Docket No. 50-334, License No. DPR-66  
BV-2 Docket No. 50-412, License No. NPF-73  
ISI (Inservice Inspection) Program  
Response to RAI and Revised Relief Request**

#### RELIEF REQUEST NO. 1-TYP-3-B5.70-1, Rev. 2

Steam Generator Nozzle Safe End to Pipe Welds:

DLW-LOOP1-2-F-04      DLW-LOOP1-3-F-05

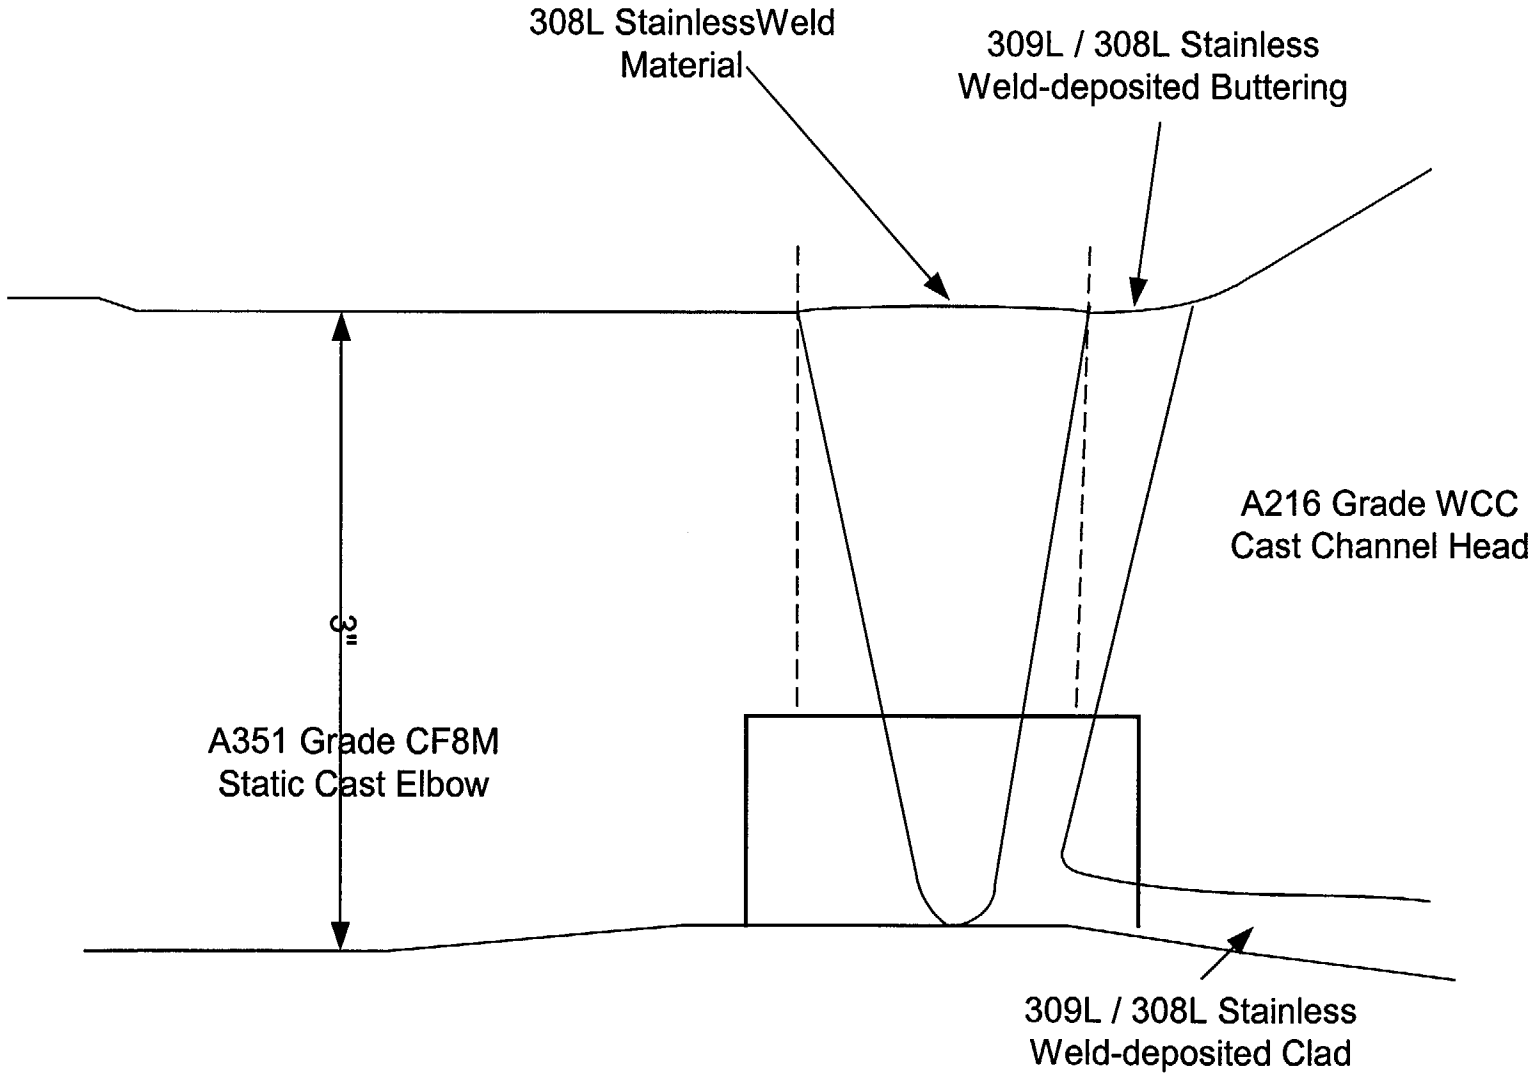
The weld configuration and materials shown in Figure 1 are derived from fabrication drawings and ultrasonic profiling. The welds are 308L filler material joining A351 Grade CF8M cast stainless steel elbows to A216 Grade WCC steam generator channel heads. The channel heads are clad with 309L/308L stainless steel and the weld – deposited safe-ends are made with 309L/308L stainless steel material.

Beaver Valley Power Station Unit 1 Steam Generator Channel head to Elbow Weld Configuration (Typical)

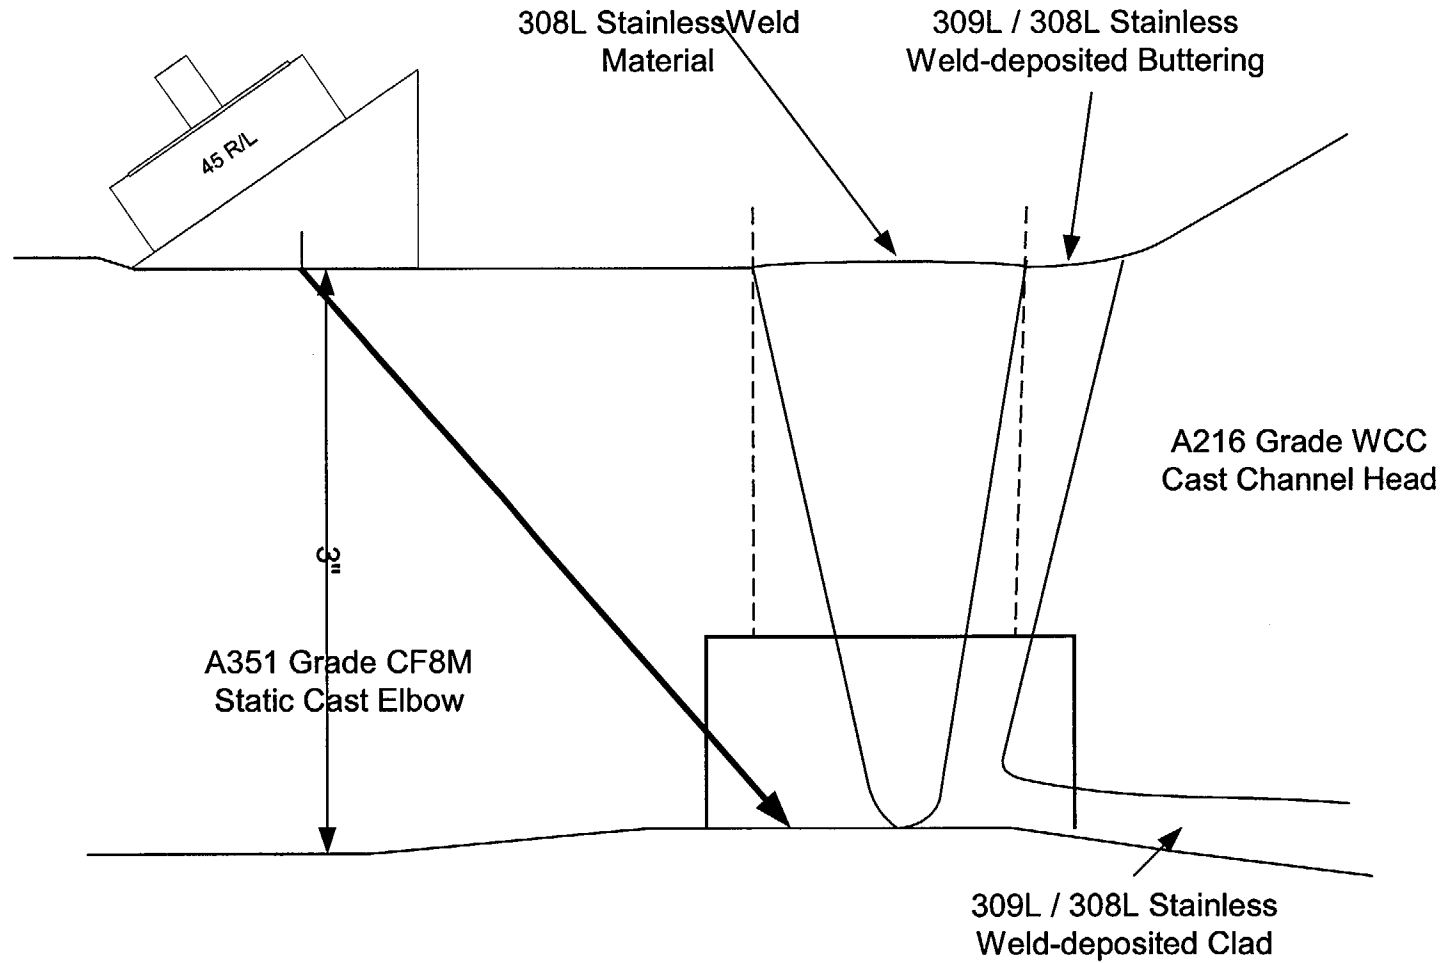
Figure 2

the required examination volume. The newly identified circumferential scan limitation is based on limited coverage of the inside diameter (ID) surface on the nozzle side of the weld (Illustrated in Figure 2). Shallow, inside diameter axially oriented flaws on the nozzle side of the required volume may not be detected, however the probability of detection of such hypothetical flaws would increase significantly if they grew to significant through-wall dimension, because through-wall growth would also result in a corresponding increase in flaw length. Surface examinations (liquid penetrant) are also performed on these welds at the same frequency as the volumetric UT examination.

Axial Scan Direction 1 - Search Unit at maximum distance from weld centerline - raster scan into the weld and HAZ

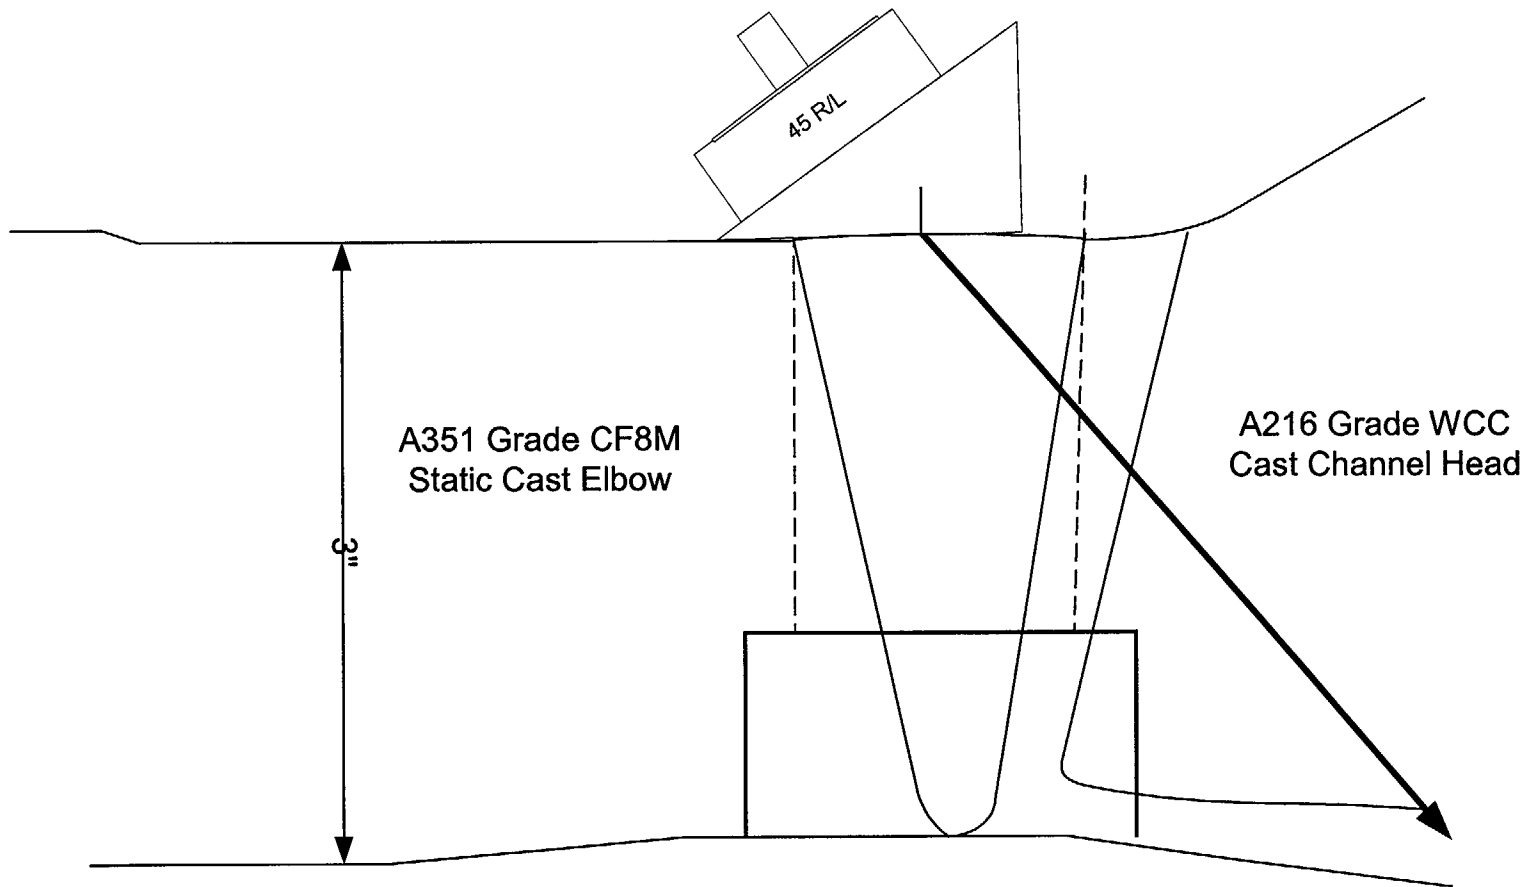
Figure 3

Axial Scan Direction 1 - search unit moved across weld - toward channel head

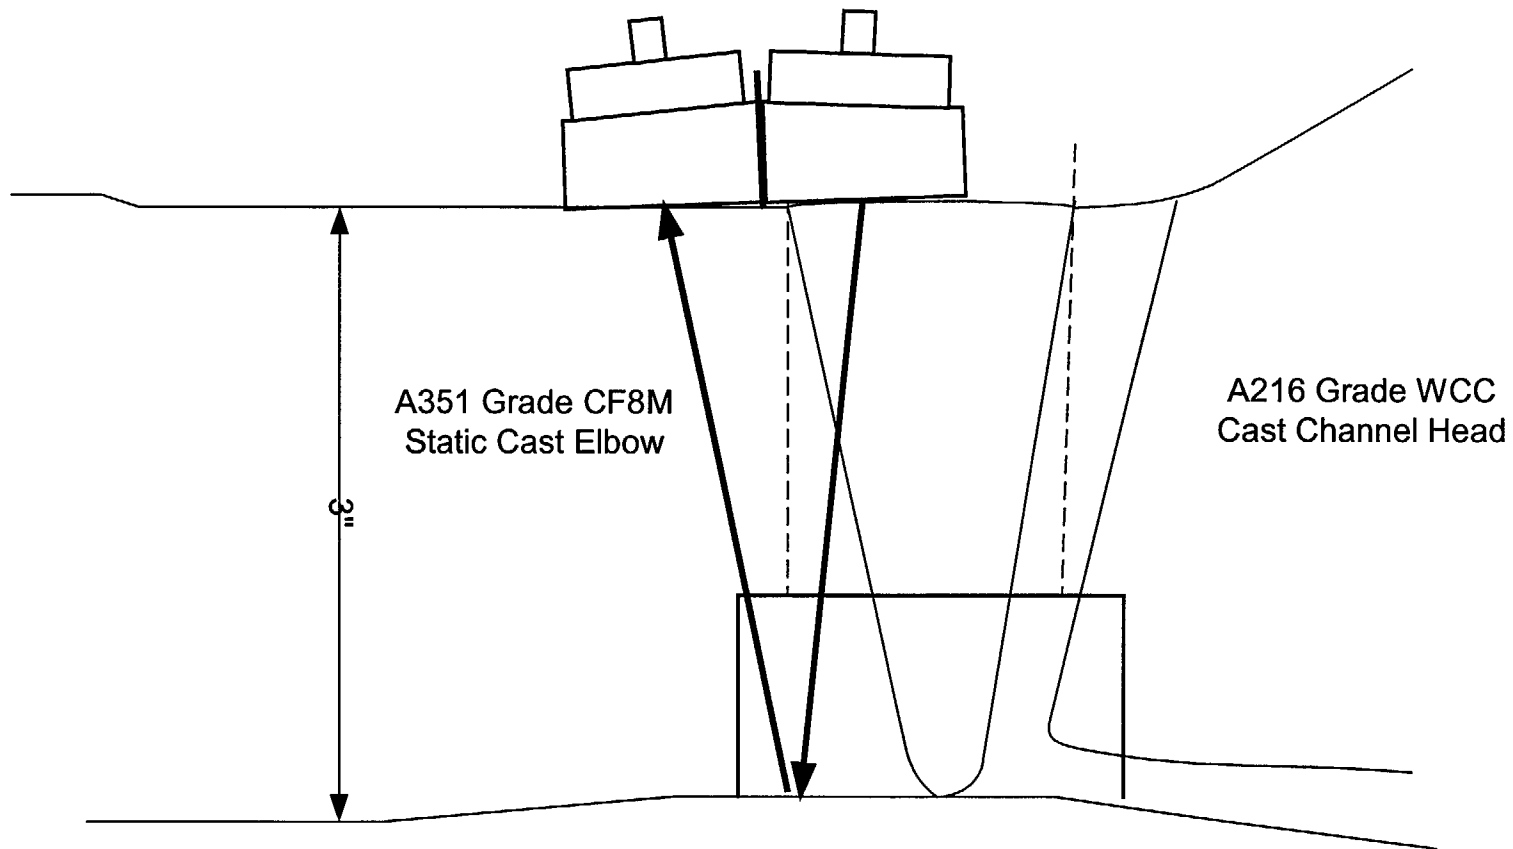
Figure 4

Circumferential Scan directions 3 & 4 - dual element contoured wedges scanned adjacent to and on the weld surface

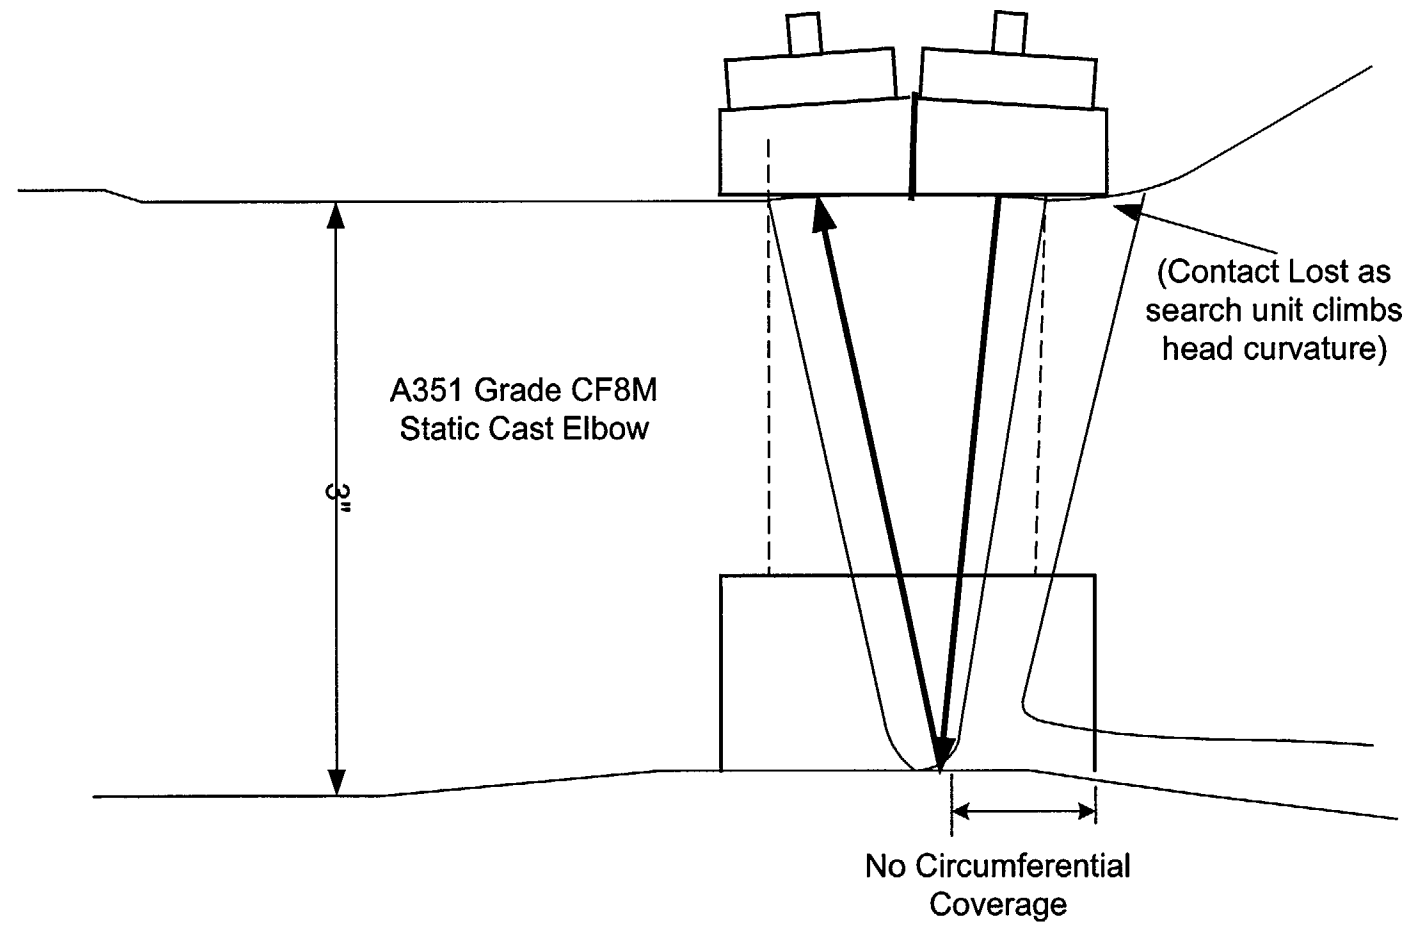
Figure 5

Circumferential scan directions 3 & 4 - scan coverage shown with contoured search unit on the weld at the point where loss of contact due to curvature starts.

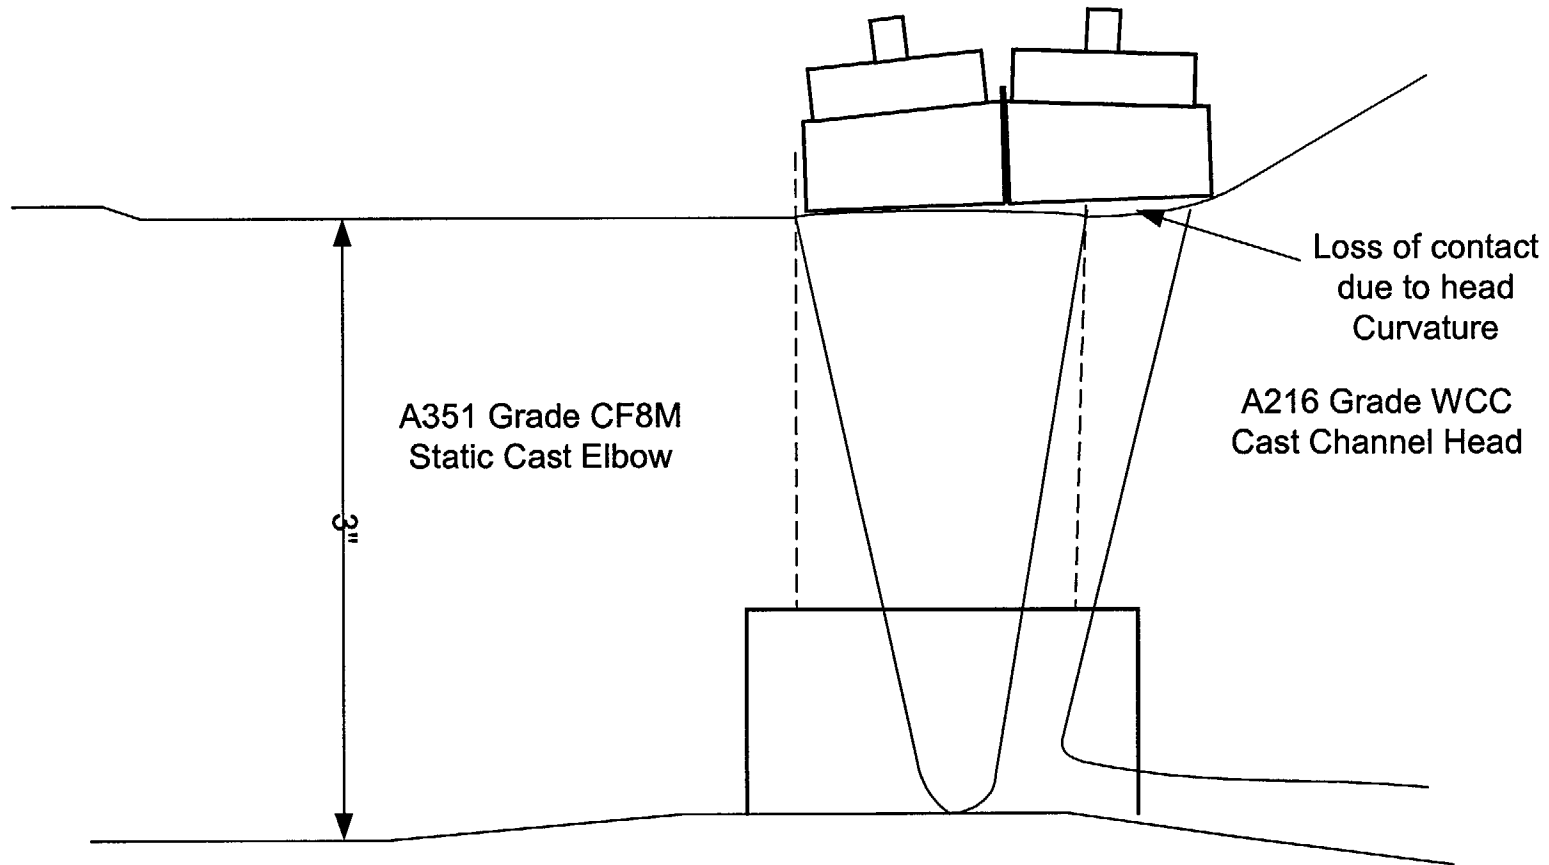
Figure 6

The identified circumferential scan limitations are believed to be the result of differences in examiner technique. Past experience in the examination of this weld configuration has shown that large contoured

search units require much more couplant than smaller search units. Liberal application of couplant can often overcome some of the surface irregularities that cause loss of contact. In the most recent examinations, the examiner felt that there was a sufficient loss of contact to result in a limitation, which was identified on the examination report.

Circumferential Scan directions 3 & 4 - Search unit contact lost when the search unit climbs the channel head curvature

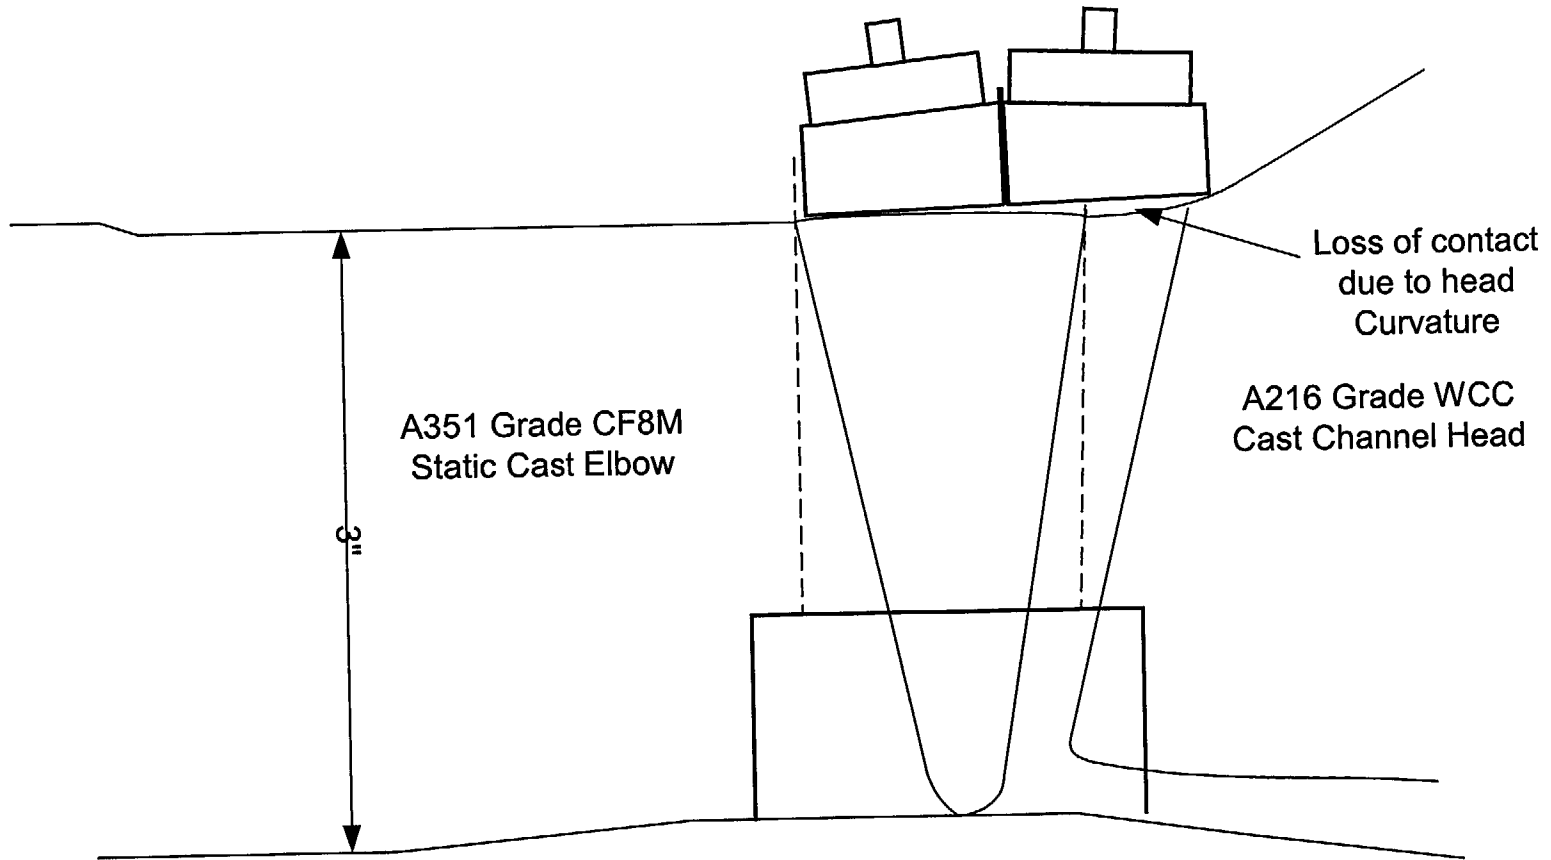
Figure 1

Previous examinations identified a limitation in axial scan direction 1 due to the distance from the weld to the edge of the machined surface on the elbow. This reported limitation may have been conservatively calculated. Subsequent examinations and plots on the profiled weld area have shown that this distance is adequate to attain coverage of the required volume in axial scan direction 1. Ultrasonic examinations performed during the current (3rd) Inspection Interval on the two welds resulted in complete coverage in axial scan direction 1, no coverage in axial scan direction 2 and a newly identified limitation that resulted in 55% coverage in both circumferential scan directions 3 and 4. This results in a total coverage of approximately 52% of the required volume. This limitation is illustrated in Figure 1.

Circumferential Scan directions 3 & 4 - Search unit contact lost when the search unit climbs the channel head curvature

The alternative to the examination requirement will be to use the completed surface examination and the completed ultrasonic examination that were performed to the maximum extent possible. The percentage of the required examination volume that was limited was recorded on the examination report and in the outage summary report.
